Summary Report

Lock and Dam 24 Physical Model, Upstream Scour

By: Timothy J. Lauth
Hydraulic Design Section
US Army Corps of Engineers St. Louis District
1222 Spruce St.
St. Louis, MO 63103-2833

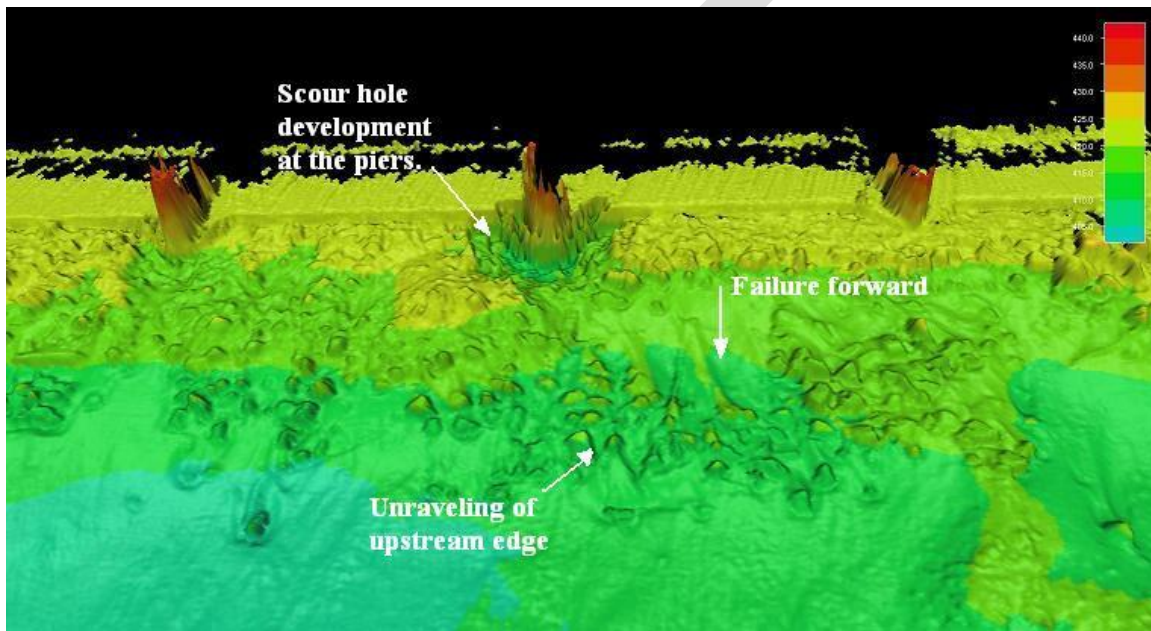
Figure 6 - February 15, 2012 Hydrographic survey

7. February 15, 2012 – Almost no change occurred in the 5 months between surveys; the single aberration is scour up to -6 ft in front of Gate 7 and Pier 8.

The main objective of the Lock and Dam 24 physical model testing was to develop a means of reducing or eliminating scouring of the upstream stone bed protection. Because of the goal-specific nature of the investigation, the testing schedule was often evolutionary as compared to regimented. To develop a means of reducing or eliminating scour, conditions representative of the scour occurring at the prototype needed to be generated in the model. Two different scour patterns were required for the model scour to be considered representative: 1) scour hole development around the piers, and 2) unraveling of the upstream edge of the stone bed protection leading to protection failing forward (Figure 6).

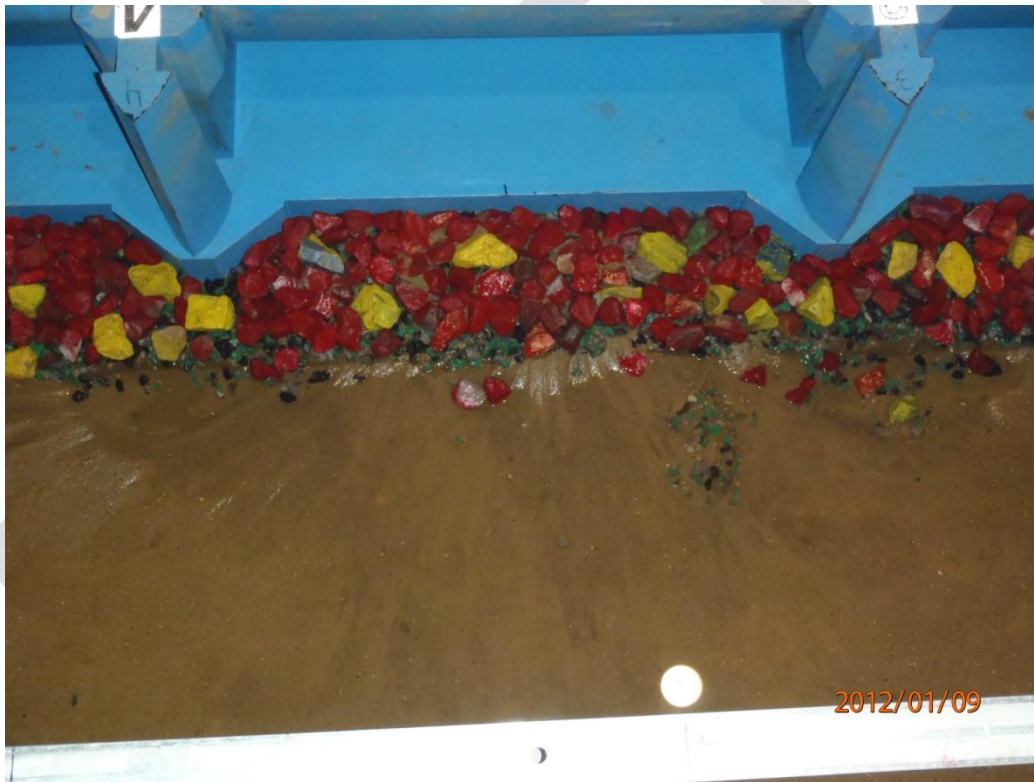
Figure 7 - Variable 3 center gates, 10 ft ice raft draft

The testing proceeded with the modeling of the build-up of ice using the ice raft as done in the Mel Price Scour modeling. Testing was conducted with the ice raft drafting 10 ft and gates 1, 2, and 3 open at multiple heights starting at 5 ft and increasing in 2 ft increments. The filter cloth was buried 6 inches below the sand elevation. This test format, with a slightly increased draft, successfully replicated the scour occurring at Mel Price Lock and Dam during the Mel Price model testing. These tests for the Lock and Dam 24 model led to little scour, and the scour that did occur was not indicative of the scour adjacent to the piers at the prototype (**Figure 7**).

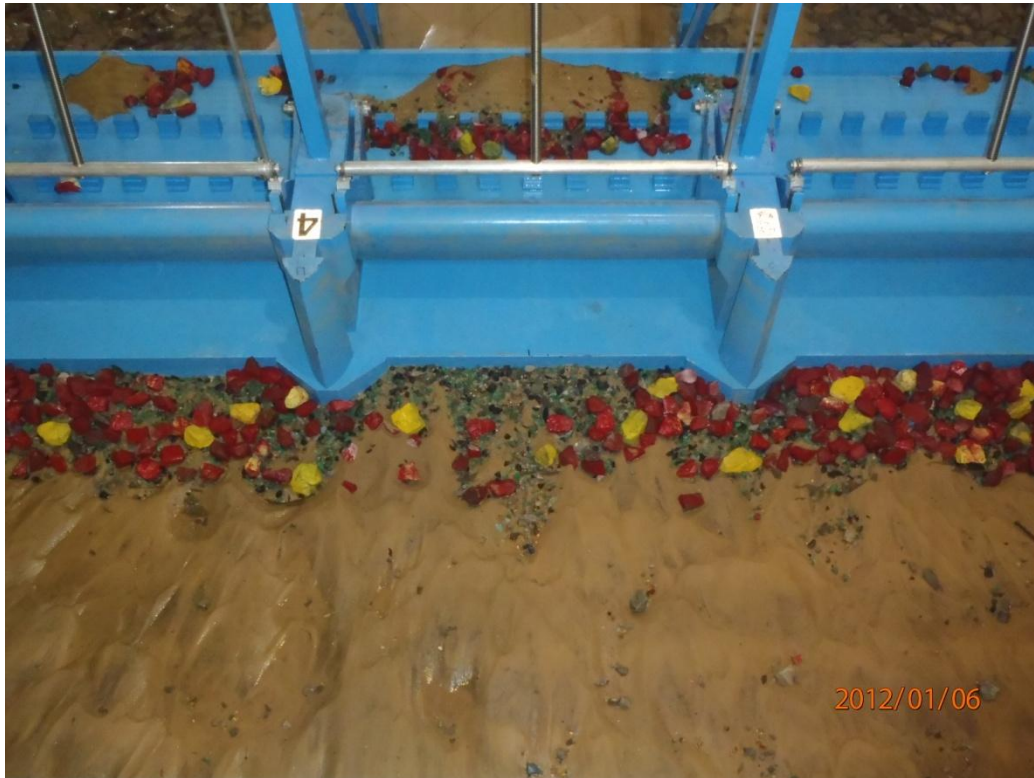
Figure 8 - Variable 3 center gates, 15 ft ice raft draft

The tests were repeated with the draft of the ice raft increased to 15 ft. Additional scour occurred, but the scour was once again not representative of the scour occurring in the prototype, where the scour was focused in front of the gates instead of the piers. This test with three gates open scoured away nearly all of the protection in front of Gate 3 with the little rock remaining in front of the adjacent piers (**Figure 8**).

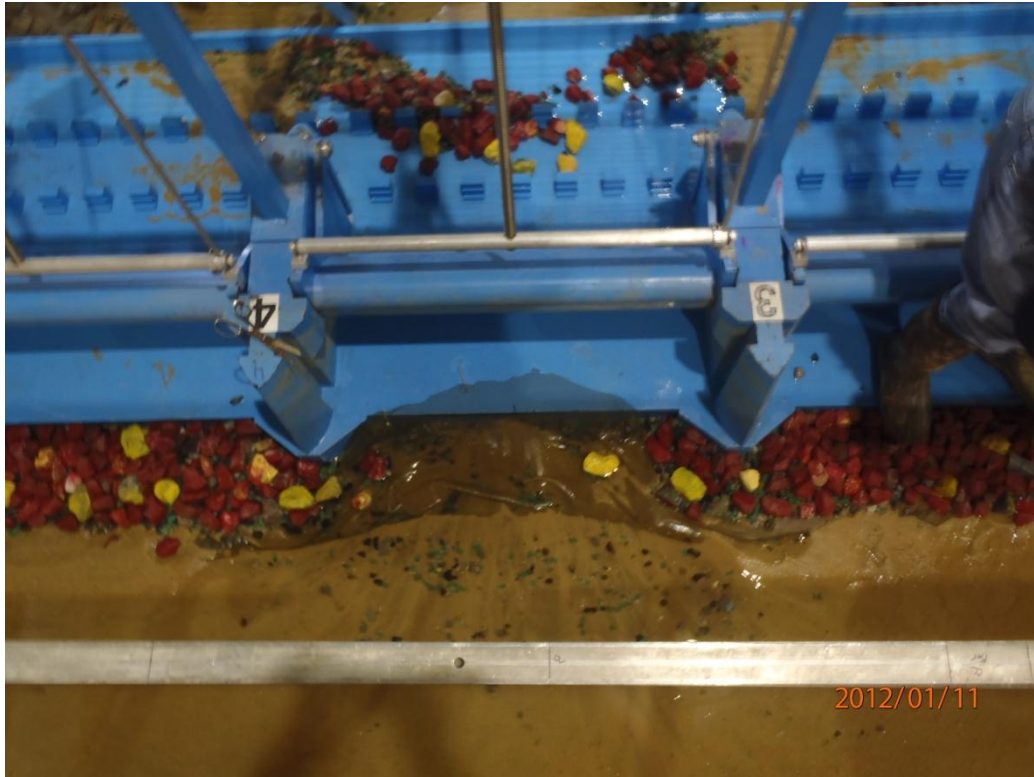
Figure 9 - Variable 3 center gates, 10 ft ice raft draft, filter cloth removed around piers

The 10 ft draft tests were repeated with the filter cloth directly below the stone protection instead of 6 inches below the surface. These tests also resulted in scour in front of the gates, and suggested failure due to the surface presences of the filter cloth. A modification was made by folding the filter cloth back around the pier to promote the stone settling instead of launching but this resulted in exaggerated scour upstream of the center gate due to the surface presences of the filter cloth (**Figure 9**).

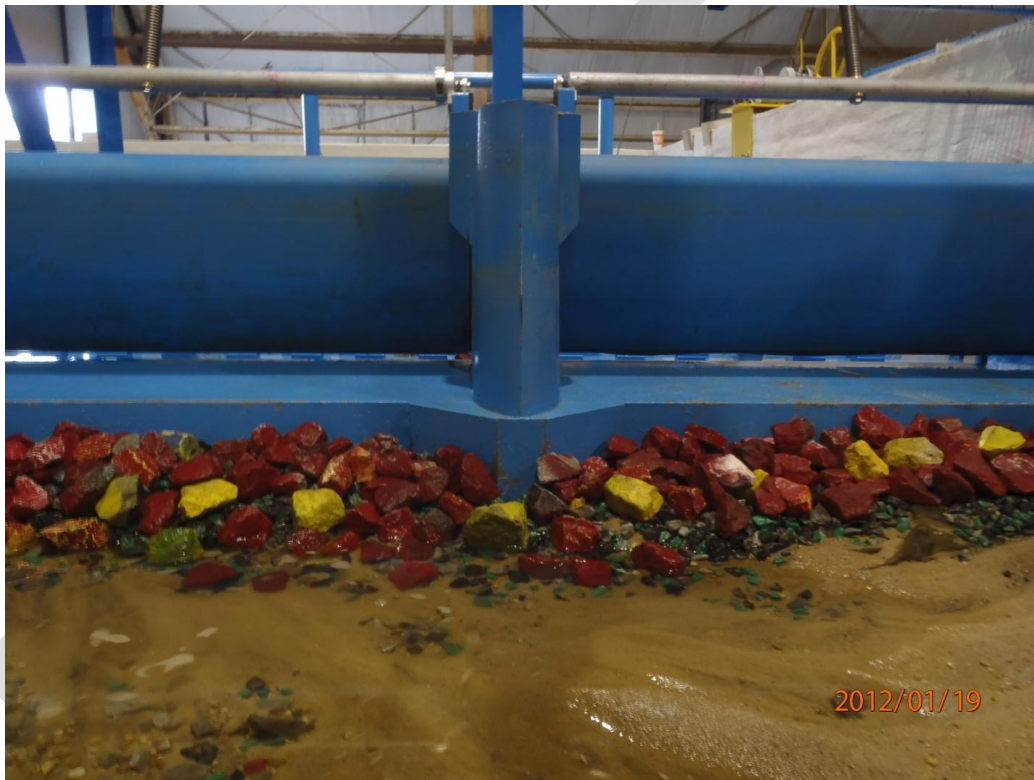
Figure 10 - 7 ft center gates, 20 ft ice raft draft

These tests did lead to representative scour along the leading edge of the scour protection and immediately adjacent to the pier. Comparing the results, a greater ice draft led to increased scour both upstream of the stone bed protection and at the dam piers.

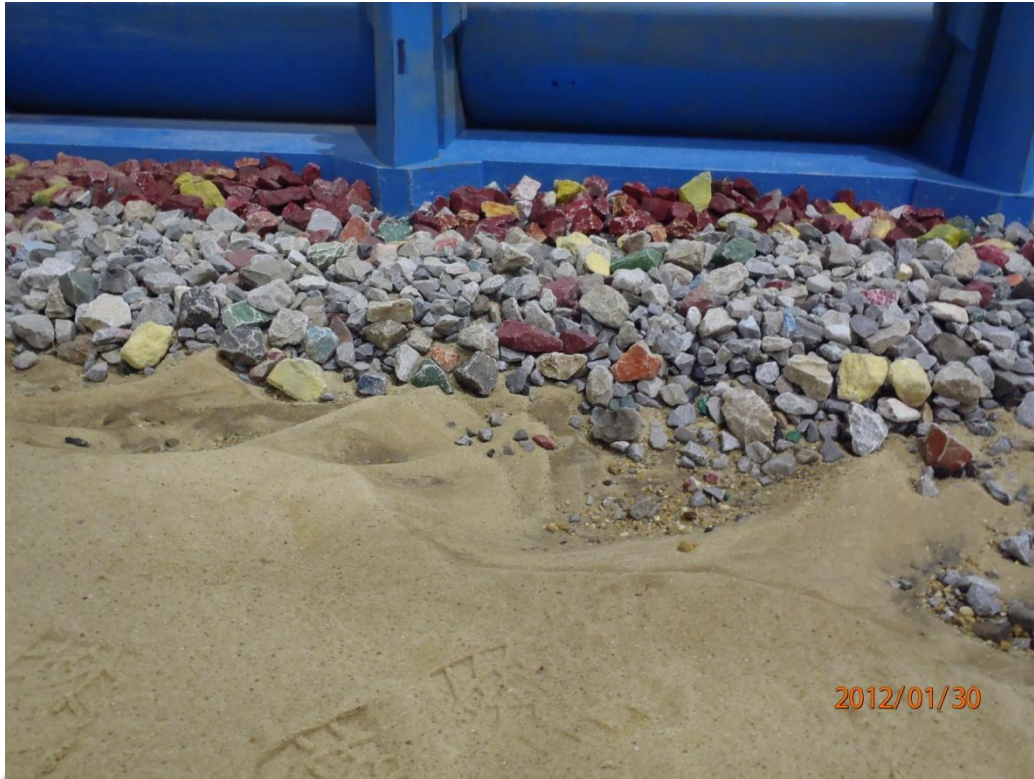
Figure 11 - 7 ft center gates, 20 ft ice raft draft, 30 ft stone protection extension

Once the prototype conditions were successfully re-created, extending the upstream stone bed protection was tested with the 5, 10, 15 and 20 foot ice drafts. The gate openings were increased from 7ft to 9ft to reflect a worse case of ice passage. While the tests resulted in bed scour upstream of the stone protection, the leading edge of the stone remained intact at each ice draft. The pier scour, however, was present at all draft conditions (**Figure 11**).

The second recommendation of this study is to extend the stone bed protection an additional 30 ft upstream of the Lock and Dam. The original design length for the stone bed protection was 21 ft; at this length, the upstream edge of protection nearly scoured enough to connect to the pier scour. Model testing supports that a longer length of stone bed protection both lessens the unraveling the leading edge of the upstream protection and supports lowered scour at the piers. This extension was found to be critical to the successful implementation of the side gate openings as a solution to scour reduction.

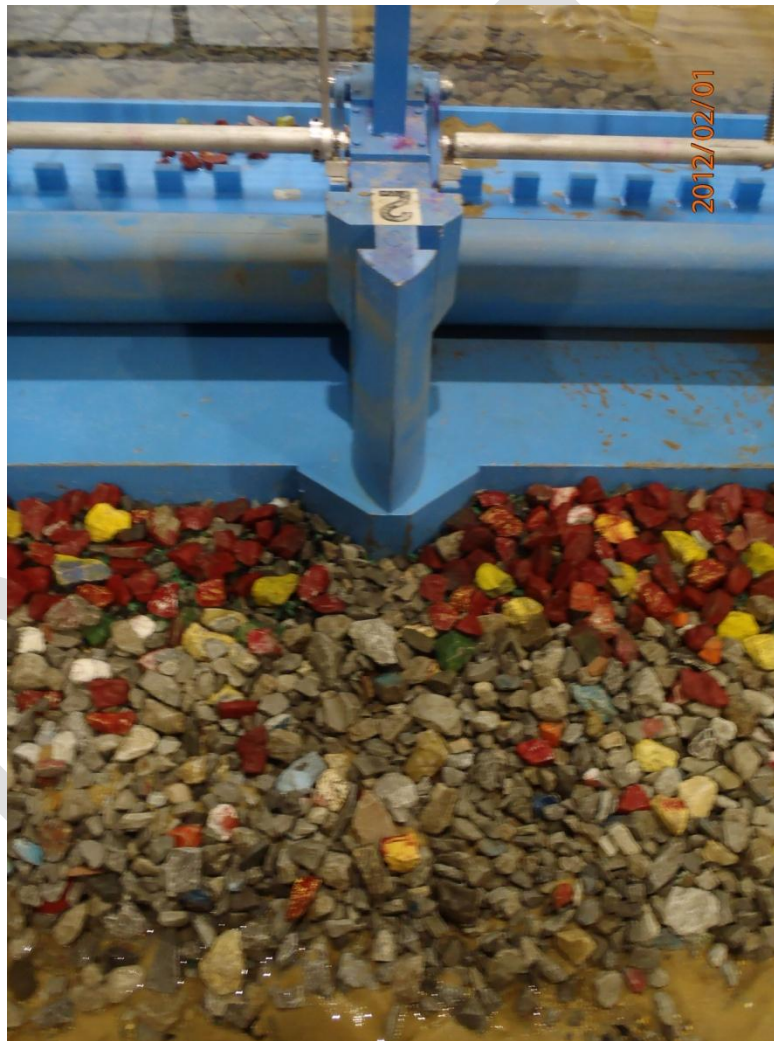
Figure 12 - 9 ft center gates, modified “A” stone over modified “C” stone

The pier scour was tested using different stone placements in the immediate vicinity of the piers. The first placement was based on the Lock and Dam 25 repair. This placement tested two conditions; 1) a pier location where 8 ft of scour had occurred, allowing for placement of both the “A” and “C” stone, and 2) a pier location where 4 ft of scour had occurred, allowing for placement of only “A” stone. For all tests with two placement conditions, a successful possible solution was determined to be a solution where a maximum of 4 ft of scour occurred at the pier on either placement condition. With the ice draft set to 15 ft, the maximum scour depth observed in the first condition was approximately 6 ft (**Figure 12**); the maximum observed in the second condition was approximately 8 ft. Both conditions were more than enough to potentially reach the pier base.

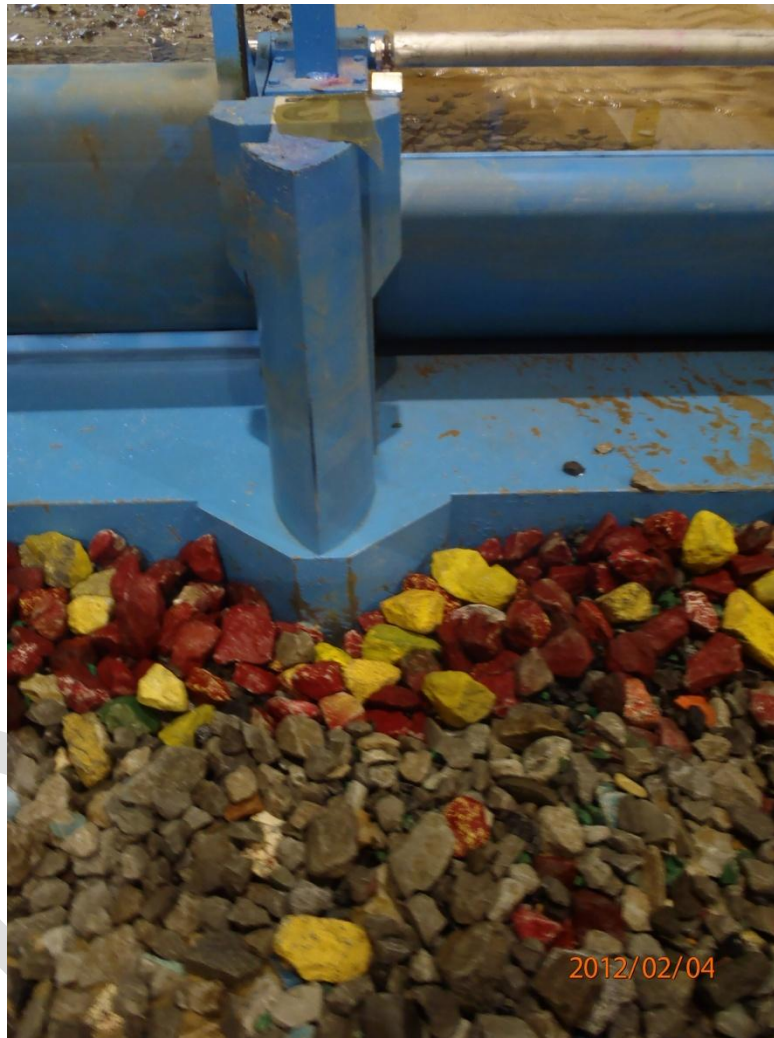
Figure 13 – 9 ft center gates, derrick stone over modified “C” stone

The second placement tested was based on using derrick stone as the top layer of stone protection. Two conditions were again tested: 1) a pier location where 8 ft of scour had occurred, allowing for placement of both the derrick stone and modified “C” stone, and 2) a pier location where 4 ft of scour had occurred, allowing for placement of only derrick stone. The tests for these two conditions both yielded a maximum scour depth of 5-6 ft at the piers (**Figure 13**).

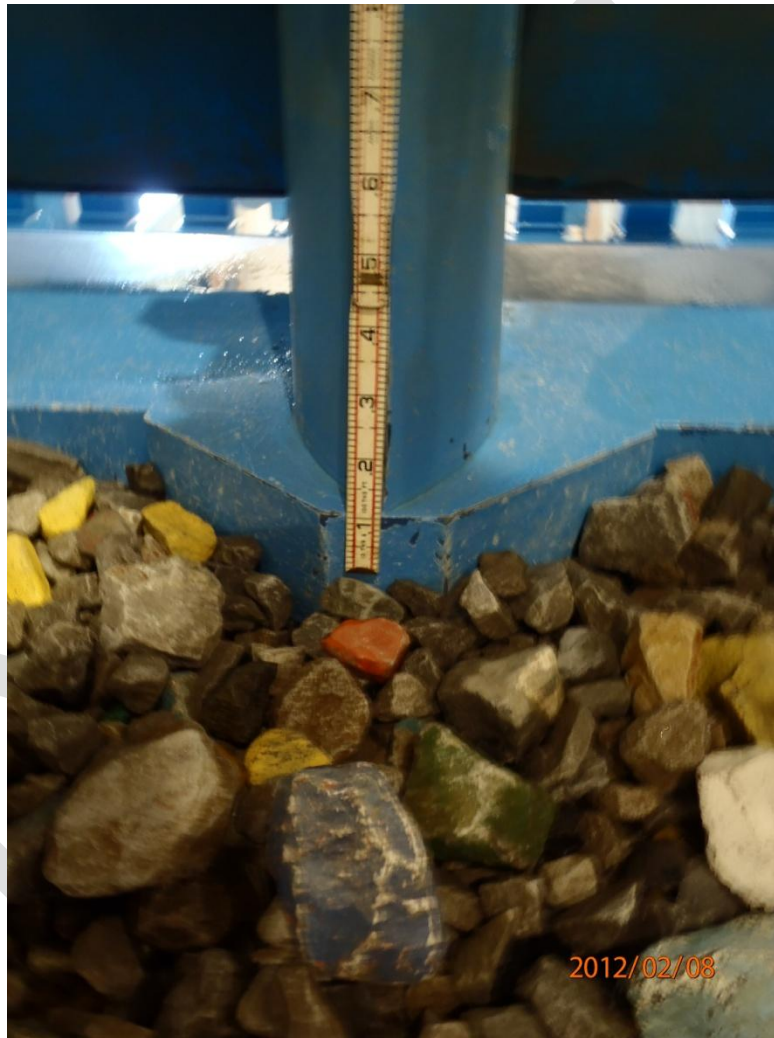
Figure 14 - 9 ft center gates, 5 ft side gates, modified "A" stone over modified "C" stone

After the stone placements were tested, the model was run with the gates adjacent to the main ice passage gates open. For these tests, the three center gates of the model were held open 9 ft with the two outer gates opened 1, 3 and 5 feet. These openings were tested for two stone placements: 1) an 8 ft scour hole filled with the L&D 25 repair and 2) a 4 ft scour hole filled with modified "A" stone. The side gates open 1ft produced a maximum of 9 ft scour in the immediate vicinity of the pier and the 3 ft open tests produced a maximum of 8 ft scour. The 5 ft side gate open tests, however, produced a maximum scour depth of 3-4 ft at one gate with the other gates experiencing less than 3 ft of scour (**Figure 14**).

The first recommendation of this study is to open the gates adjacent to the main ice passage gates at least 5 ft during ice passage situations. Opening the adjacent gates limits the formation of vortices around the piers as the river flows through the open gates and lowers the near-bed velocity which will reduce the transport of sands and protection stone. This was found to reduce scour to a maximum of 3-4 ft in the model, a depth above the pier base elevation not threatening the sheet pile cutoff wall.

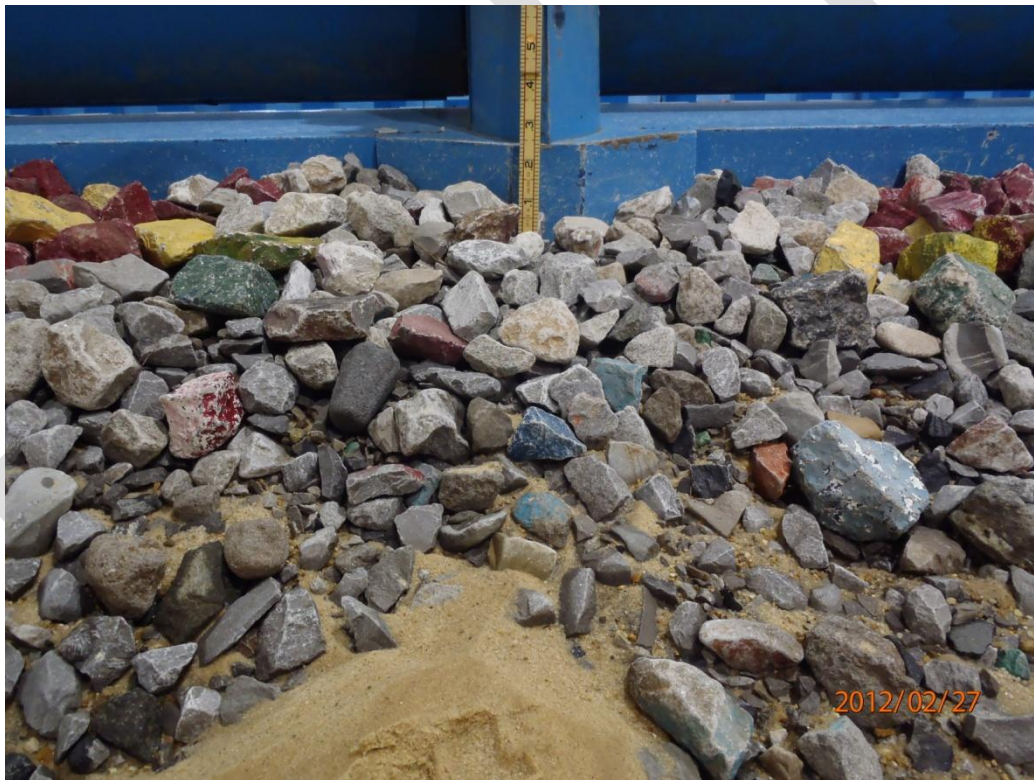
Figure 15 - 9 ft center gates, 5 ft side gates, 15 ft protection extension

A test with a 15 ft extension of the stone bed protection produced 5 ft of pier scour and, although the upstream protection edge again unraveled, the stone protection in front of the gates was more stable than in previous tests (**Figure 15**). A re-testing of the 30 ft extension produced a scour depth of approximately 3-4 ft with little unraveling of the upstream edge of protection.

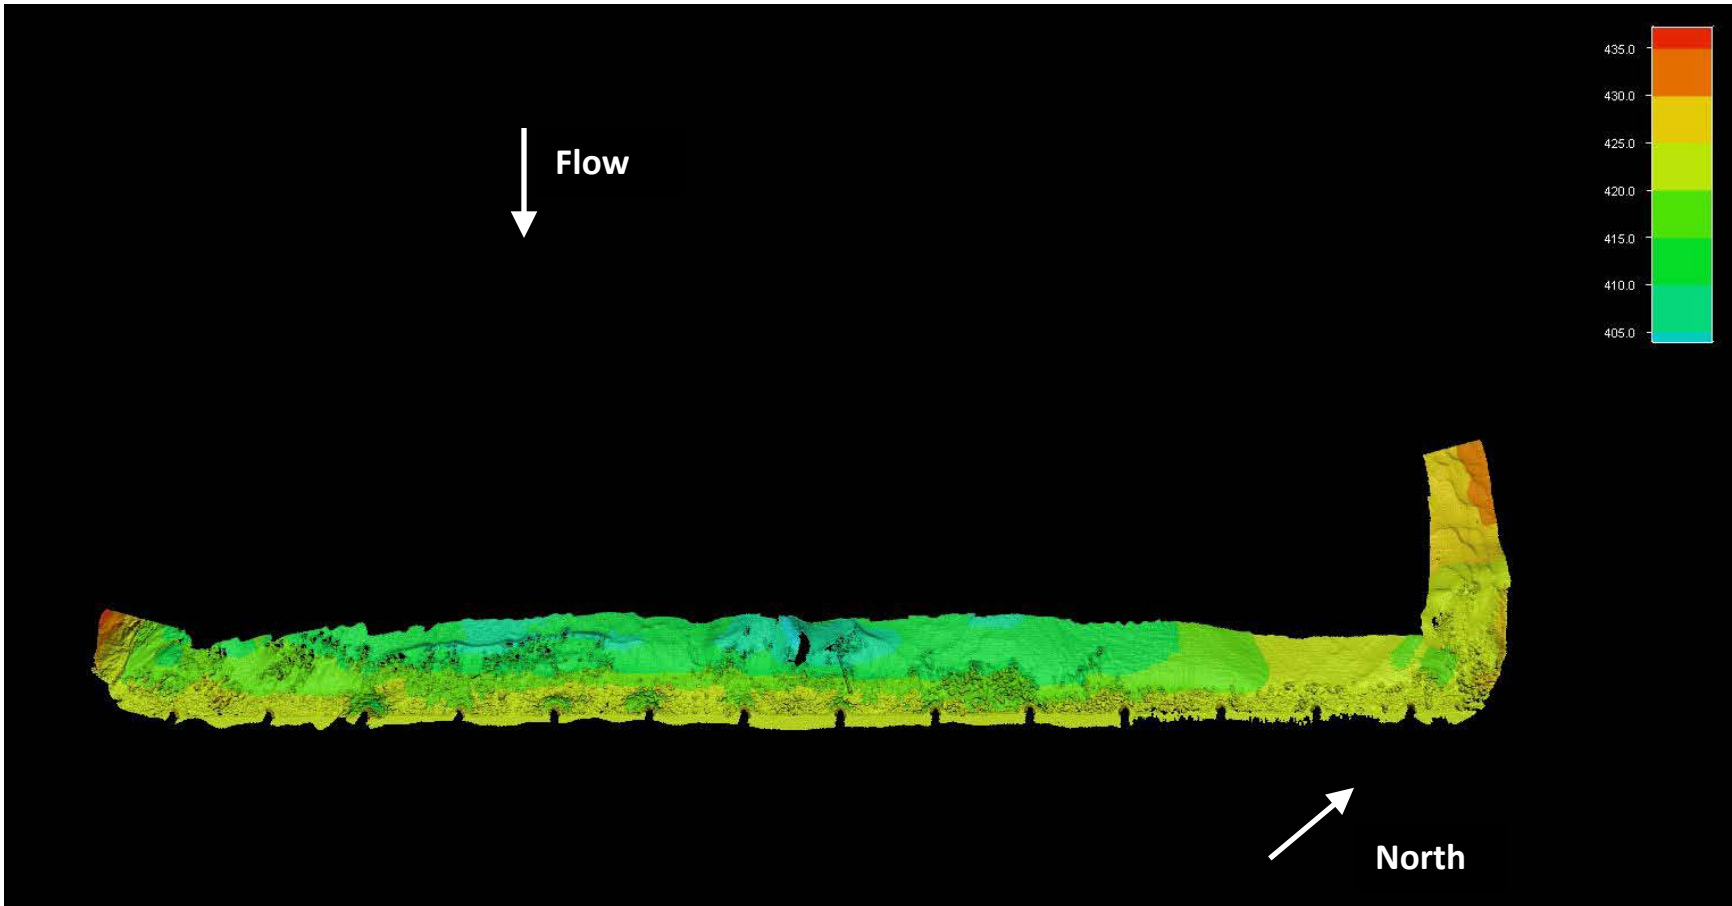
Figure 1 - 12-4-2007 Survey

1. December 4, 2007 – Scour holes are evident at Piers 4 thru 11, with no scour hole extending completely across a gate bay. The holes reached a maximum depth of approximately 10 ft (adjacent to Pier 4) which put the structure at a risk of undermining, as the concrete sill of the dam extends down only 6 ft.

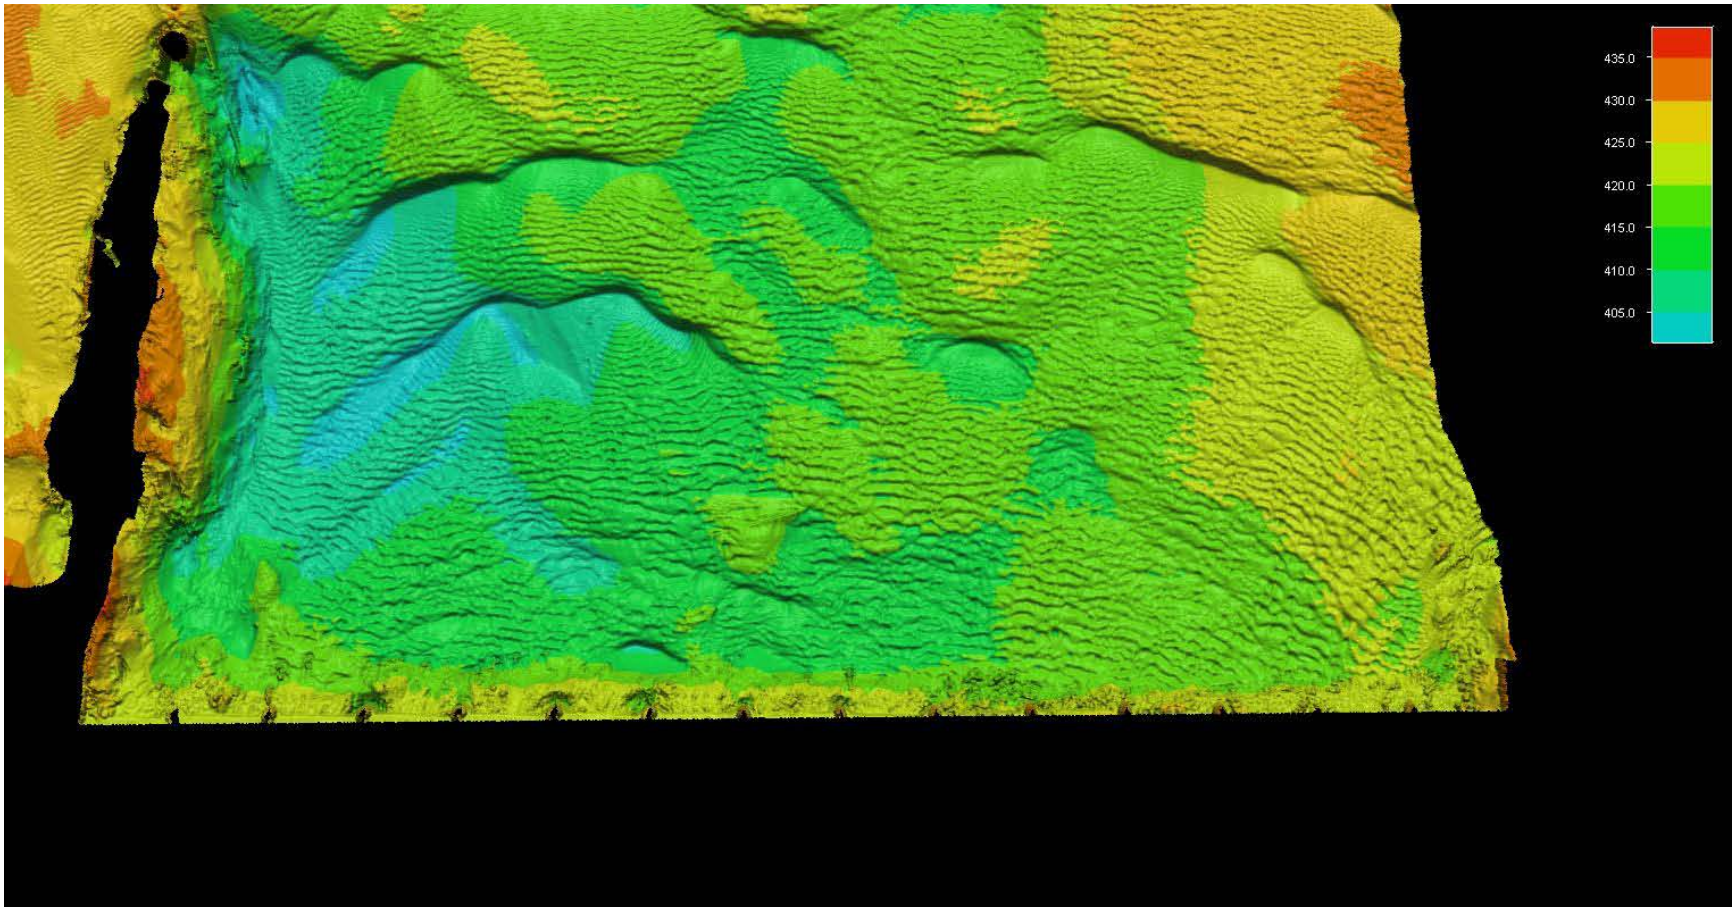
Figure 2 - 7-9-2008 Survey

2. July 9, 2008 – In the 7 months since the last survey, 1-2 ft of material were deposited in large areas upstream of the lock and dam. Further upstream, deeper deposition occurred upstream of gates 1 and 3 thru 12; scour occurred upstream of gates 13 and 14.

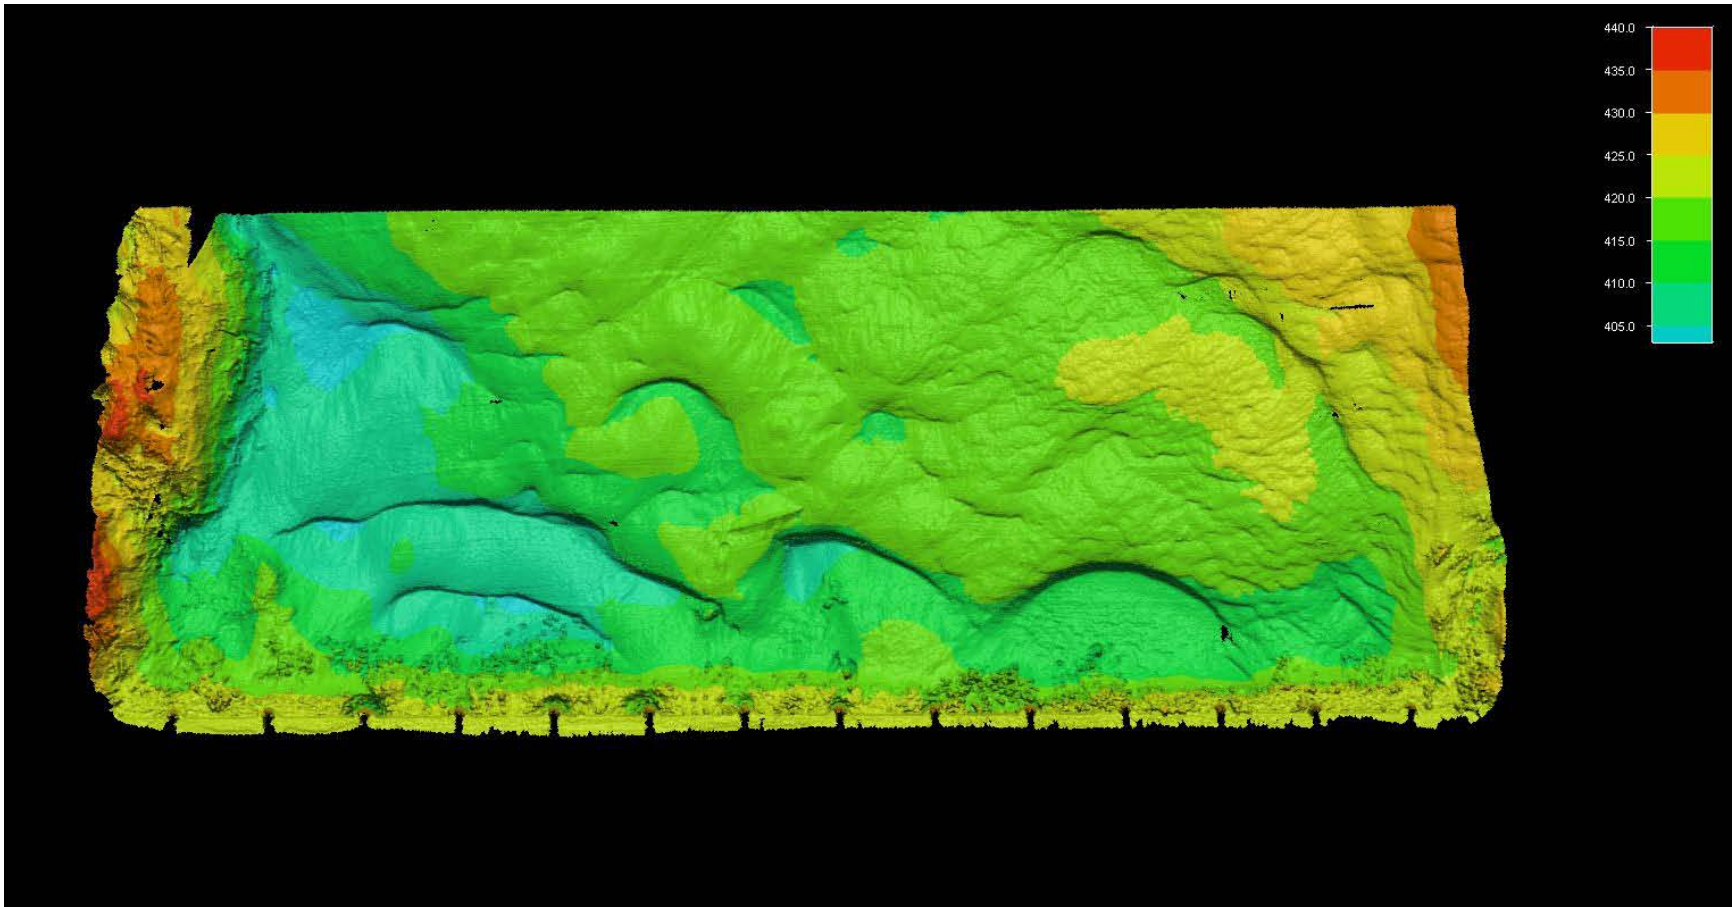
Figure 3 - 12-8-2008 Survey

3. December 8, 2008 – Five months later, the majority of the stone bed protection had changed ± 1 ft; what change outside of that occurred was a loss of material of -1 to -2 ft. Immediately upstream of the stone bed protection, losses of elevation up to -9 ft had occurred in multiple locations, though this was likely due to the passing of sand waves.

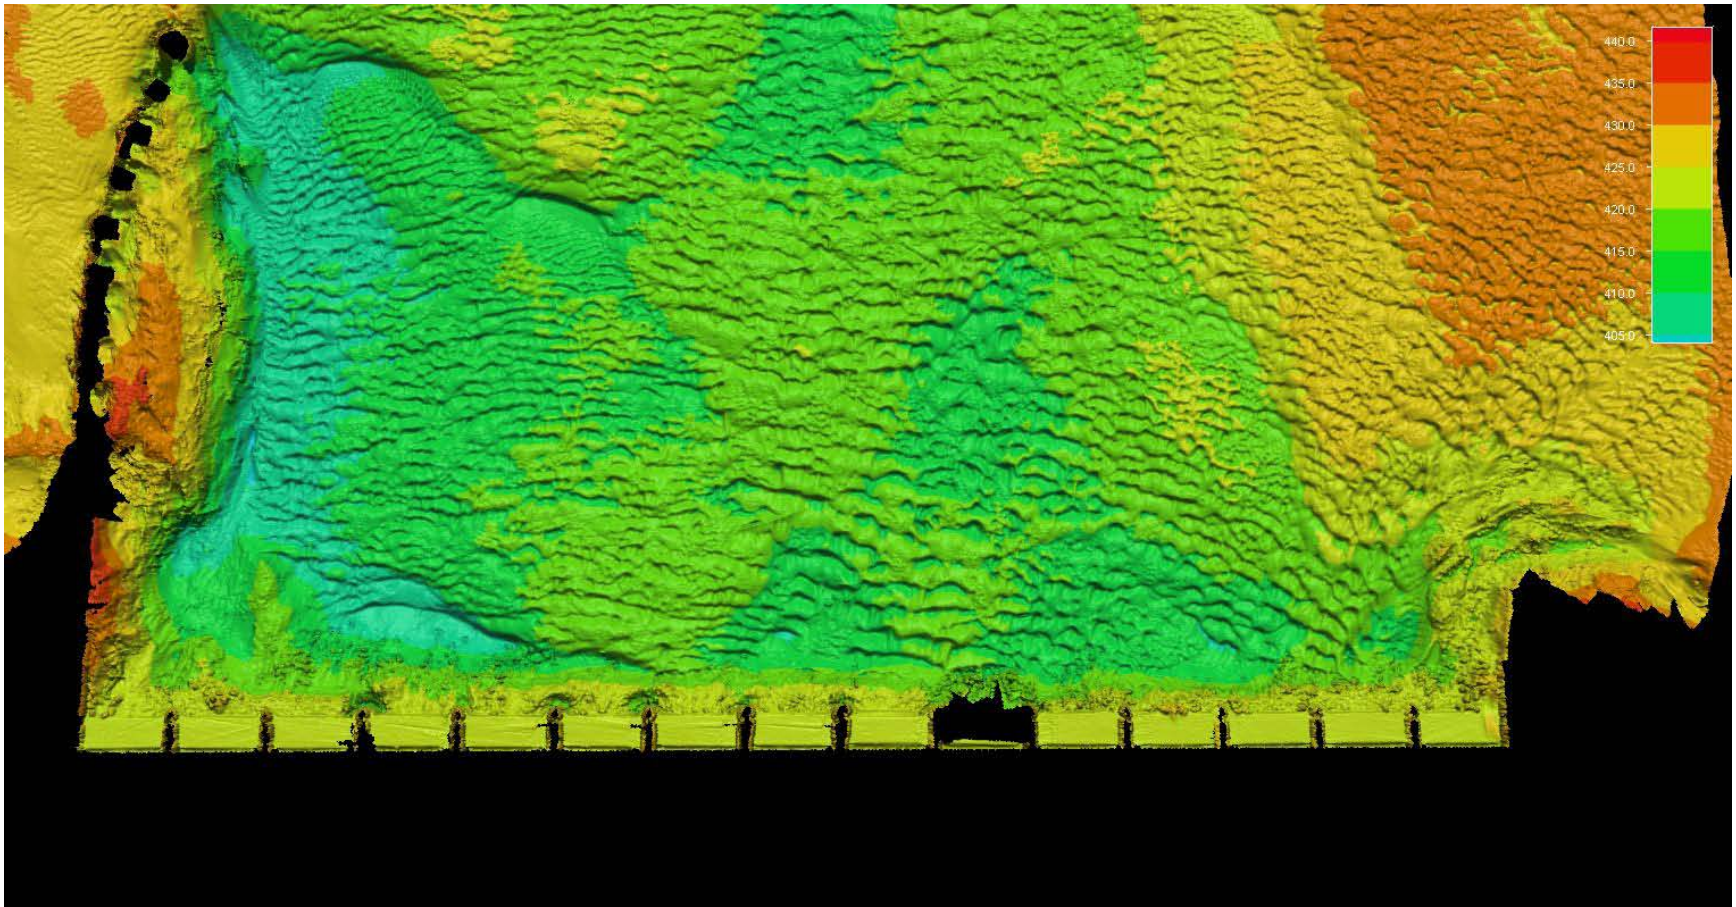
Figure 4 - 4-1-2009 Survey

4. April 1, 2009 – The first survey of the location performed in 2009 revealed little change in the stone bed protection in the preceding 4 months, and the change that did occur was typically +1 to +2 ft of aggregation. Upstream of the stone bed protection, the losses of elevation previously were once again gaining material, with gains of approximately +10 ft occurring in front of Gates 2 and 3.

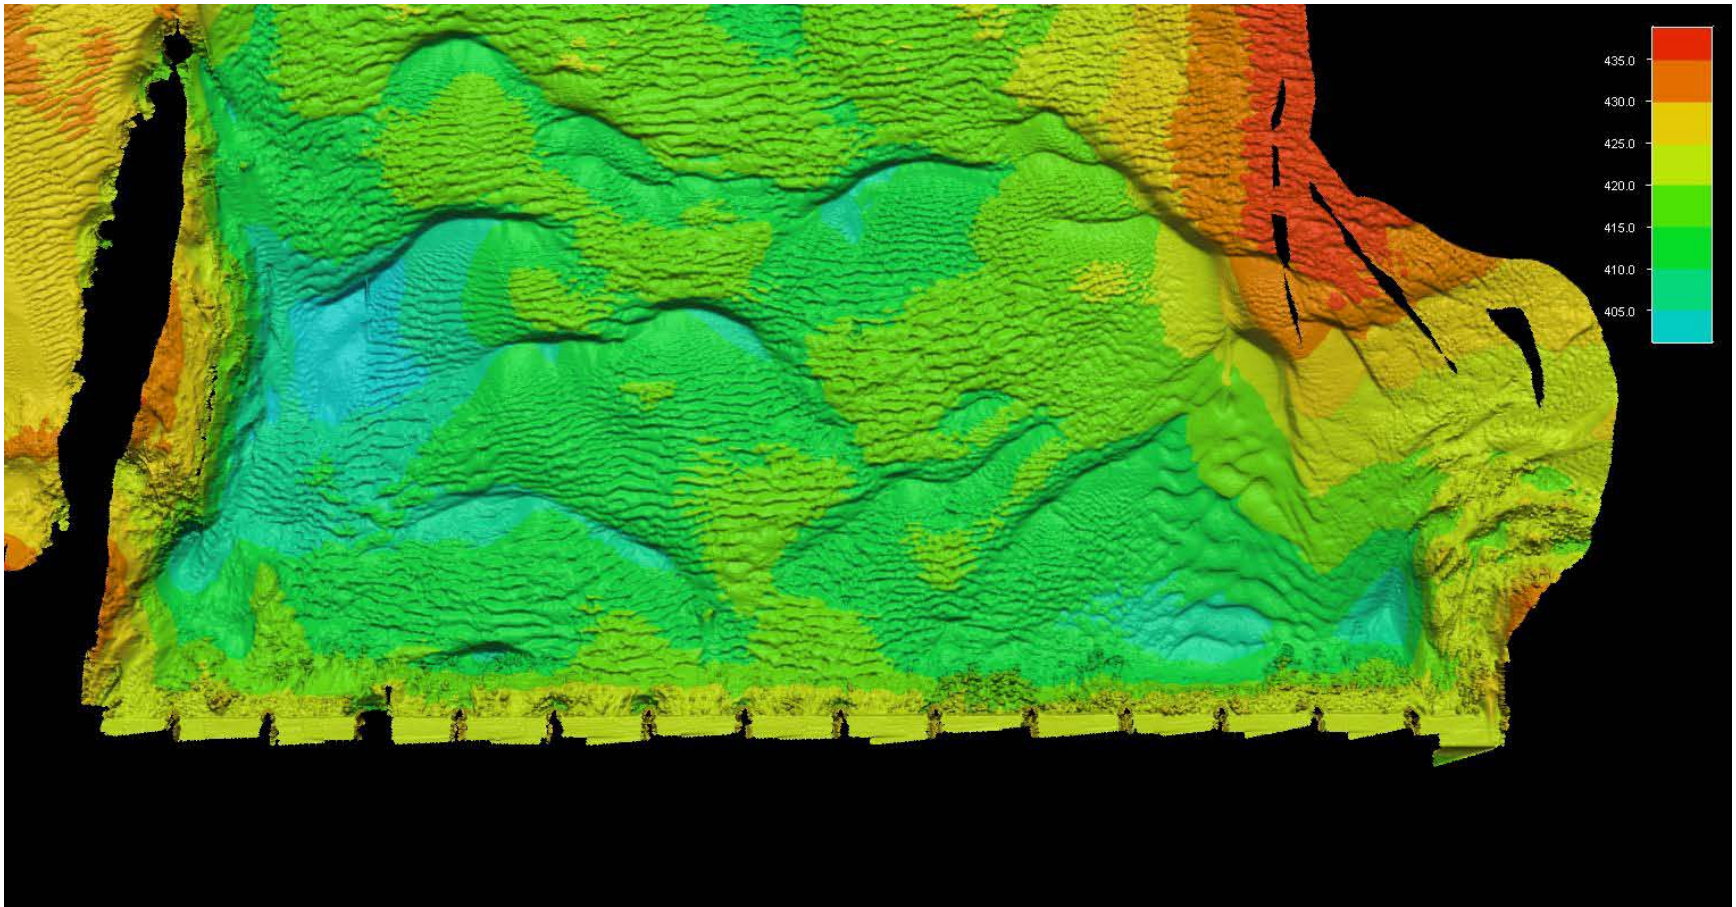
Figure 5 - 5-3-10 Survey

5. May 3, 2010 – No significant change was evident in the stone bed protection. Upstream of the protection, both areas of erosion and deposition were evident, with erosion prominent in the center and on the right descending bank side of the channel and deposition on the left descending bank of the channel.

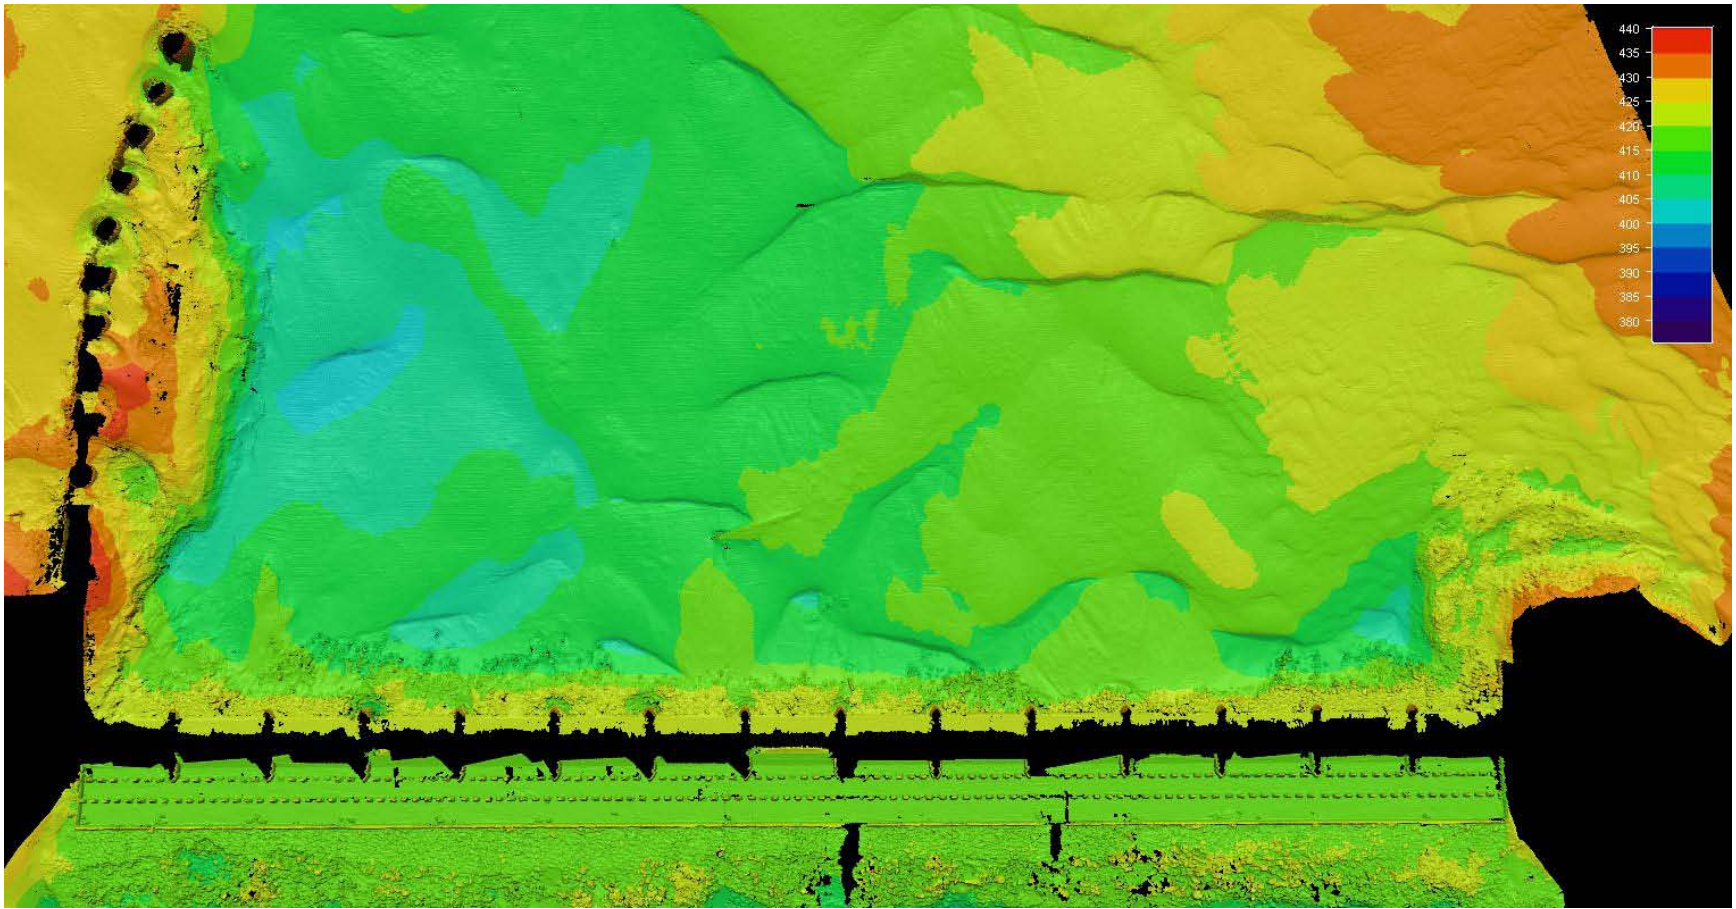
Figure 6 - 9-8-11 Survey

6. September 8, 2011 – In the 16 months since the previous survey, the stone bed protection exhibited little to no change; what change did occur was largely a loss of material of -1 to -2 ft. Changes upstream of the stone bed protection are split between deposition and erosion.
