May 2013

# DRY BAYOU – THOMPSON BEND

# DRY BAYOU – THOMPSON BEND REPORT

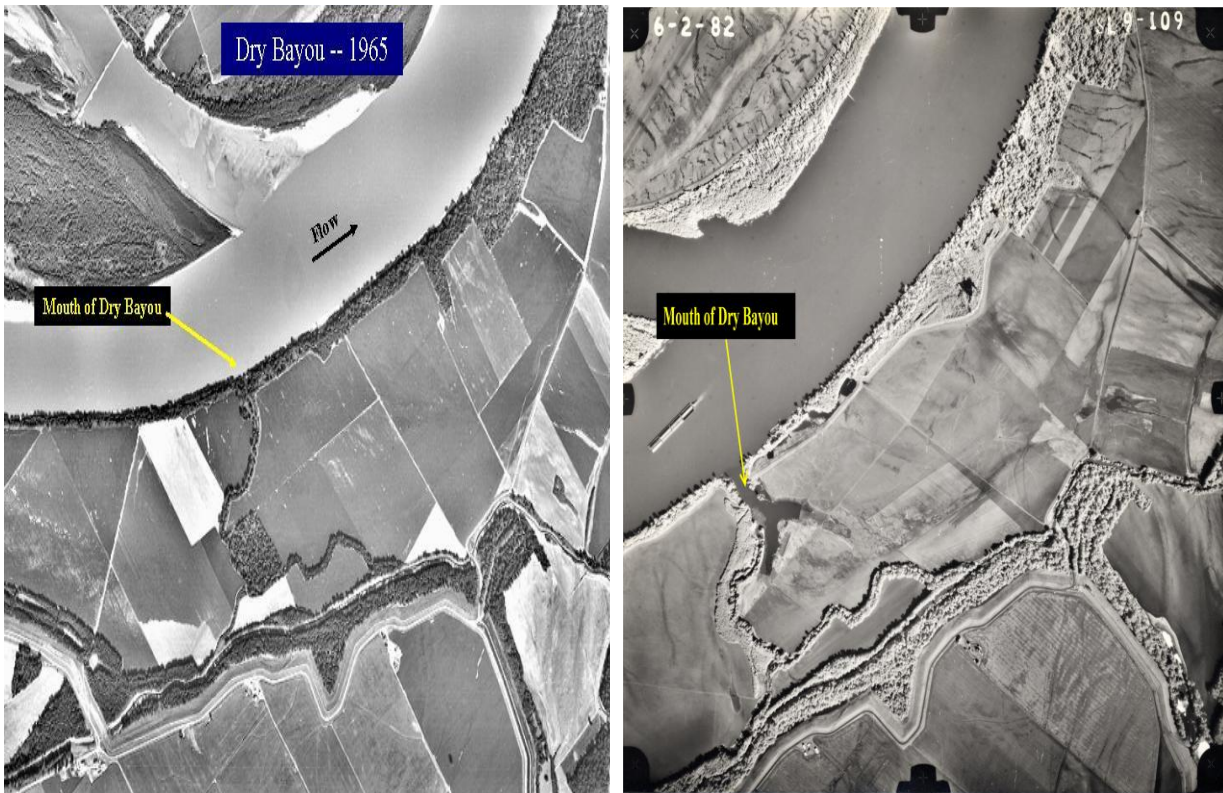
A high water event occurred in 1982 while the study process for the initial report was ongoing. During this high water event, some barges broke loose from their tow. They went through the bank line and the private levees. Not only was damage done to the bank line and private levee, but the propeller wash from the recovery efforts also scoured interior farmland.

Figure 5: Mouth of Dry Bayou Before and After Barge Accident

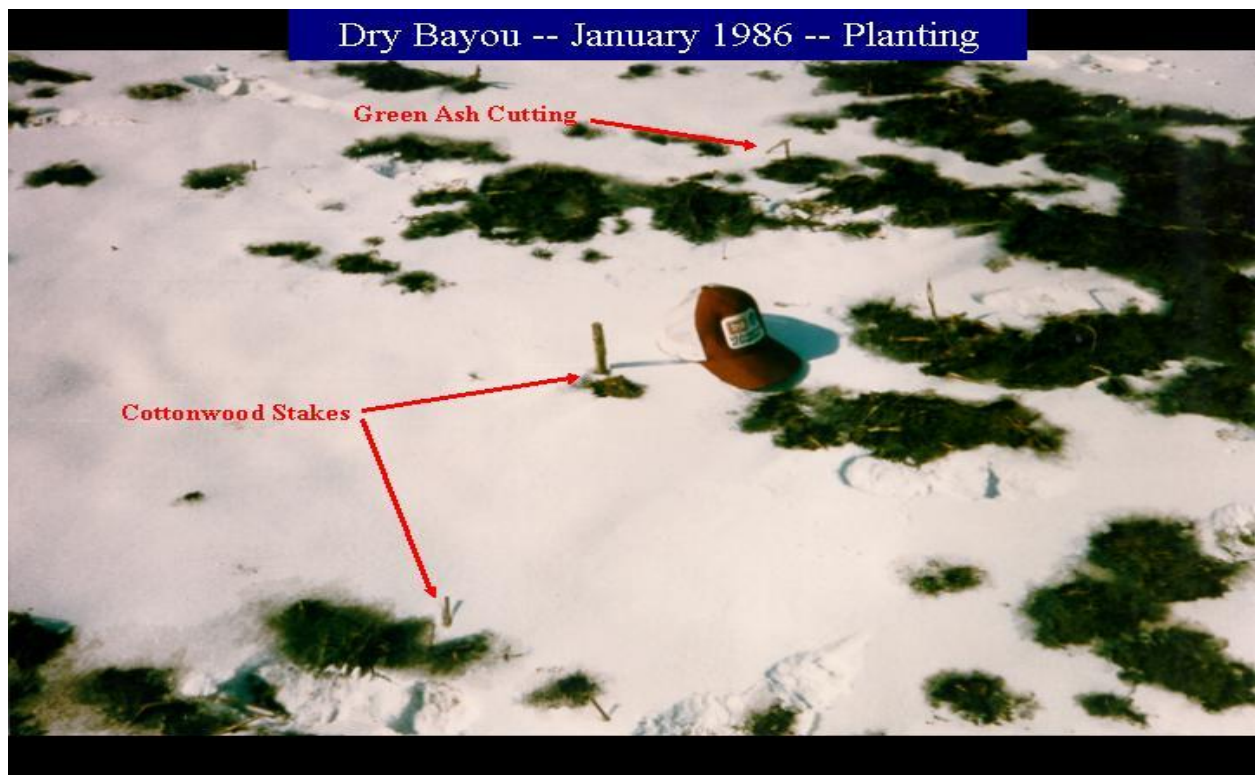
Figure 8: Photo of Some Tree Plantings in Dry Bayou-Thompson Bend

After the high water receded, the local interests undertook efforts to establish tree screens. During the period of January and March 1986, local interests, in cooperation with various agencies, planted more than 53,000 tree cuttings in the bend. In addition to these improvements, stone repair was also done to the private levee breach and the bank line at Graveyard Ridge was repaired.

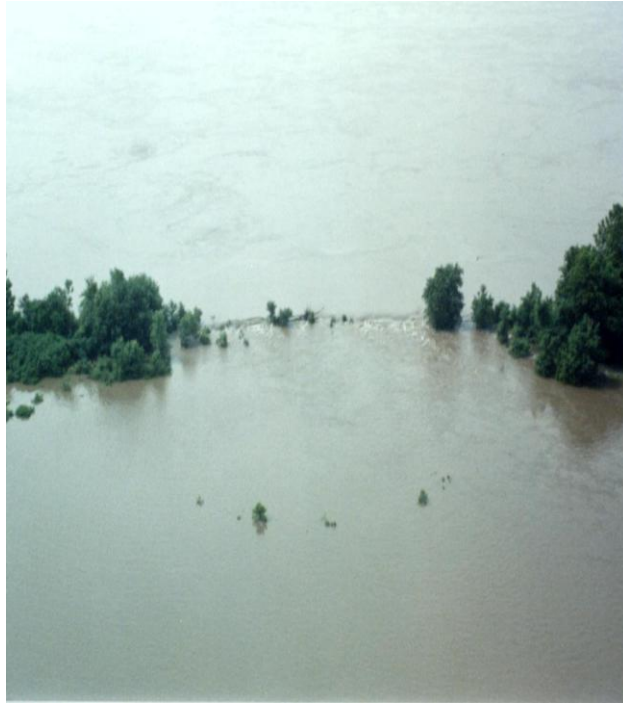
**Figure 11: Hillhouse Break 1 During 1993 Flood**

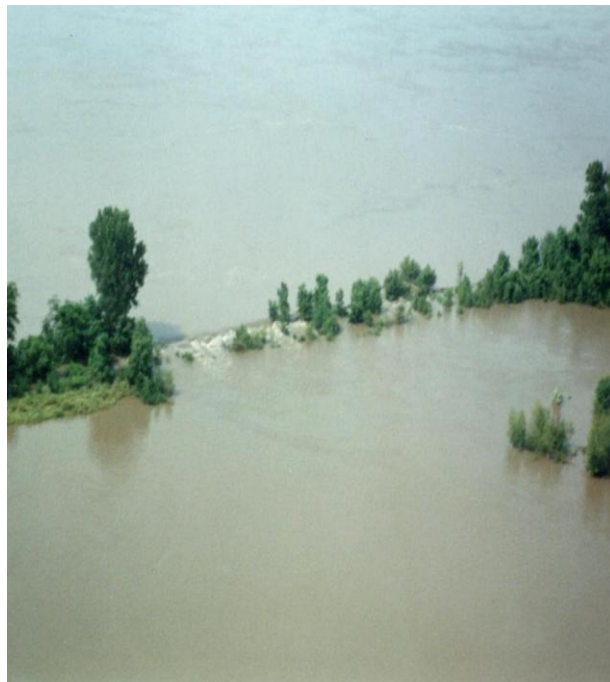
**Figure 12: Hillhouse Break 2 During 1993 Flood**

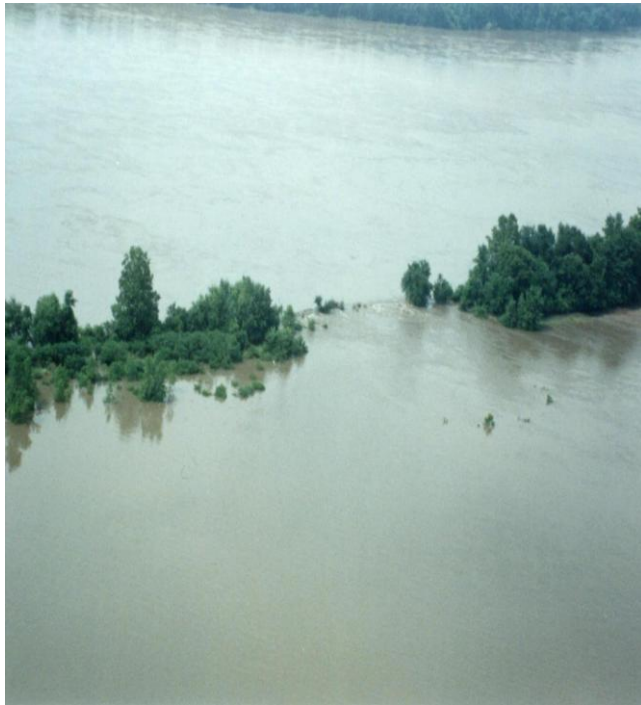
**Figure 13: Hillhouse Break 3 During 1993 Flood**

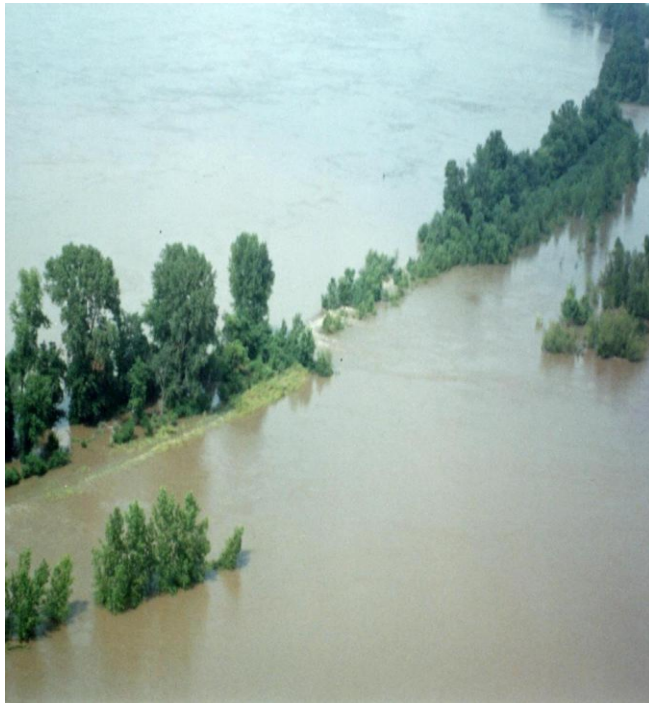
**Figure 14: Hillhouse Break 4 During 1993 Flood**

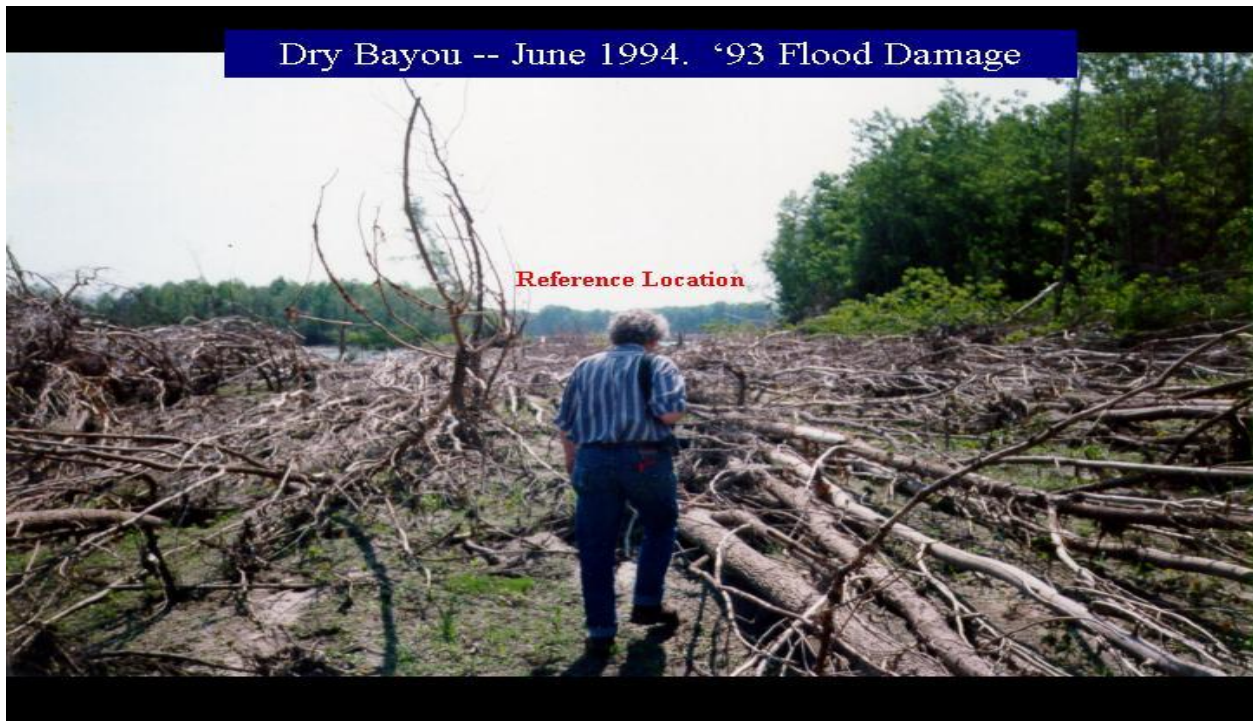
The flood of 1993 was a far greater test for the project area as the flood caused 130 days of overland flow in the bend. At times, flow velocities were in excess of 10 feet per second, partially due to a lower flow on the Ohio River. Although vegetation that was inundated with flood flows for the four month period did not survive the event, it did protect the land from severe scour. And while most vegetation was destroyed, no crops were produced, and some damage was done to the bank line, the project fared better than expected.

**Figure 23: 1993 Flood Damage**

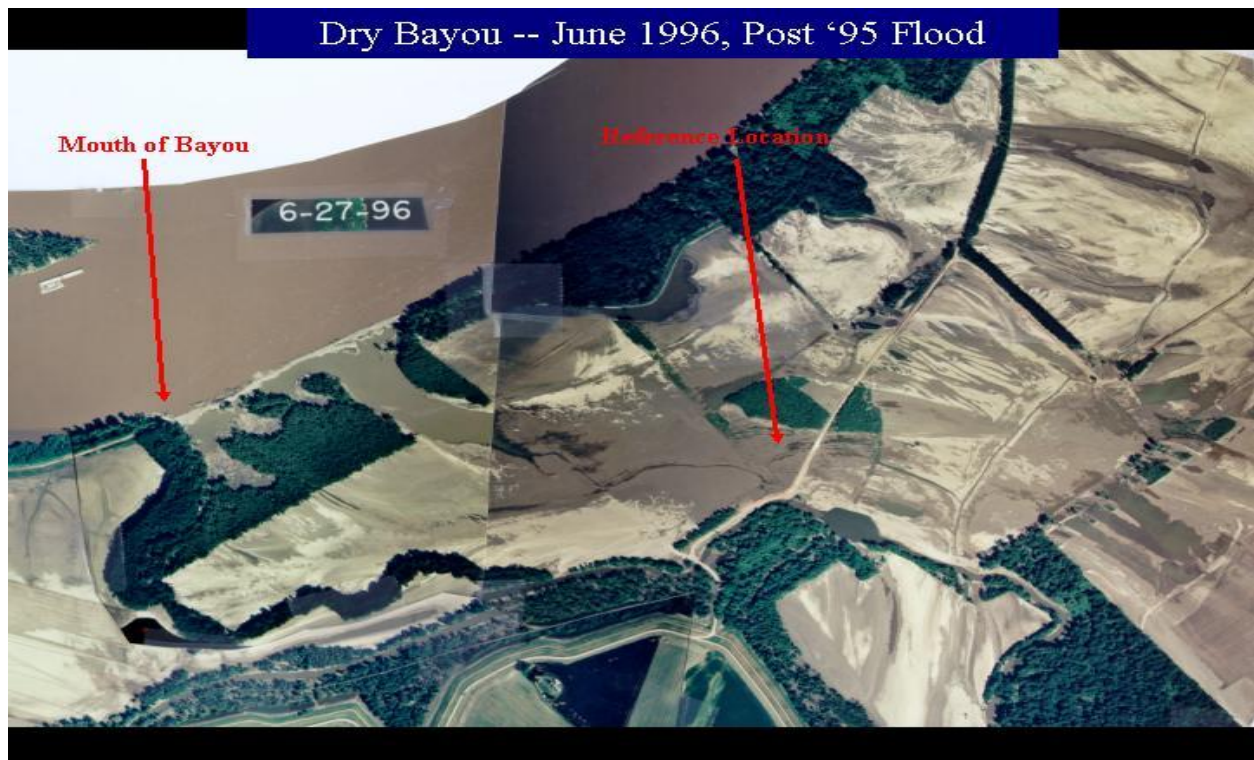
The flood of 1995 was the first since 1986 to cause obvious damage to the project area. Post flood analysis, Figure 24, shows a flow path across the bend, erosion, surface scour, as well as the damage done to the vegetation from three consecutive years of flooding.

Figure 24: Dry Bayou After the 1995 Flood

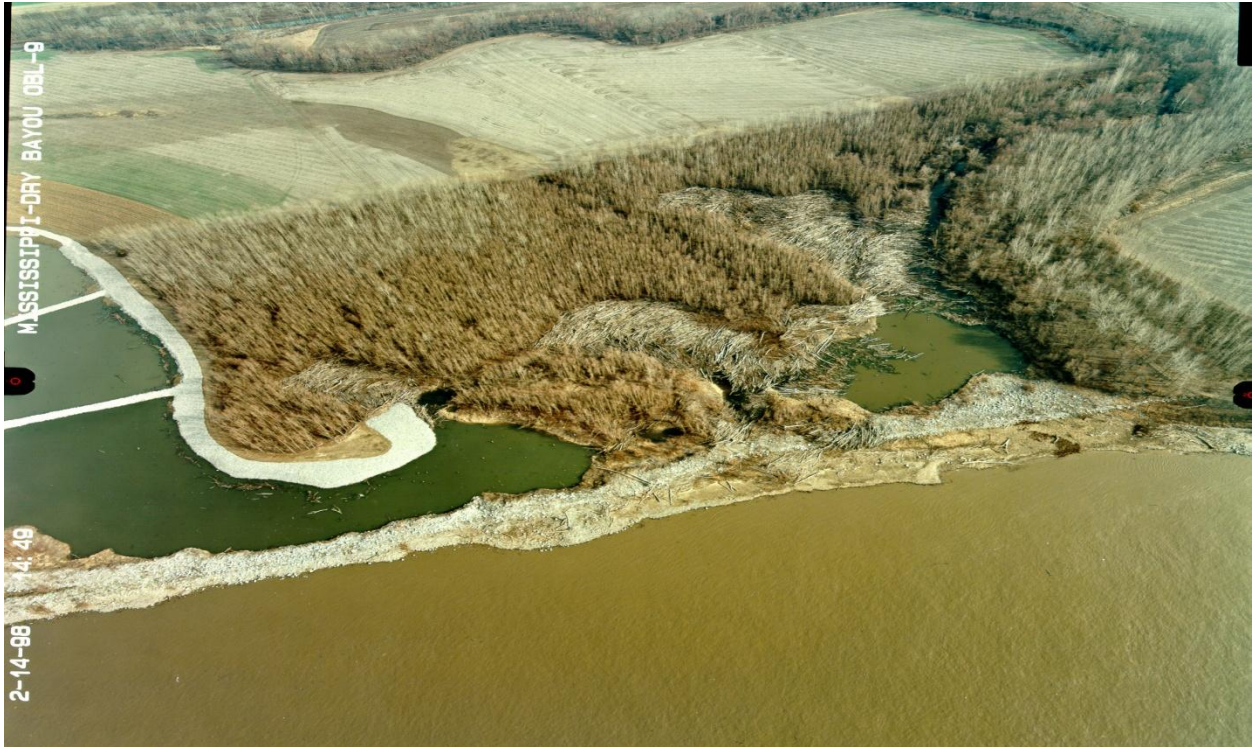
**Figure 25: Dry Bayou Revetment February 1998 (demonstrating effective tree screen reducing scour)**

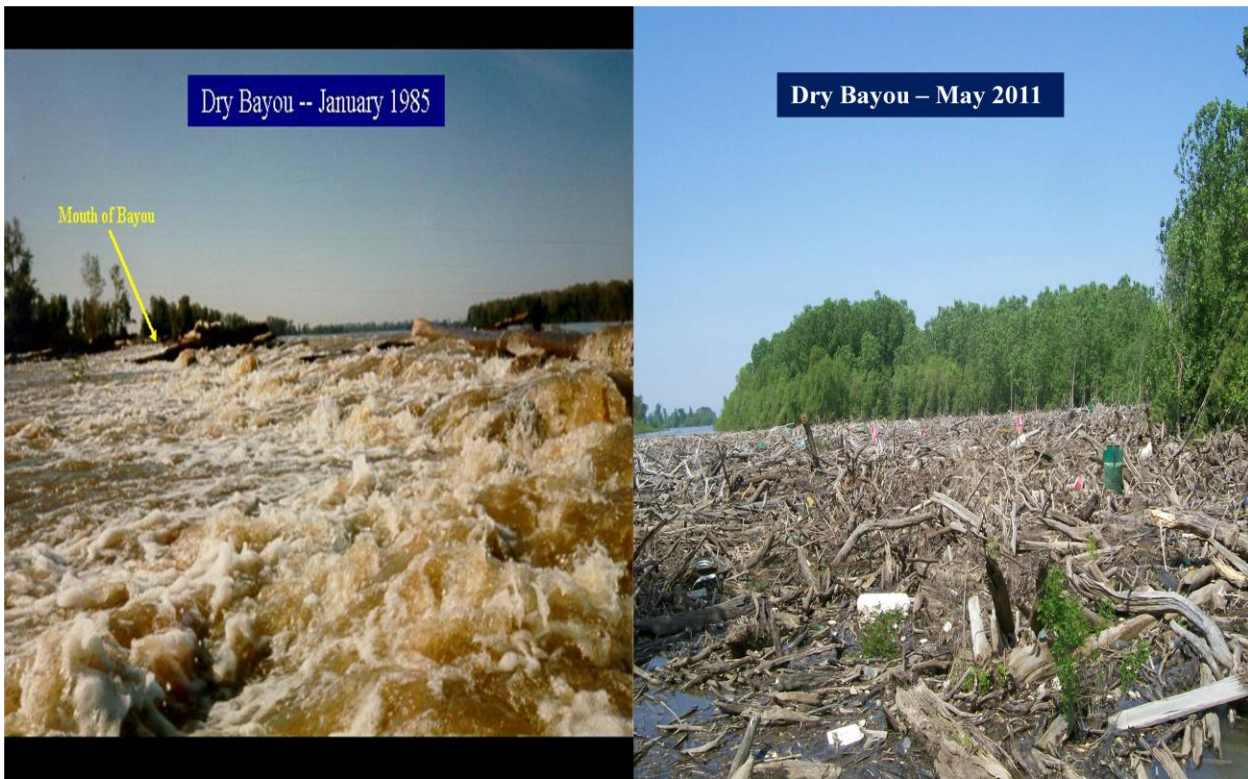
During the flood, flow velocity measurements were in the 2 fps or less range; well below the velocities required to cause concern about scour. The pictures below show the same basic location at the entrance to Dry Bayou. The picture on the left of Figure 33 shows the water pouring in to the project area with a lot of energy and high velocities. The picture on the right of Figure 33 shows the project area after the addition of tree screens. The water appears calm and a debris plug has developed due to tree screens catching the debris and holding it in place.

**Figure 33: Entrance to Dry Bayou**

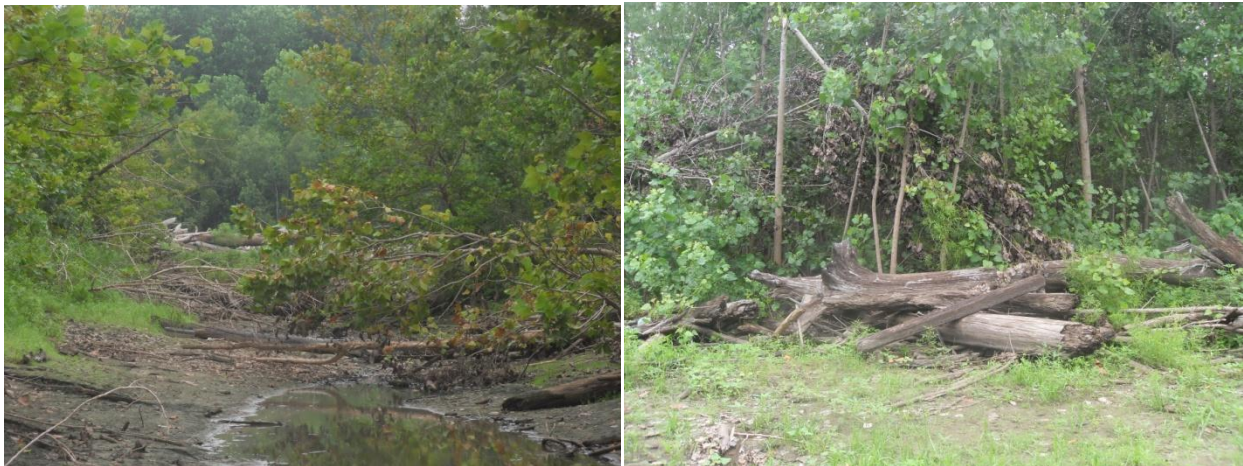
A second follow-up site visit was made after the waters receded. The land had been dry for three or four weeks and the damages to the project area appeared minimal. The vegetation appeared green and vibrant. See Figure 34.

**Figure 34: Vegetation after 2011 Flood**

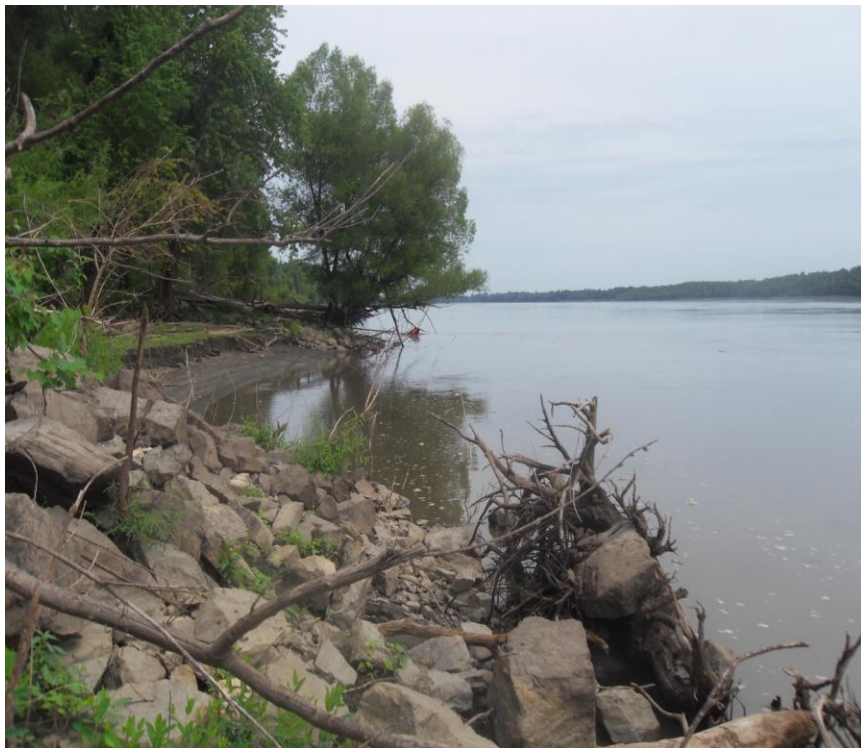
There were some damages noted after the flood event. Some additional scour was noted in low lying areas of the peninsula and there was some erosion on the bank line between RM 10 and RM 9. See Figure 35 and 36.

**Figure 36: Bank Erosion between RM 10 and RM 9 after 2011 Flood**
