Technical Report M22

SIDE CHANNEL STUDY OF THE MIDDLE MISSISSIPPI RIVER AT MORO CHUTE RIVER MILES 122.6 TO 120.2

GEOMORPHIC AND POTAMOLOGIC INVESTIGATION

Final Report – January 2002

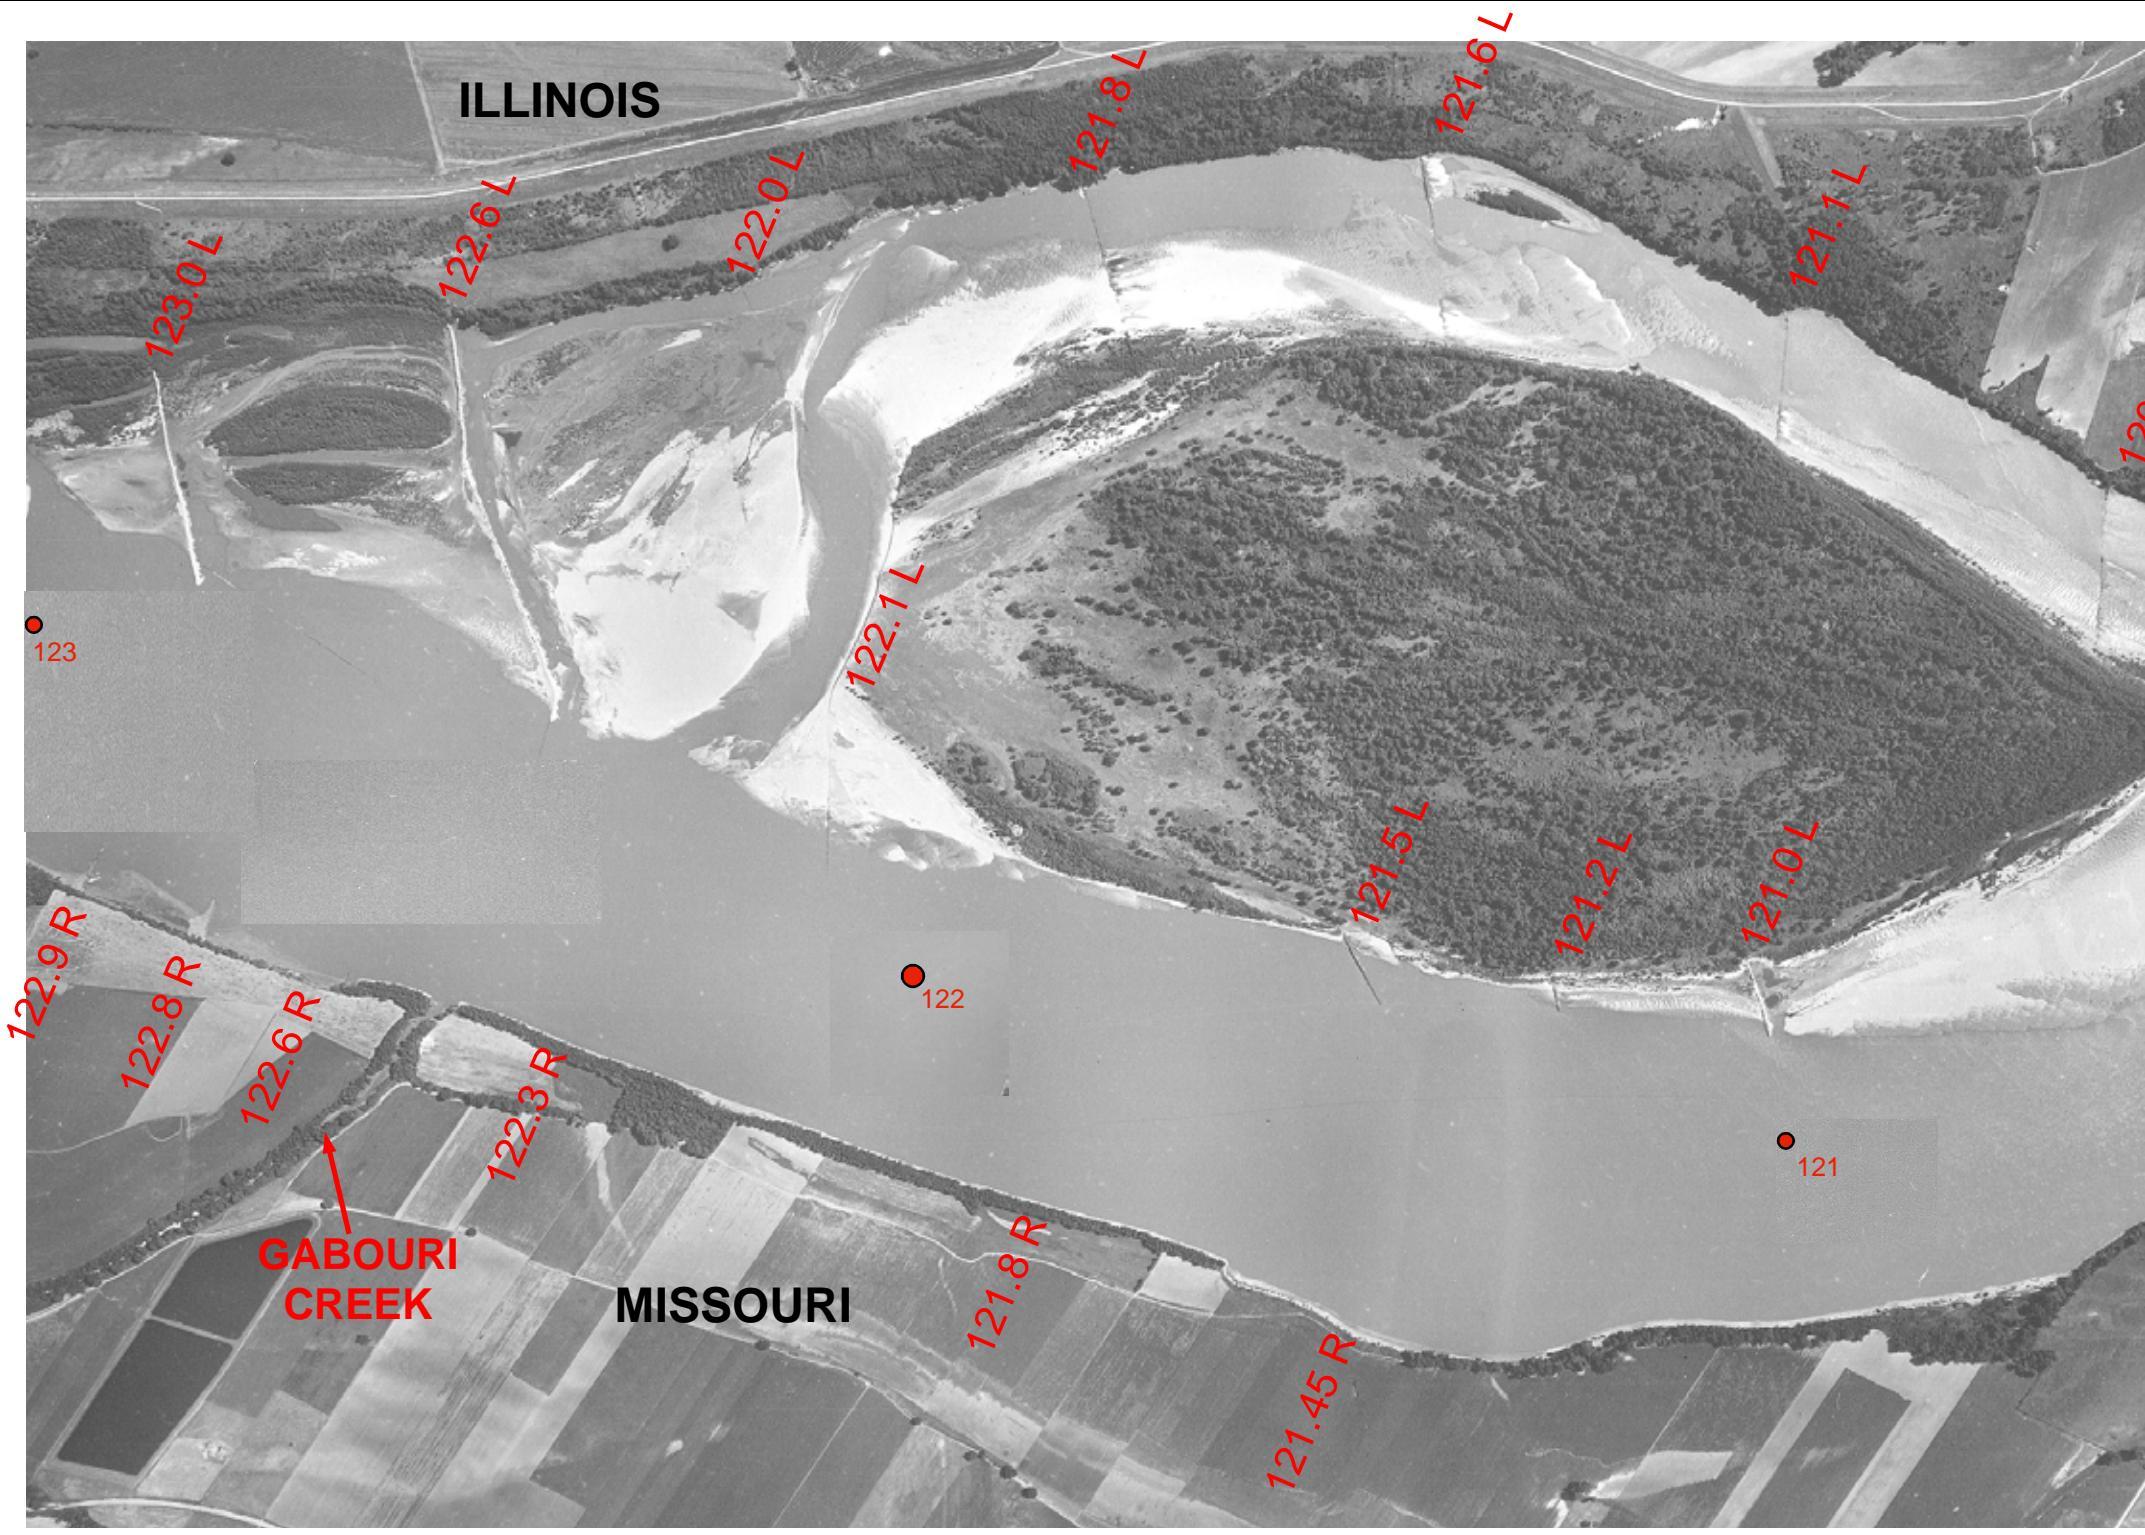
An aerial photo from 1965 (Plate 7) shows that Pile Dikes 123.0 L, 122.6 L, 121.0 L, and 120.2 L had been reconstructed with stone except for the trails. A large vegetated island with a well established side channel was observed in this photo. Additional islands and an expanded bankline had also developed upstream of the side channel complex. The photograph indicated multiple inlets to the side channel. Numerous narrow secondary inlets that connect into the main side channel complex

PHOTO TAKEN ON 8/3/1965 AT +7.18 FEET LWRP ACCORDING TO THE CHESTER, ILLINOIS GAGE

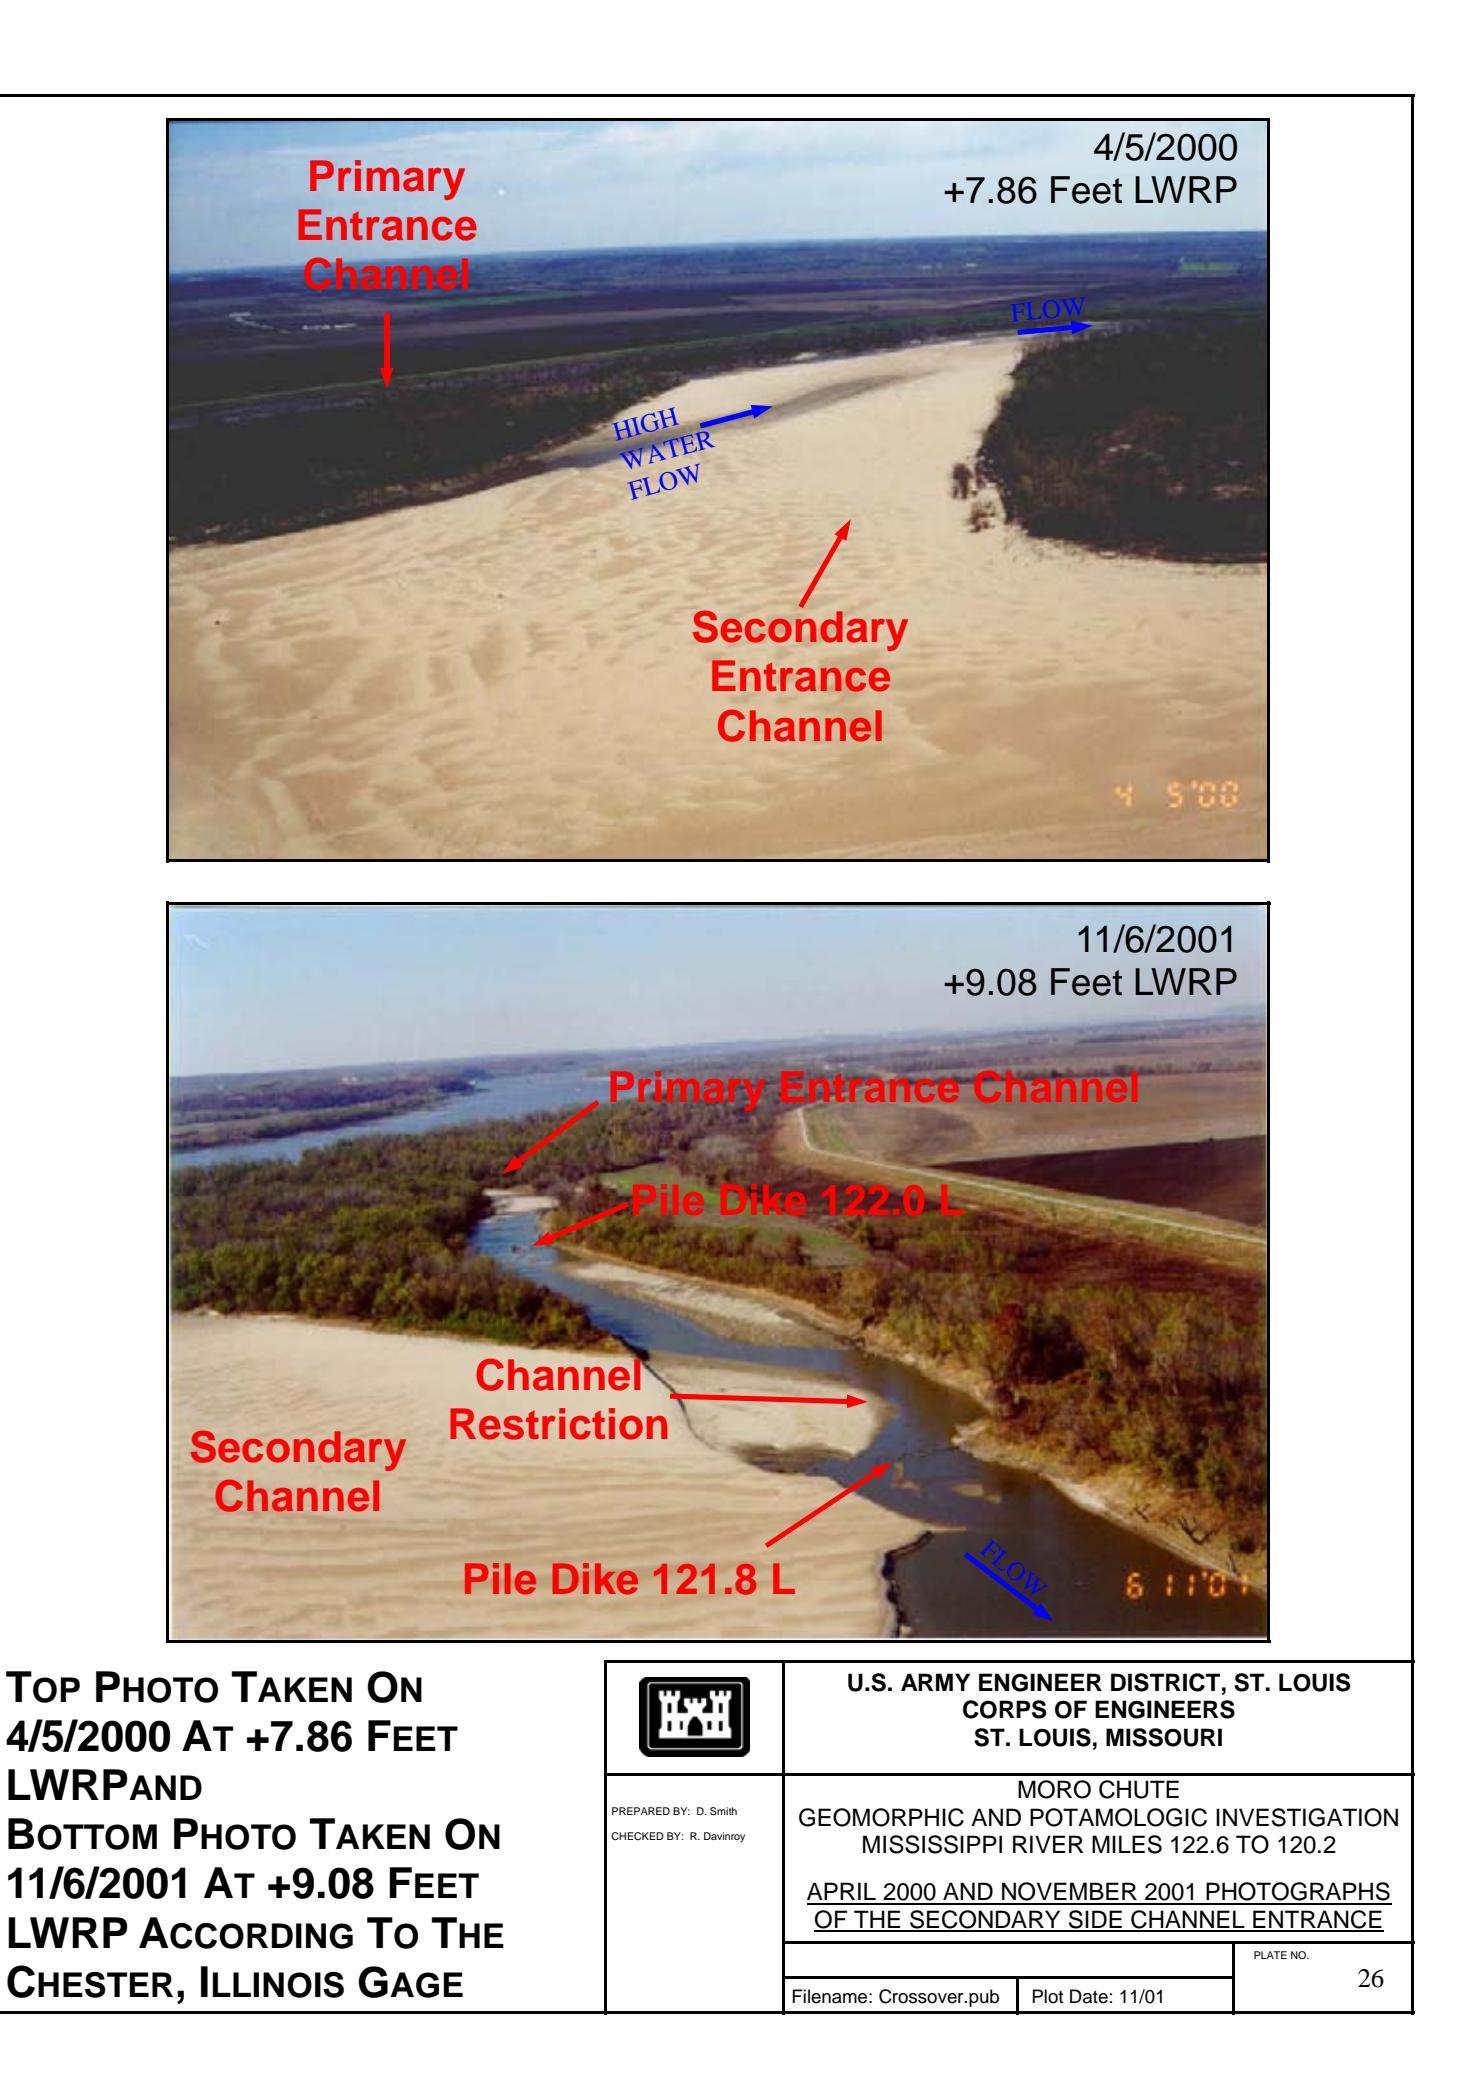
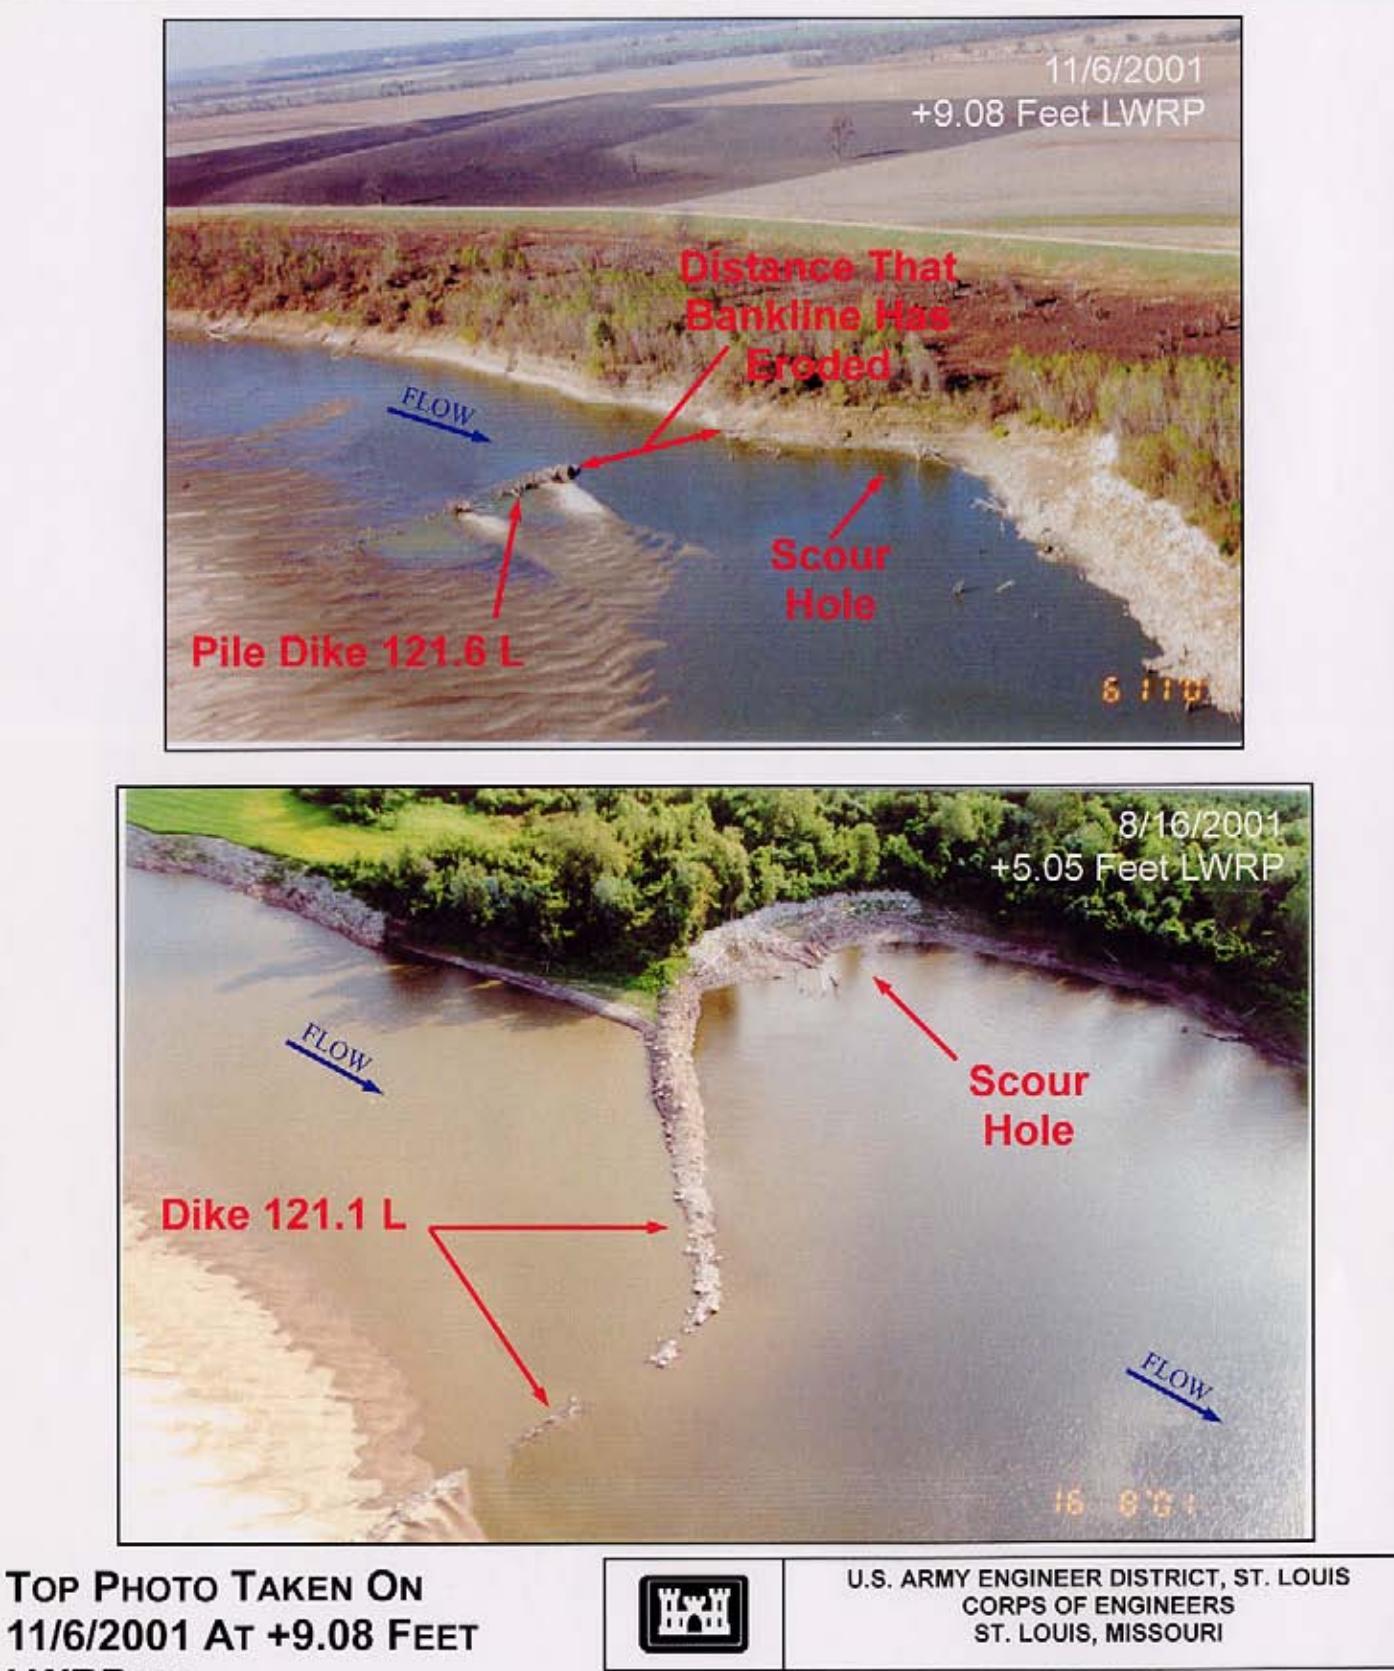
NOVEMBER AND AUGUST 2001 PHOTOGRAPHS OF THE DIKES 121.6 L AND 121.1 L

11/6/2001 AT +9.08 FEET LWRPAND BOTTOM PHOTO TAKEN ON 8/16/2001 AT +5.05 FEET LWRP ACCORDING TO THE CHESTER, ILLINOIS GAGE
