Summary Report

Mel Price Lock and Dam Physical Model, Upstream Scour

By Timothy J. Lauth
Hydraulic Design
US Army Corps of Engineers St. Louis District
1222 Spruce St.
St. Louis, MO 63103-2833

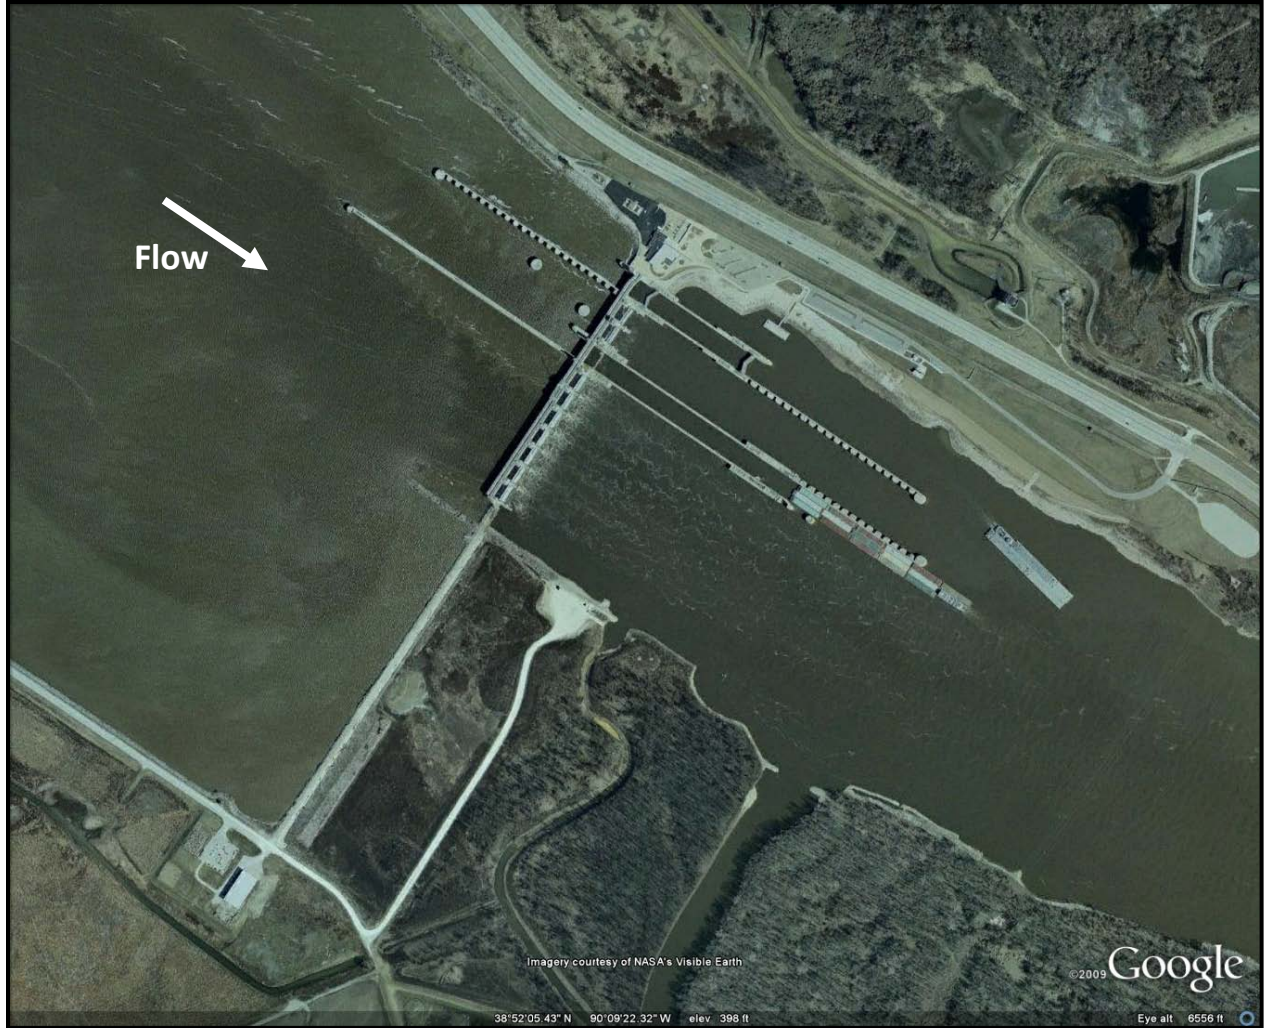
Figure 2 - Aerial photograph of Mel Price Lock and Dam

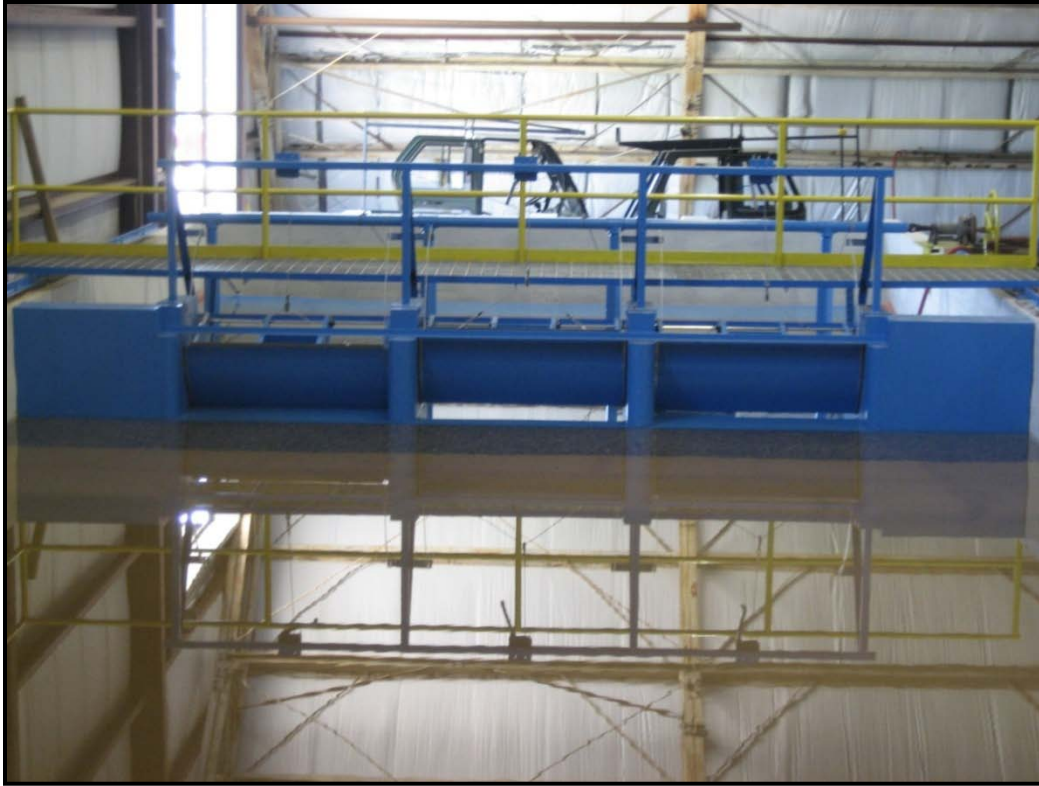
Figure 3 - The model gate structure and walkway viewed from upstream

A walkway was built over the gates to provide better access to the gates' winch controls. A second, moveable walkway was used to assist with taking measurements and recording video. The gates were outfitted with scaled rulers indicating the equivalent feet opening of the gate setting. Markings were placed on the upstream face of the model to aid with the placement of stone bed armor and with setting the gate openings for tests involving the use of underwater video.

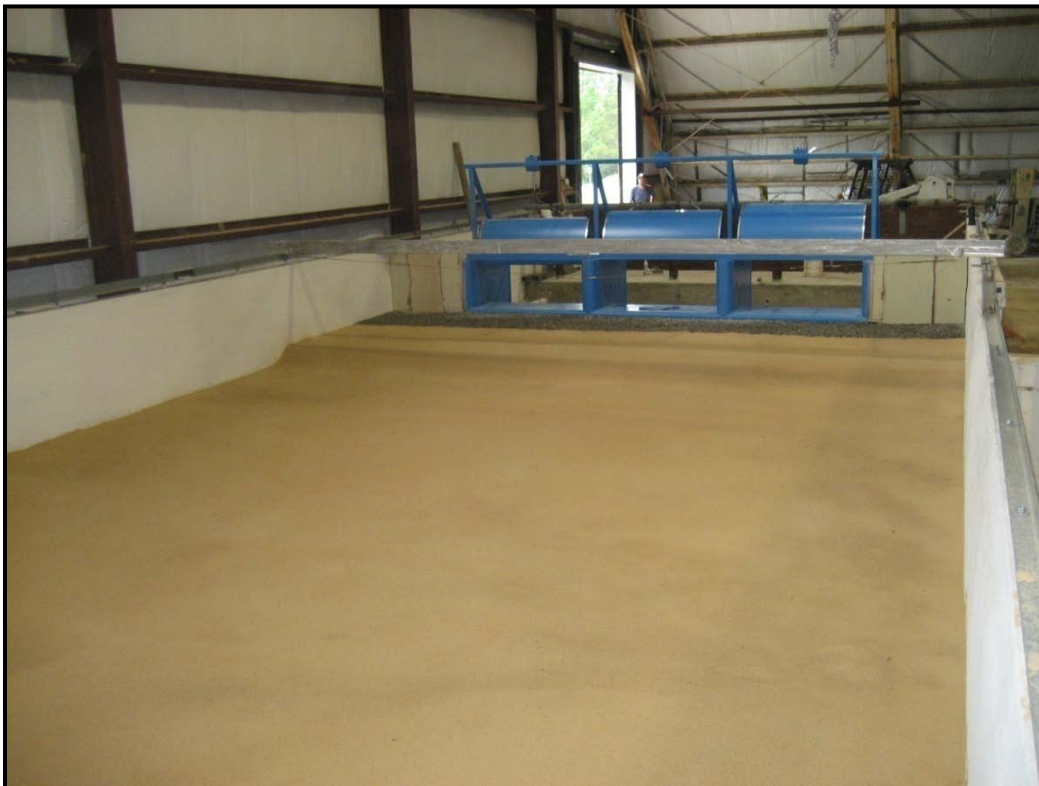
Figure 4 - The bed upstream of the model gate structure

The Mel Price physical model was built at the Engineer Research and Development Center (ERDC) Coastal and Hydraulics Laboratory in Vicksburg, MS. Model development began in January 2009. The 1 ft to 25 ft scale model was constructed in a 69 ft long, 21.1 ft wide flume. Three tainter gates were simulated in the flume instead of the full upriver dam face (Figure 3), due to size and cost limitations and to better isolate the flow occurring in front of individual piers. To lower cost and reduce fabrication time, the majority of the gate structure was re-used from the Olmsted Lock & Dam physical model. This was possible because of the large degree of similarity between the geometries of the two dams. The upriver sand bed section of the model (Figure 4) consisted of up to a bench in front of the gate structure to better replicate the approach geometry for the upstream. As in the prototype, an armor layer of stone bed protection rests immediately in front of the upstream section of gate structure. This stone has been sized to replicate the in-situ stone at the prototype, for the original stone place, the first repair, and the second repair. Underneath the bed stone armor, filter cloth was used to provide a better simulation of bedding material, with the main objective of reducing piping.

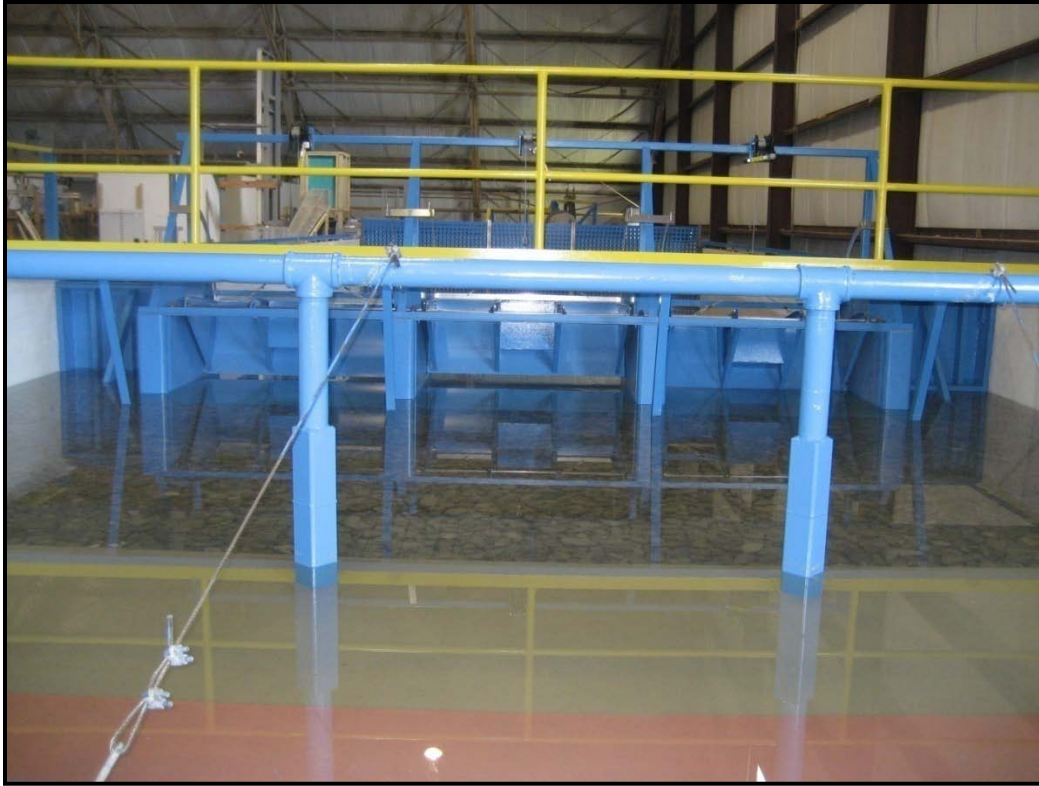
Figure 5 - The model gate structure and walkway viewed from downstream

A stilling basin was not constructed since it would have no effect on the upstream scour. Stone cobbles were used below the gate outlet to dissipate the velocity of the flow through the gates (Figure 5). The tailwater and upriver pool elevations were determined with rulers set to scale in both portions of the model. The flow into the flume is supplied by a 12-inch diameter pipe and a 20-inch diameter pipe from a constant head tank fed by multiple pumps. The maximum flow possible into the flume from this system is 40 cfs. At the end of the flume, a gate was used maintain tailwater pool elevation. Two drains below the tailgate empty the flume into the building's sump.

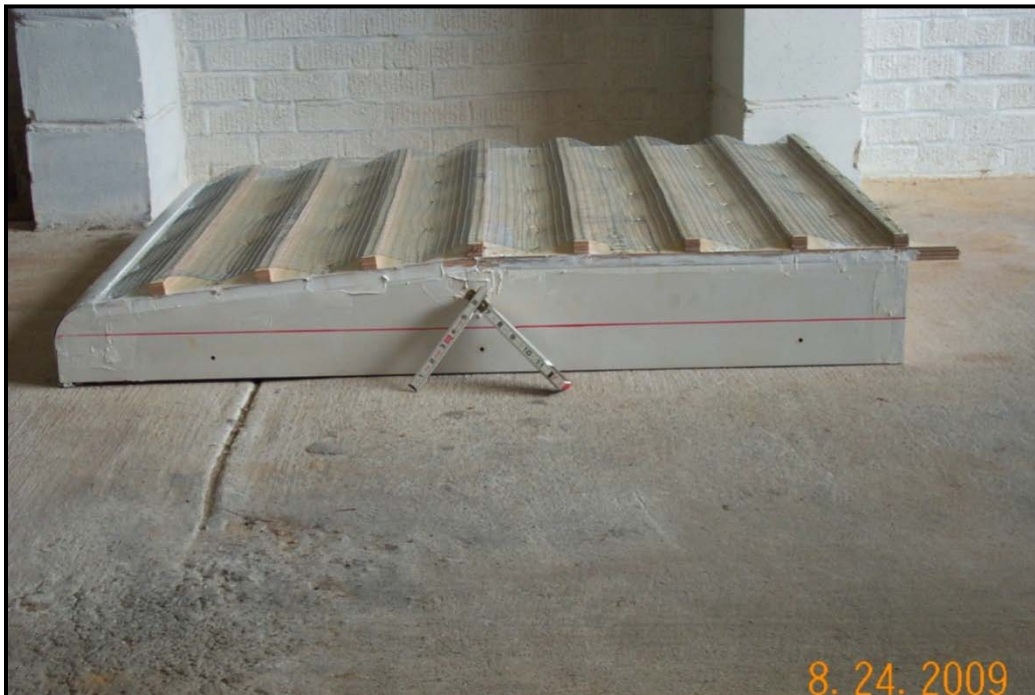
Ice development was simulated using a 21ft x 4ft x 1ft wooden raft built in four sections to facilitate installation and removal (Figure 6). Draft was controlled by adding or removing lead weights and the bottom of a raft was sloped and lined with chicken wire to simulate the natural friction of real ice. To facilitate the use of a 2D acoustic Doppler velocimeter (ADV) to take velocity measurements, three holes aligned parallel to the flow were drilled in the raft and lined with PVC to prevent the raft from flooding. Later, a fourth hole and a box were added for additional instrumentation use. The walls of the raft were raised during testing to accommodate deeper drafting of the raft.

Figure 6 - Wooden raft used to simulate upstream ice

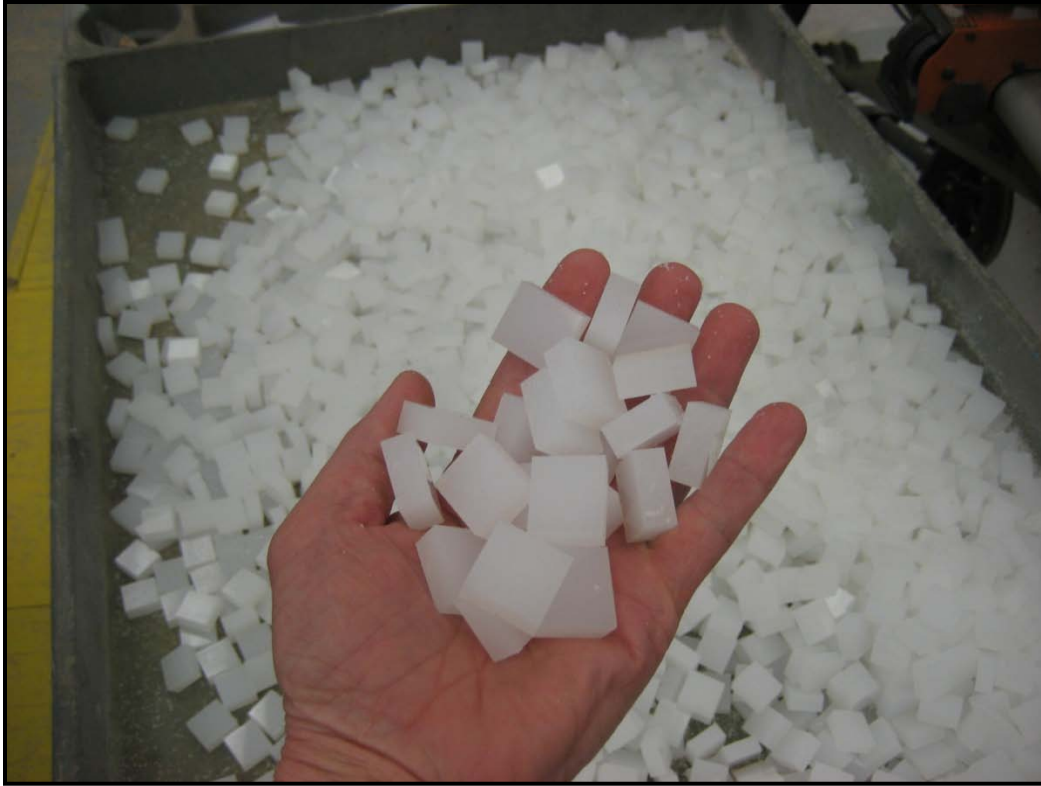
Ice development was also modeled using cubes cut from sheets of 0.375 in. thick polyethylene (Figure 7). Based on CRREL's recommendations for ice size distribution, the sheets were cut into five different size squares: 0.75 in., 1.25 in., 2.00 in., 2.75 in., and 4.00 in. Because of its volume and weight, the acrylic ice was dumped by skid steer into the flume after the flume had been filled but before test conditions had been established for each test. To prevent the acrylic pieces from getting into the sump, metal cages were installed over the flume drains and the acrylic ice cleared out of the flume after the completion of a test.

Figure 7 - 0.75 in. thick pieces of acrylic ice

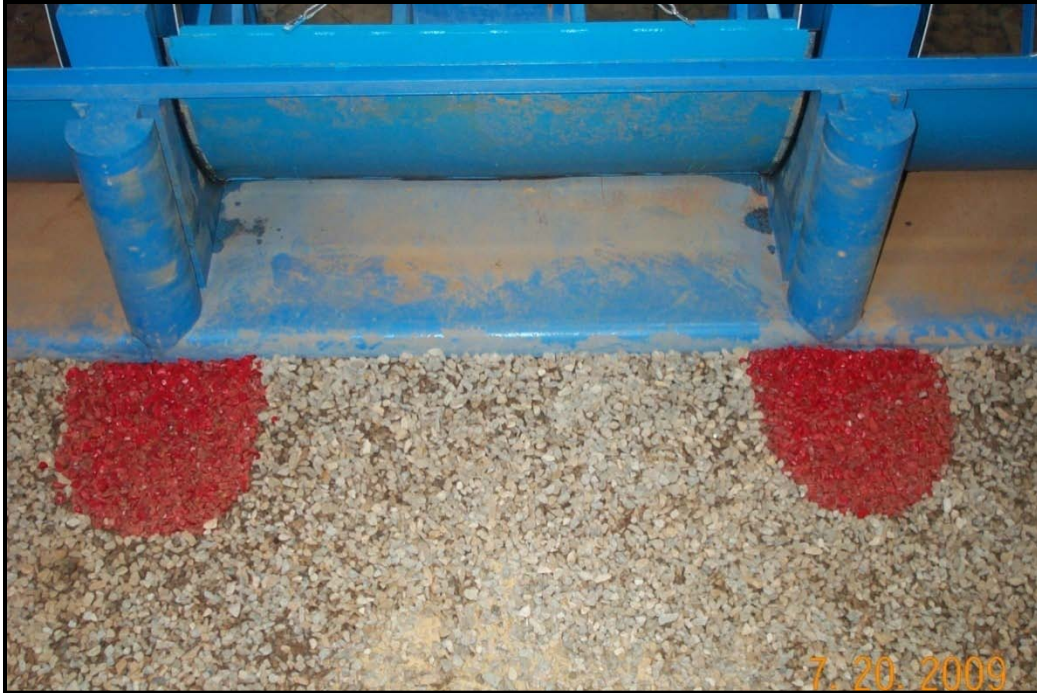
**Figure 8 - Upstream pre-test conditions for a 23 ft. center gate opening
Upper pool = 419 ft., original stone placement test**

The initial tests in July 2009 attempted to determine if the scour would occur under normal operating conditions. The test was run with a center gate opening of 23 ft (the largest gate opening used by the lock staff when not at open river conditions) and simulating a 419 ft prototype upper pool elevation and a 395 ft. prototype lower pool elevation. The upper pool was almost always kept at 419 ft. or 420 ft. depending on test water demands and the lower pool was always run at a prototype elevation of 395 ft. Neither the original stone bed armor nor the first repair stone underwent any considerable scour (Figure 8 – Figure 13).

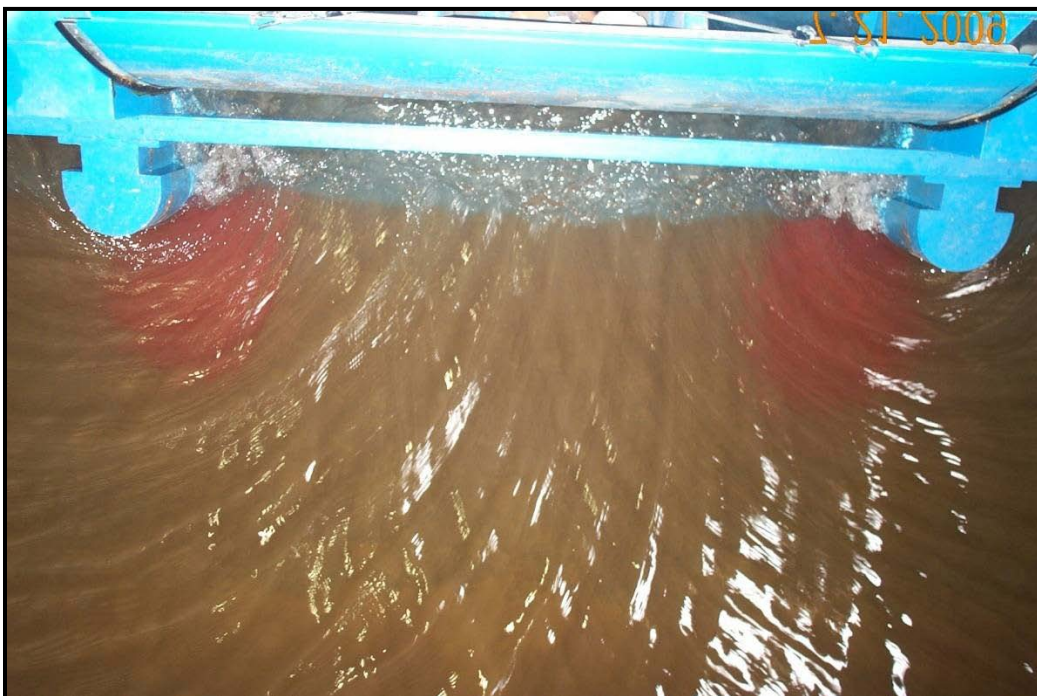
Figure 9 - Upstream view of the center gate during testing

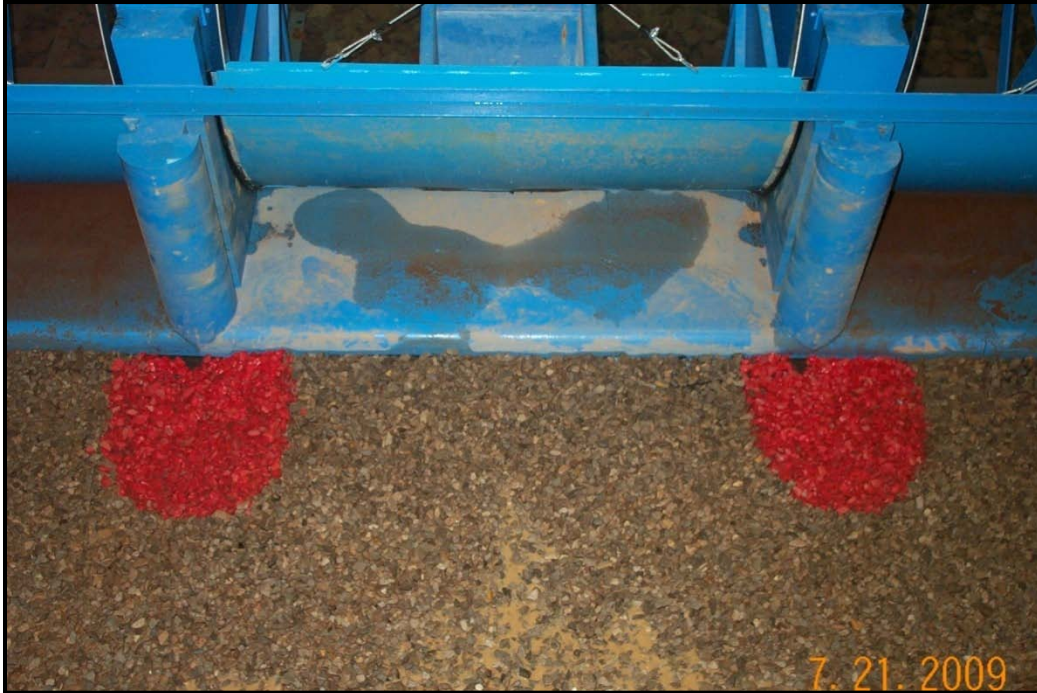
**Figure 10 - Post-test conditions for a 23 ft. center gate opening
Upper pool = 419 ft., original stone placement test**

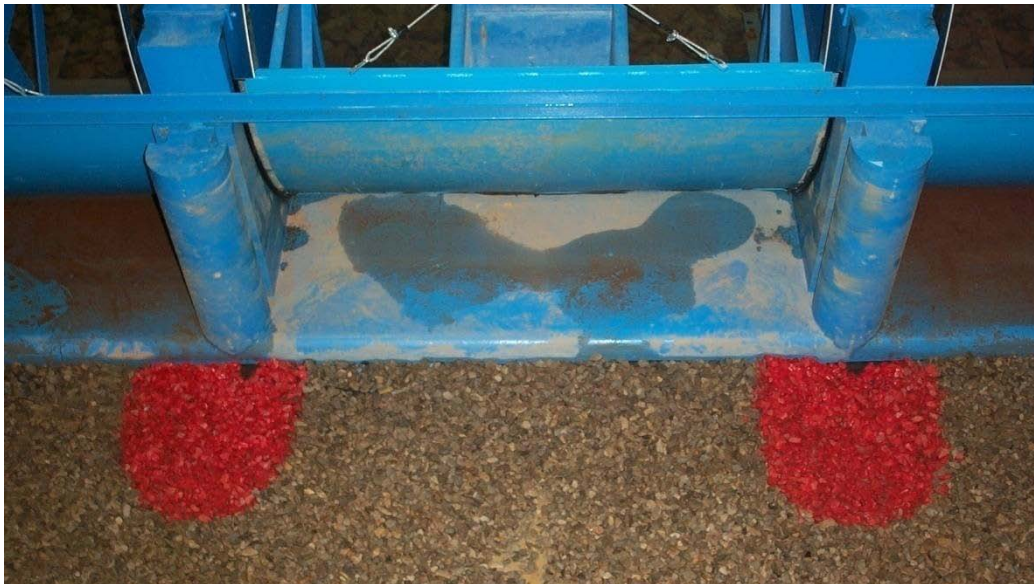
Figure 11 - The post-test 23 ft center gate opening, original stone, filter cloth, no ice

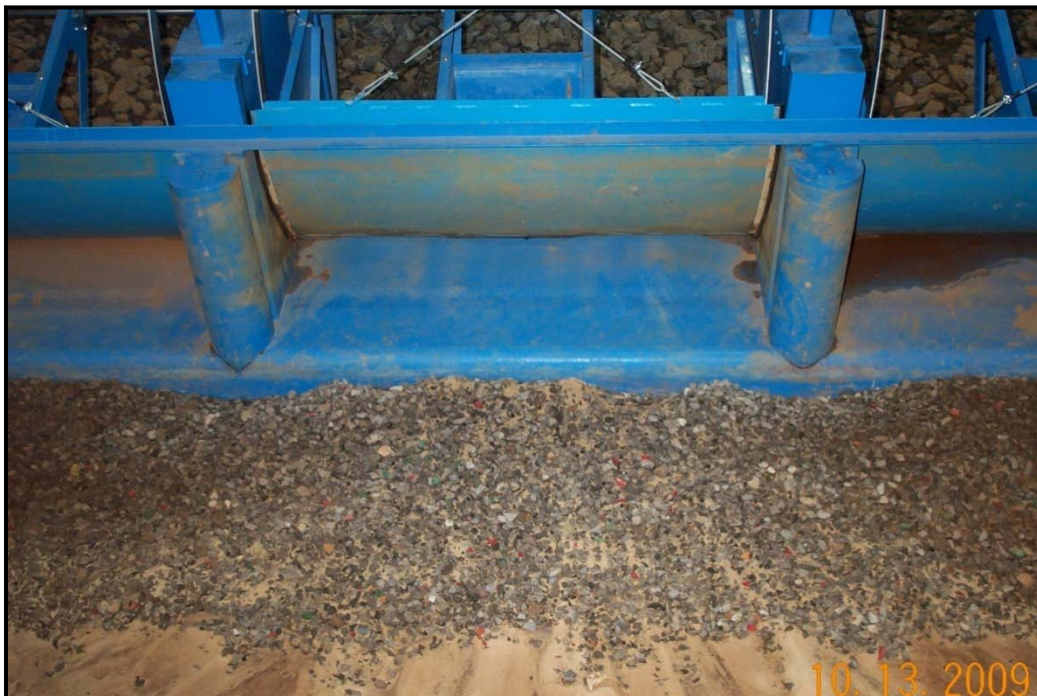
Figure 14 - 23 ft center gate opening, original stone, no filter cloth, with ice raft

After the testing of normal operating conditions was concluded, testing focused on a possible cause suggested by lock and project staff: the buildup of ice in front of the dam during the winter. It was theorized that ice build-up occurs along the gates of the locks and dam into the upper pool and serves as a constriction to the flow, which in turn increases flow velocities and bed shear stress. This theory was supported by the findings of the numerical model. Based on conversations with CRREL staff, the ice raft was designed to simulate the thickness and roughness that could be expected from natural ice. The initial ice tests focused on different gate openings on the main gate, the use of filter cloth, the ice raft (drafting at 10 ft), and stone type. The tests conducted revealed that ice causing scour was possible and that the use of filter cloth and gate opening affected the rate of scour occurring. However, the level of scour occurring was not representative of the scour seen occurring of the prototype (the model scour was significantly less than seen in the prototype). During these tests, the open river condition was modeled as it was considered a unique condition of river operation. However, minimal scour was observed (Figure 14 – 15), and all ADV measurements revealed relatively low velocities of approximately 5 fps.

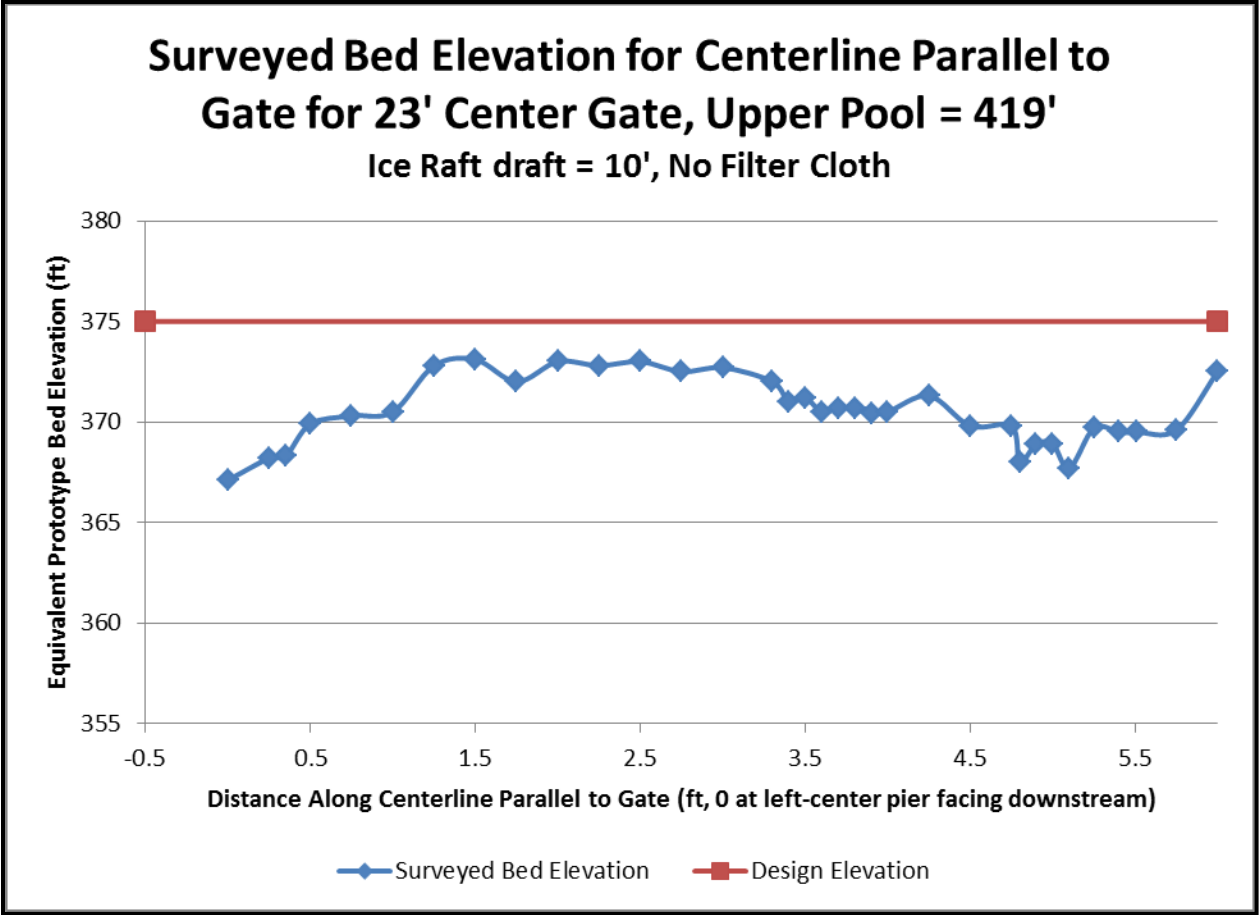
Figure 15 - Bed scour survey taken after test run 10-13-09

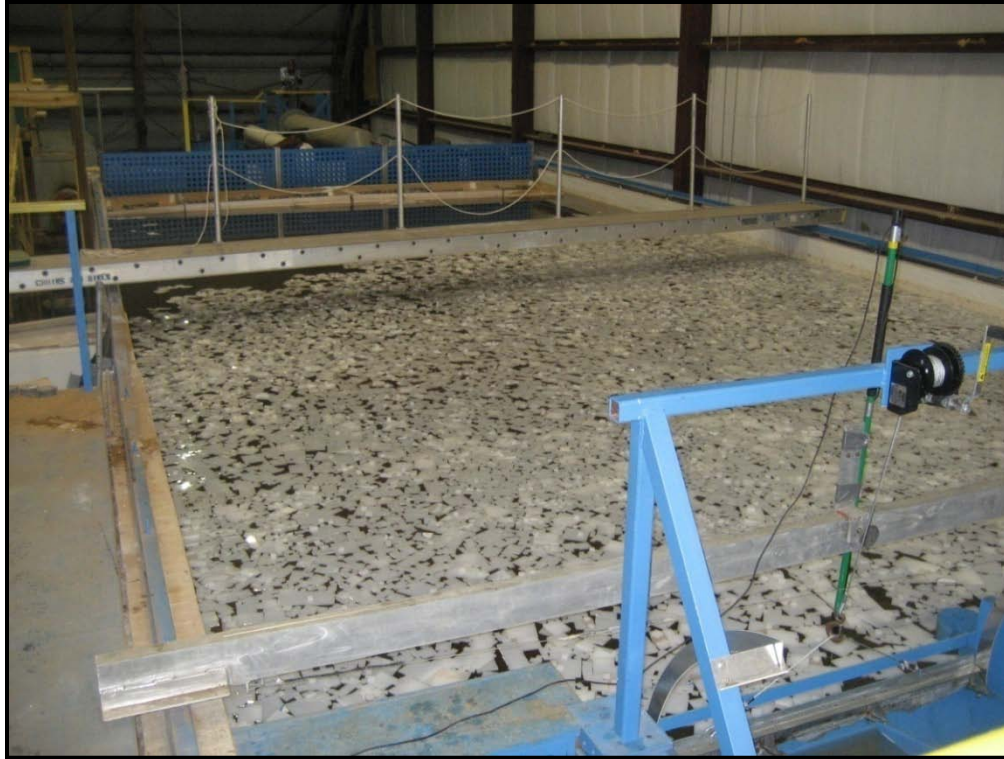
Figure 16 - Acrylic ice pieces in the flume upstream of the gates

To this point in the testing, the buildup of ice around the piers was simulated using the wood raft. The project team questioned whether the raft represented a legitimate simulation of the effects of ice on scour. The project team decided to model the ice using the polyethylene cubes described above. The polyethylene ice had the advantage over the ice raft in that it, like the river ice, consisted of a multitude of different chunks that could pack. The initial tests with the polyethylene ice focused on getting the ice to pack and tighten like real ice (Figure 16). These tests quickly revealed that the polyethylene was a poor proxy for real ice; the polyethylene lacked the variable shape and thickness of real ice. Because of the geometry differences, the polyethylene formed a single-piece-thick matrix on the water surface, unlike real ice, which can slide, stick, and tighten into a mass with other pieces. Higher flows were used in an attempt to get the ice to pack, but these flows led to a flushing passage of the polyethylene. With the polyethylene ice failing to pack on its own, manual packing was initiated a broom to agitate the upstream water surface bed with a stirring motion to submerge and layer the ice (Figure 17). Tests utilizing manually-packed polyethylene were run, but as before, no scour occurred before high flows passed the polyethylene through the model gates.

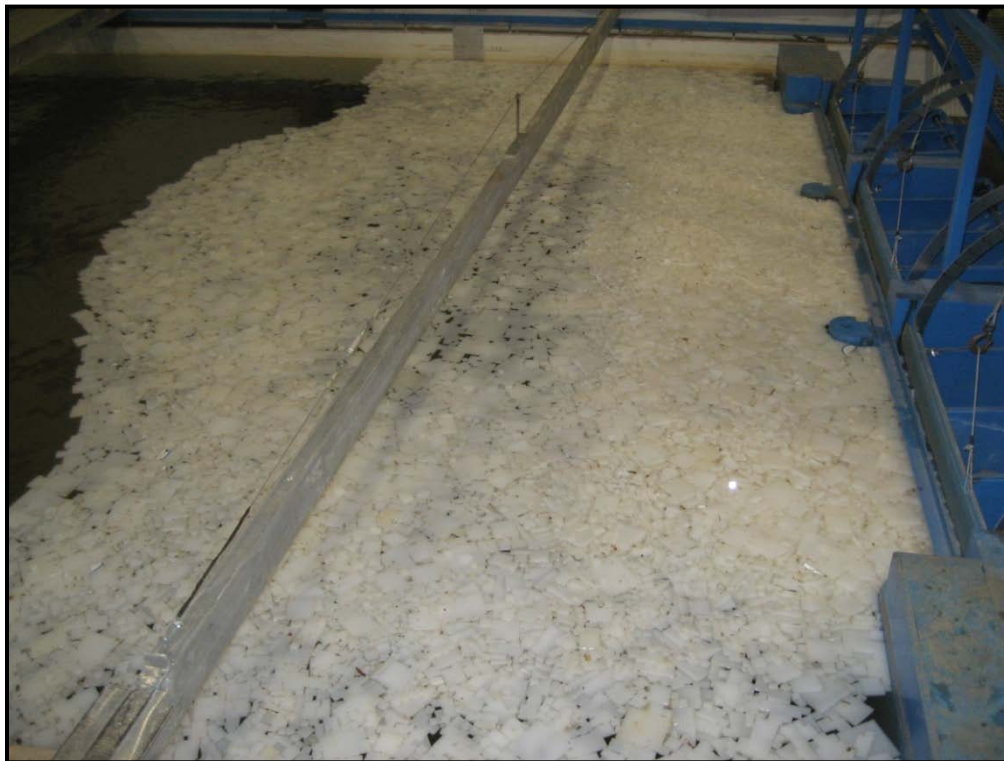
Figure 17 - Mechanically packed acrylic ice upstream of the gates

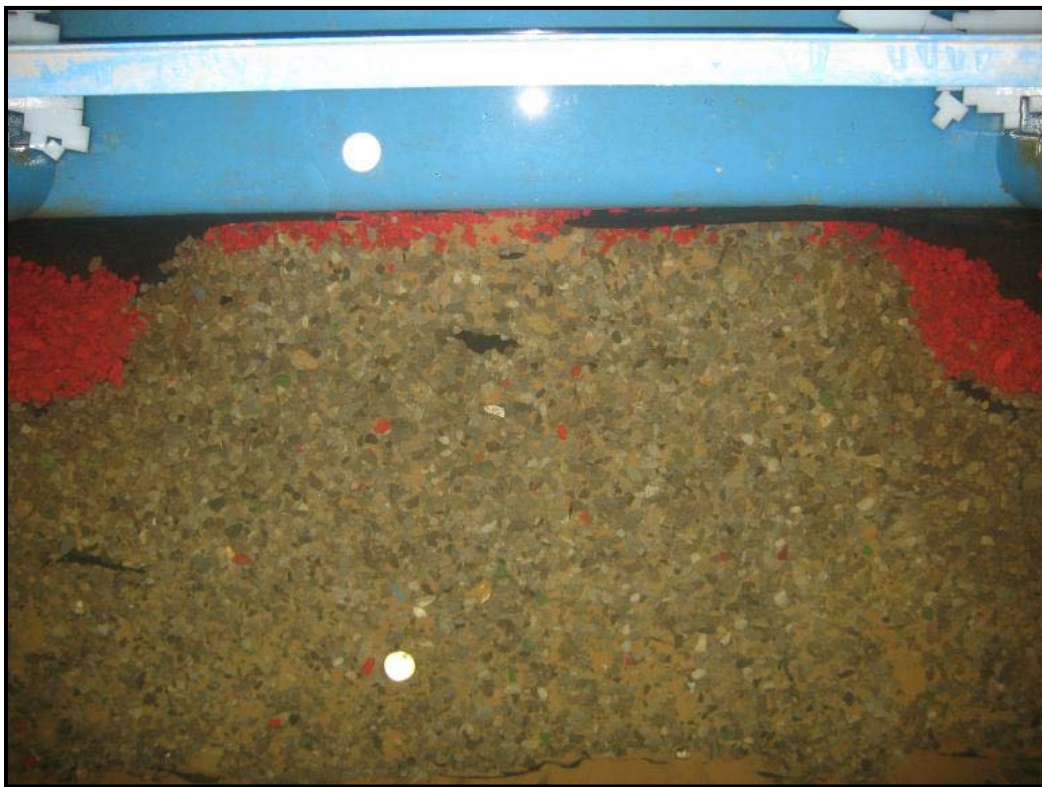
The test showed a significant amount of scouring had occurred immediately adjacent to the pier heads; the scour depth reached to an equivalent of a 10 ft prototype depth (Figure 18 - 19). Sand from underneath the filter cloth was pulled out through the gates. There was also scour directly in front of the gate, again with both rock and sand moving. The scour around the center gate appeared similar to prototype scour, suggesting that a case had been found that mirrored the real-world. The test was repeated with similar results recorded. The stone was then switched to the first repair to insure that the scour was not specific to the rock size or the particular rock placement, and again similar results occurred.

Figure 18 - Pier Scour after testing with a 13 - 14 ft ice raft draft

Tests were conducted with the draft of the ice raft drafting approximately 13 ft – 14 ft instead of the original 10 ft. This slight increase in depth was found to significantly change the scour effects on the bed; unlike the 10 ft. draft, the 13 – 14 ft. draft was found to produce scour similar to scour identified in the prototype. A series of tests performed with different gate openings revealed that the use of smaller gate openings and the opening of multiple adjacent gates reduced the bed velocity, leading to a lower bed shear stress and less scour.

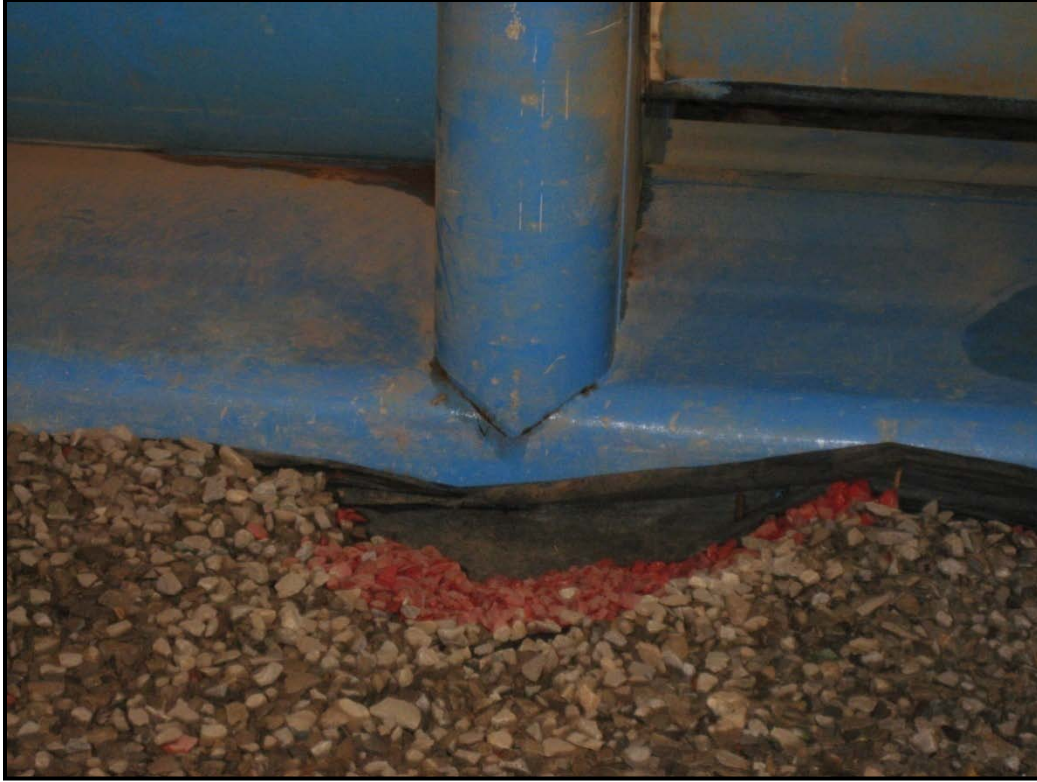
Figure 19 - Close up on right pier scour after testing with a 13 - 14 ft ice raft draft

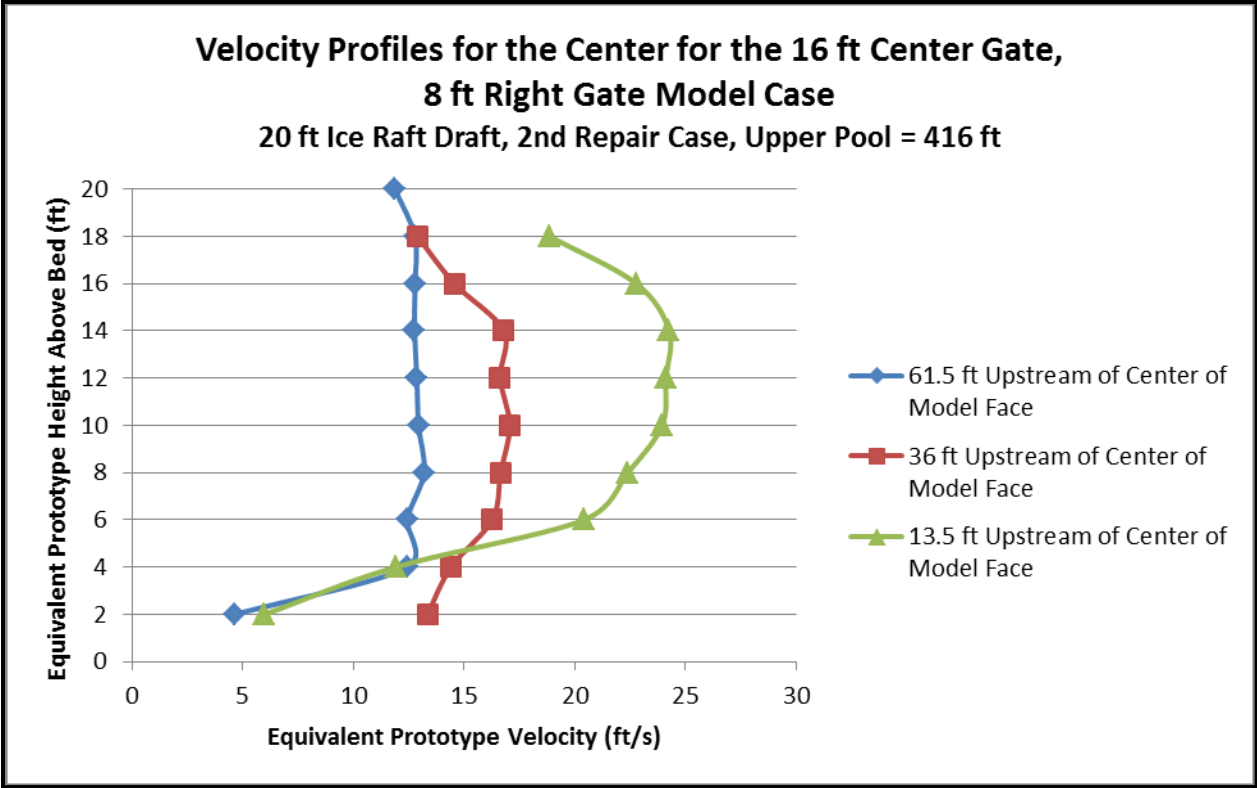
Figure 22 - Velocity profiles for 16 center gate, 8 ft right gate openings

Figure 23 - Velocity profiles comparing 1- and 2-gate openings at 8 ft

Figure 24 - Velocity profiles comparing 1- and 2-gate openings at 10 ft

The ADV measurements revealed two important findings: 1) the maximum possible velocity obtained with multiple testing configurations was approximately 24 fps; and 2) variable side gate tests suggest that opening a side gate and the center gate to 16 ft. open at the same time reduces bed velocity (Figures 20 - 24). The velocity measurements taken during the multiple open gate simulations demonstrate the correlation of dam operations with shear stress and scour. The tests suggest a combination of operations-based and design base improvements should be considered to decrease the shear stress and scour.

Once the scouring conditions were established in the prototype and physical model, the focus of the testing shifted to finding a measurable distinction when scouring did and did not occur in the model. Tests were conducted to determine the effects of operating with: a center gate opening between 16 ft. and a 20ft.; an additional gate open at different heights; and one gate open to a set height versus two gates open to the same height. Flow velocities were measured using an Acoustic Doppler Velocimeter (ADV) and velocity profiles graphed to determine the change in velocity representative of scour occurring and not occurring.

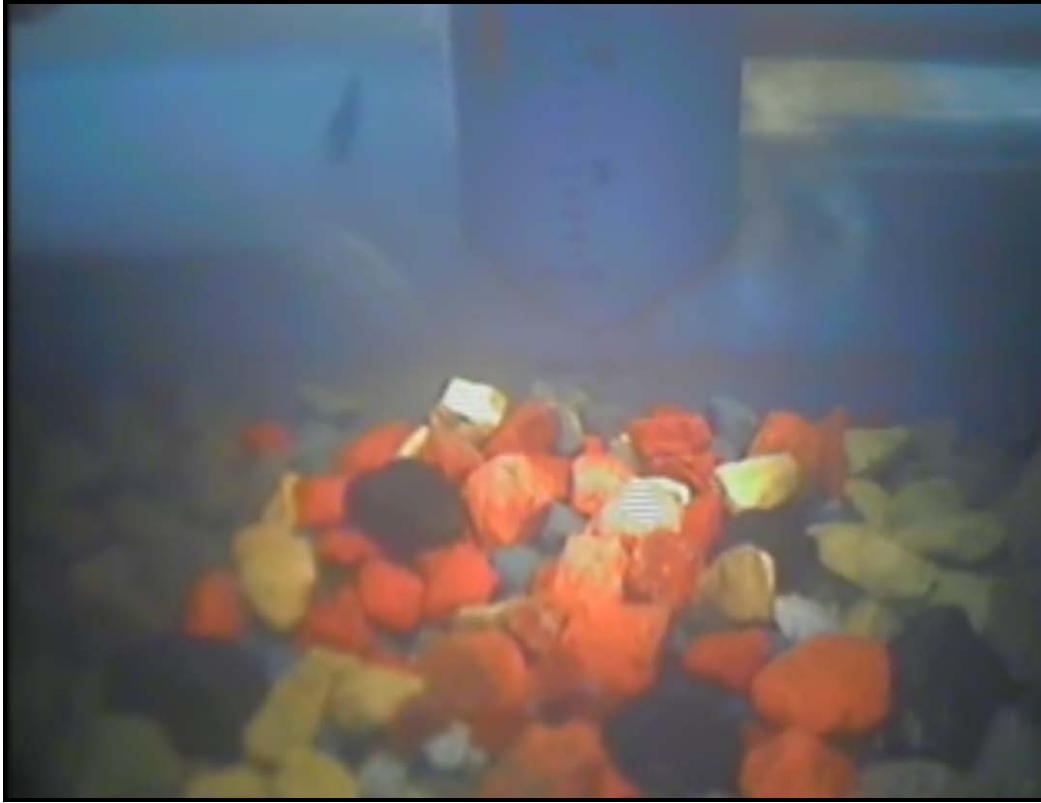
During the gate opening process, underwater video taken of the bed activity recorded stone ejection starting at a 14 ft center gate opening with movement continuing sporadically until the end of the test. The video along with close-up photographs taken at the end of the test showed that scour was evident under the high flow conditions but was limited to the area in close proximity to the pier. The test was repeated with the stone gradations painted different colors (Table 3) to improve stone recognition. A section of the stone bed armor protection immediately in front of the right model pier was replaced with the painted stones mixed to replicate the 2nd repair gradation. Repeating the test with the painted stones revealed that the flow was mobilizing typically only the smallest size stones (Figure 25).

Figure 25 - Movement of painted 2nd repair stone

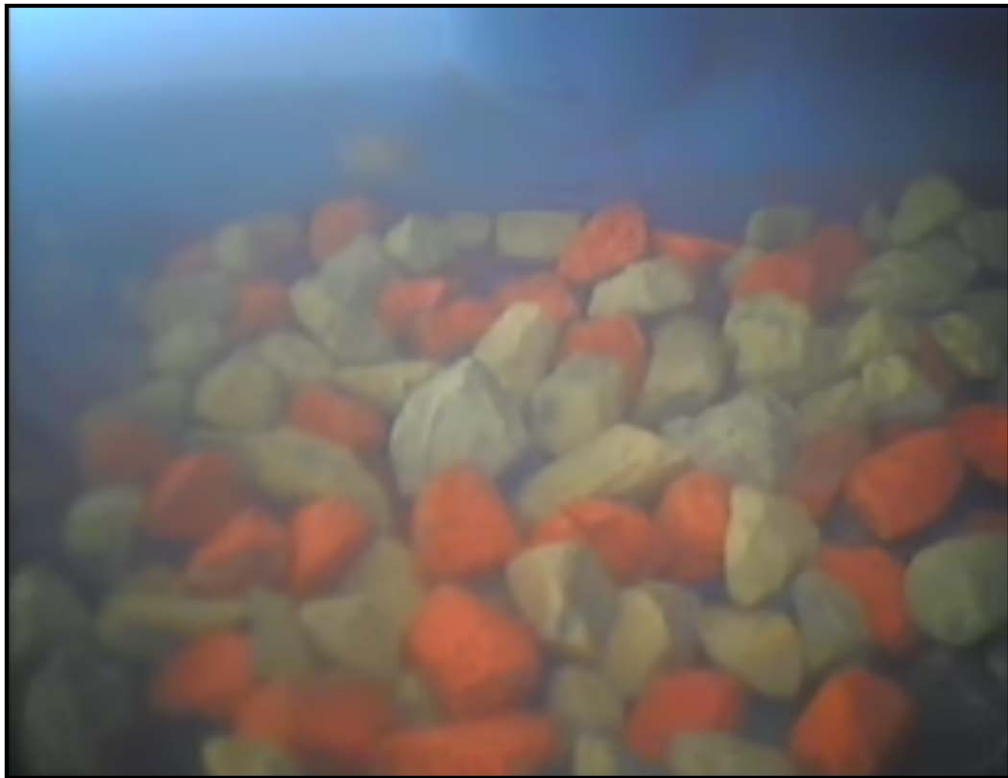
Figure 26 - Orange and yellow stone cap layer movement

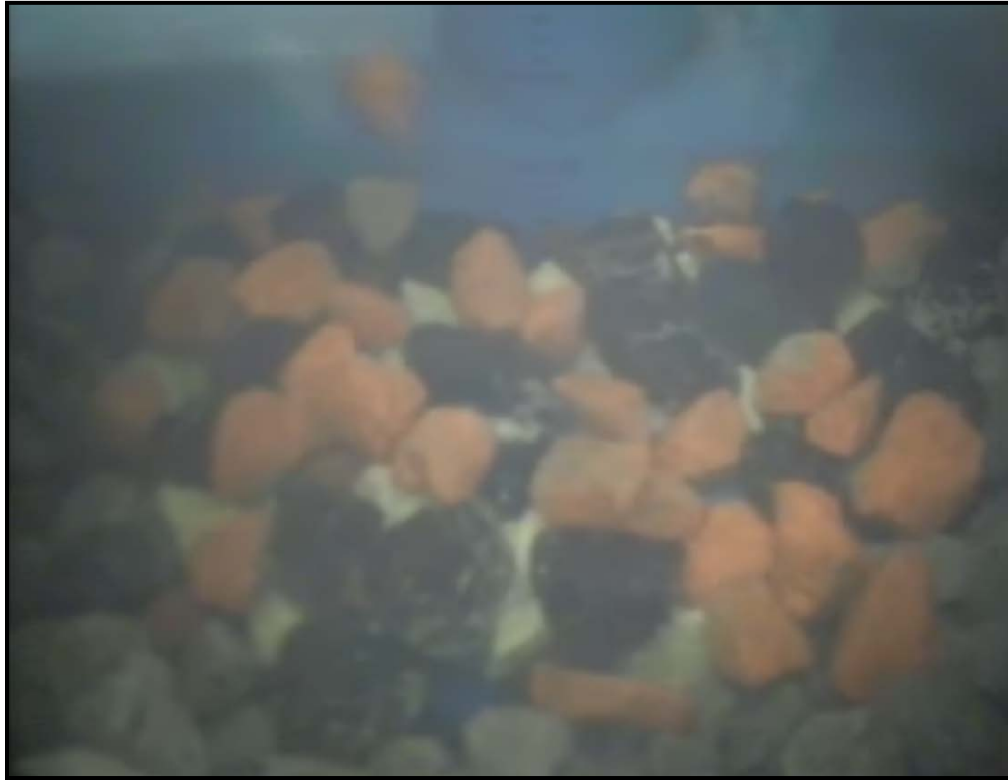
Because of the failure of the yellow and orange top layer, a test was run with a bottom layer of yellow, red, and blue stone and a single thickness top layer of black and orange stone (believing the orange stone ejection from the previous test to potentially be an outlier). For this test condition, rock movement again began at a 14 ft. center gate opening. Ejection of two orange rocks occurred with the center gate open 18 ft. and the right gate just beginning to be opened to 2 ft. (Figure 27).

Figure 27 - Black and orange stone cap layer movement

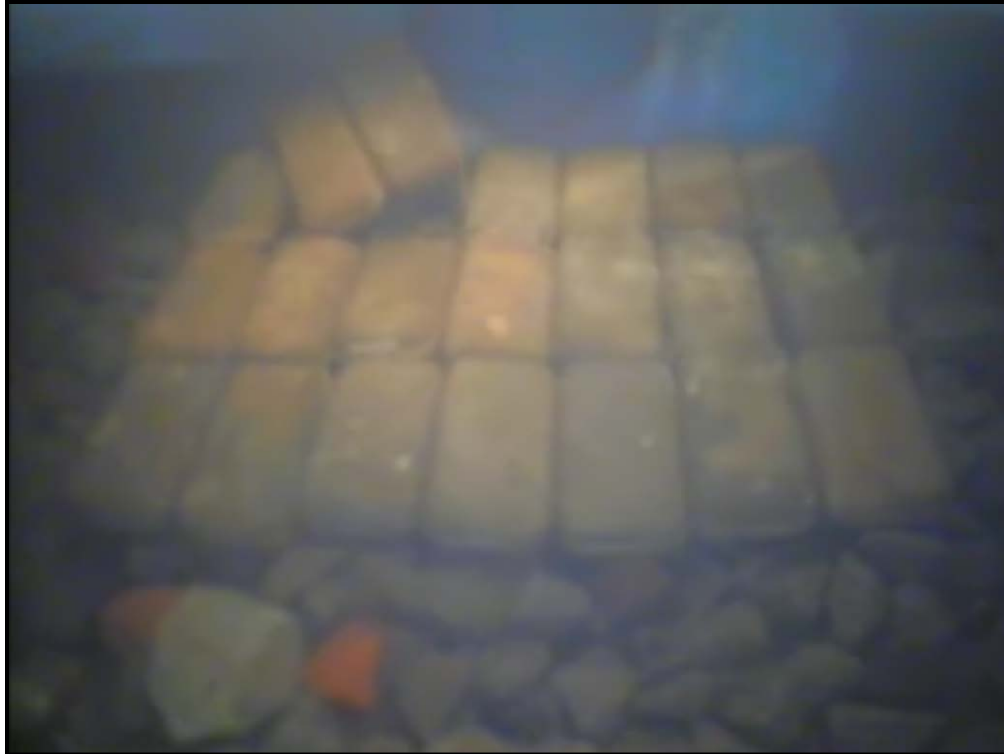
The smaller sized bags were tested first and were placed on top of the stone bed armor repaired to the design elevation with the 2nd repair stone and with the long dimension oriented parallel to the flow. During the test, five of the grout-filled bags were lifted from the bed and ejected through the gate bay, with two of the bags lifting off as the gate transitioned to a 14 ft. center gate opening (Figure 29).

Figure 29 - Movement of model 9,000 lb grout-filled bags during testing

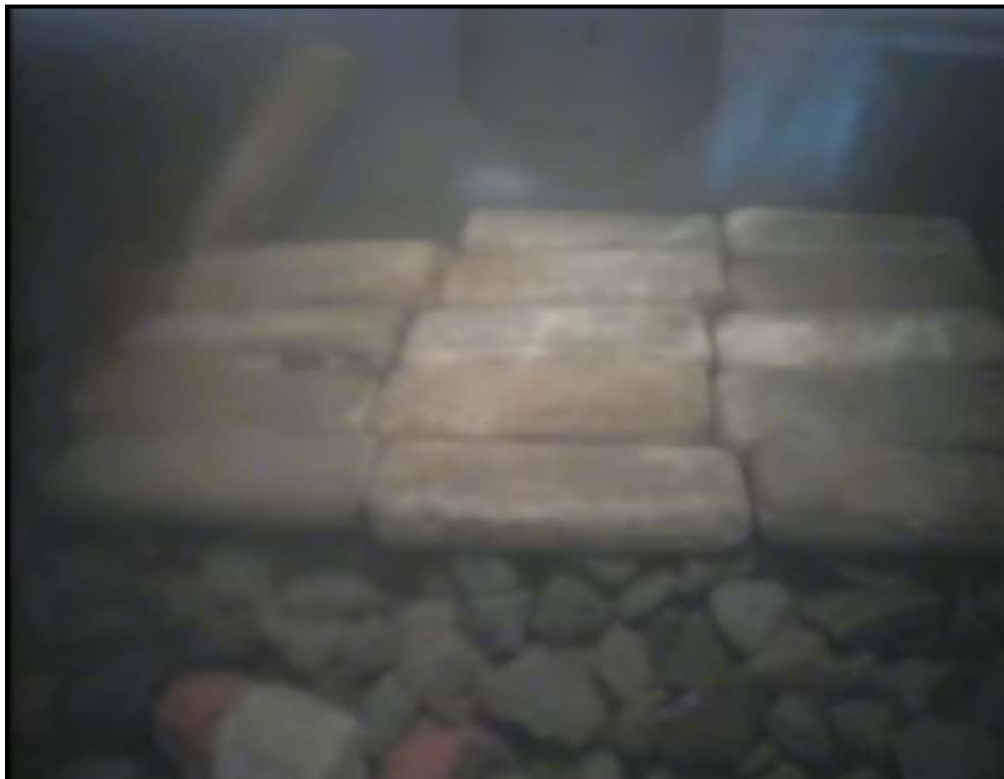
The larger grout-filled bags were tested next but with the bags positioned perpendicular to the flow. During the test, six grout filled bags were lifted and ejected through the gate bay, the first when the gate was at a 12 ft. gate opening (Figure 30). It should be noted that movement below the 14 ft. – 16 ft. threshold was frequently seen in the underwater video tests. Because of concerns that the grout-filled bags protruded from the bed, the test was rerun with the top of the bags level with design bed elevation. The bags were again ejected starting at the transition to a 14 ft. center gate opening (Figure 31).

Figure 30 - Movement of model 14,000 lb grout-filled bag during testing

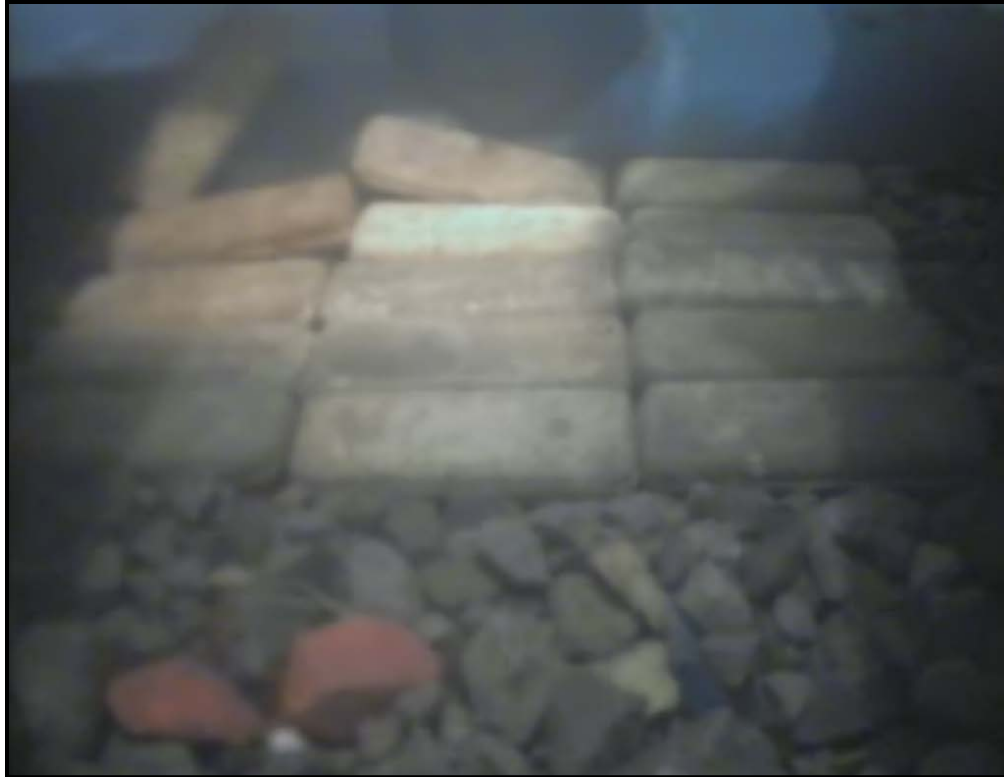
Figure 31 - Movement of model 14,000 lb grout-filled bag during testing
