Summary Report

Mel Price Lock and Dam Physical Model, Upstream Scour

By Timothy J. Lauth
Hydraulic Design
US Army Corps of Engineers St. Louis District
1222 Spruce St.
St. Louis, MO 63103-2833

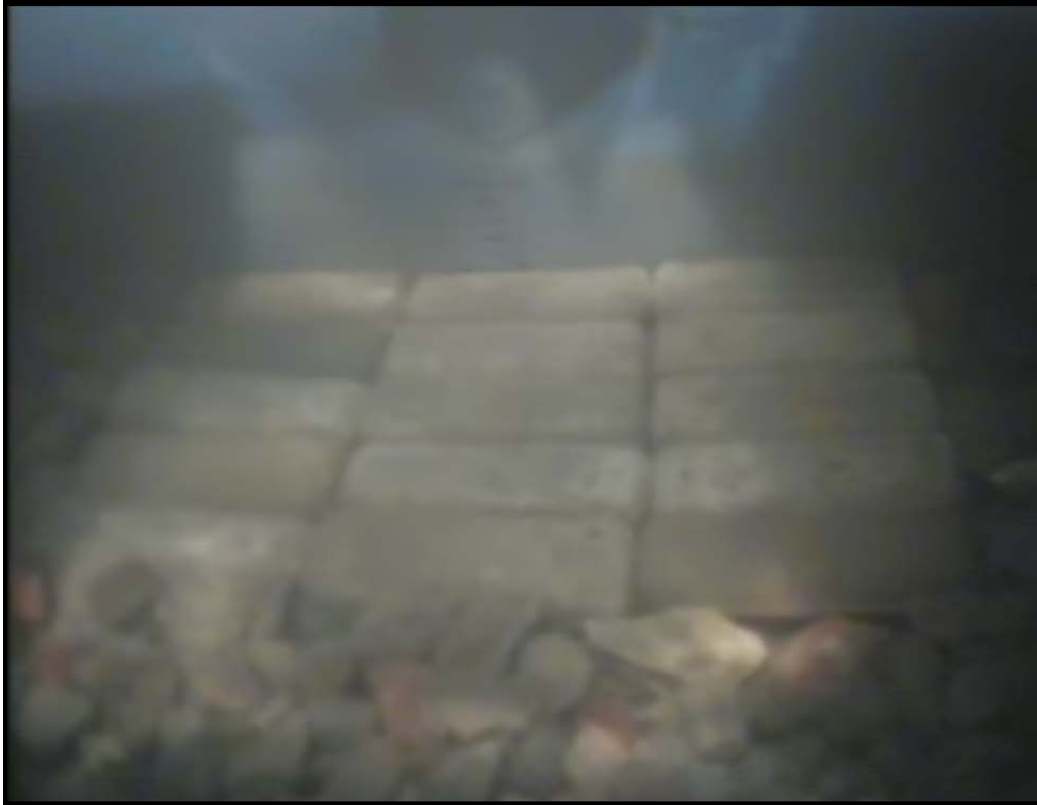
The movement of the larger grout-filled bags shifted the emphasis of the possible solutions testing away from the use of a capping layer to changing the design elevation of the stone bed protection. Changing the elevation of the stone bed protection potentially does two things to alleviate scour: 1) it increases the cross-sectional area, reducing velocity and bed shear stress, and 2) it lowers the stone bed protection away from near-sill turbulence. The stone bed protection was lowered to an elevation of 370 ft. and the 14,000 lb bags were buried in the immediate vicinity of the sill and piers to match the design top elevation of the stone bed protection. This test was run with center gate starting at an 8 ft. opening and incrementally increasing to an 18 ft. opening. During this test, none of the grout-filled bags moved (Figure 32).

Figure 32 - 14,000 lb grout-filled bags in place after testing at 370 ft. elevation

Lowering the design elevation of the stone bed protection from 375 ft. to 370 ft. was tested for stone bed protection consisting entirely of the 2nd repair gradation. No recordable movement was observed in both high opening and variable opening gate conditions. The tests were repeated with the stone bed protection simulating the current stone conditions of the prototype at the 370 ft. elevation with similar results.

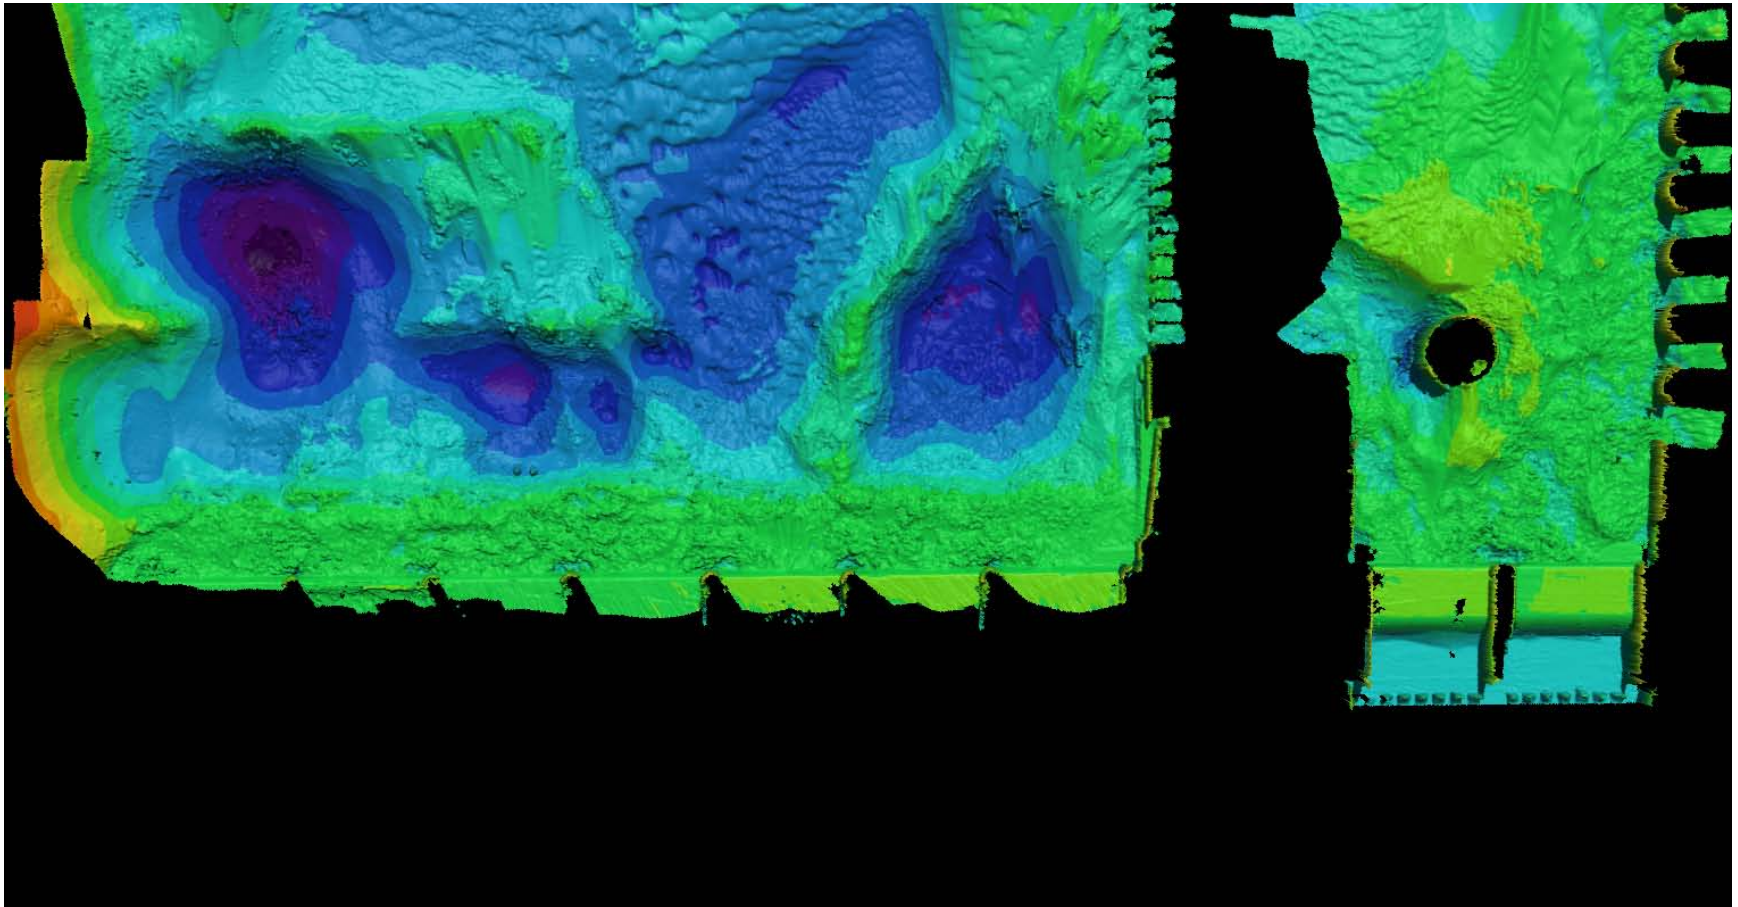
13. March 2, 2011 - The most recent bathymetric survey again displayed similar scour to the previous survey. All stone bed protection in the immediate vicinity of the piers has undergone between 1 ft to 5 ft of scour, with the deepest scour occurring at the pier between Gates 1 and 2 and the piers flanking Gate 4. No more than 2 ft of scour has occurred in the sill-adjacent stone bed protection.
