Technical Report M61

**Bird's Point HSR MODEL
River Miles 5.8 – 0.0**

**HYDRAULIC SEDIMENT RESPONSE MODEL
INVESTIGATION**

Final Report – November, 2011

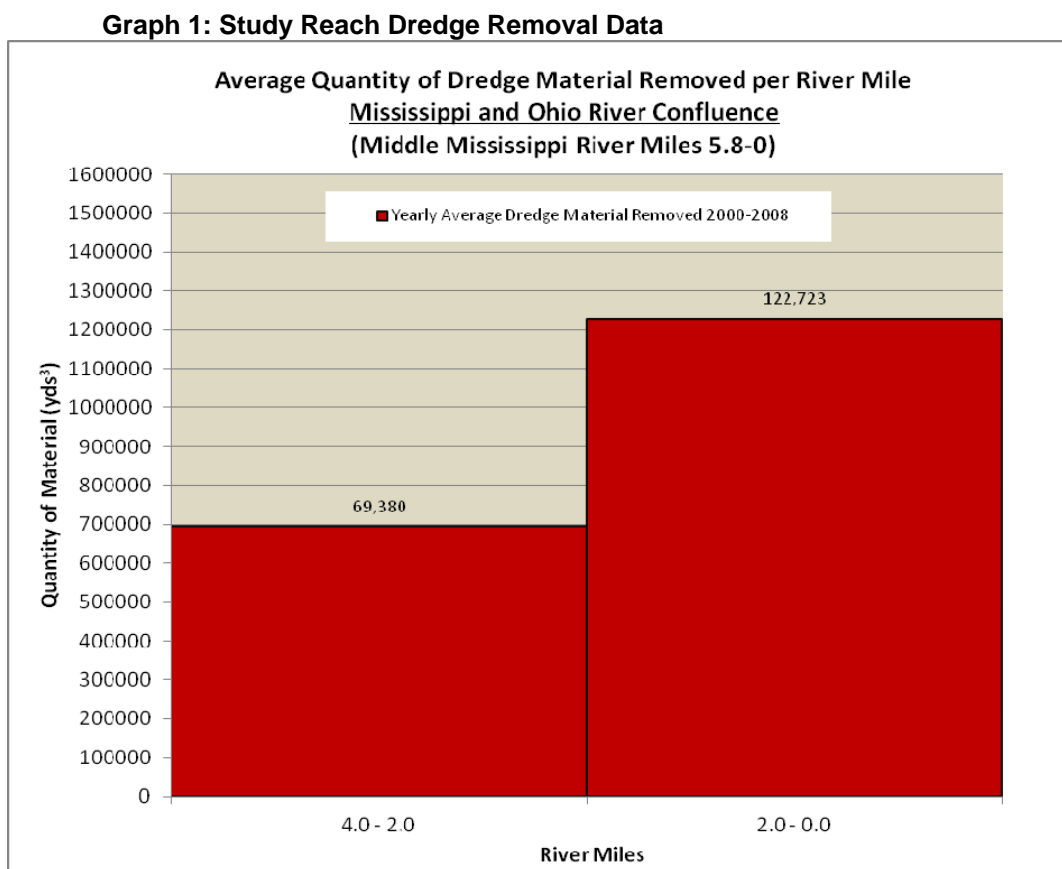
Dredging in the Mississippi River is commonly used to provide required navigation dimensions of depth, width, alignment, or a combination thereof. In the case of the Bird's Point reach, repetitive channel maintenance dredging is required for all three dimensions. Without dredging, the sandbar located along the LDB between River Mile (RM) 2.0 and RM 3.0 has grown in size and shoaling has occurred between RM 1.4 and RM 0.0, resulting in an unacceptable navigation approach through the U.S. – 60/62 Bridge (see Plate 3). On average, dredging in this area has been required nearly every year from 2000 - 2008. During that time frame, between RM 4.0 and RM 2.0, an average of 69,380 cubic yards (cy) has been dredged annually at a cost of \$166,000. Between RM 2.0 and RM 0.0 an average of 122,723 cy has been dredged annually at a cost of \$171,550. See Graph 1 for a comparative analysis of the dredge material removed in Bird's Point reach.

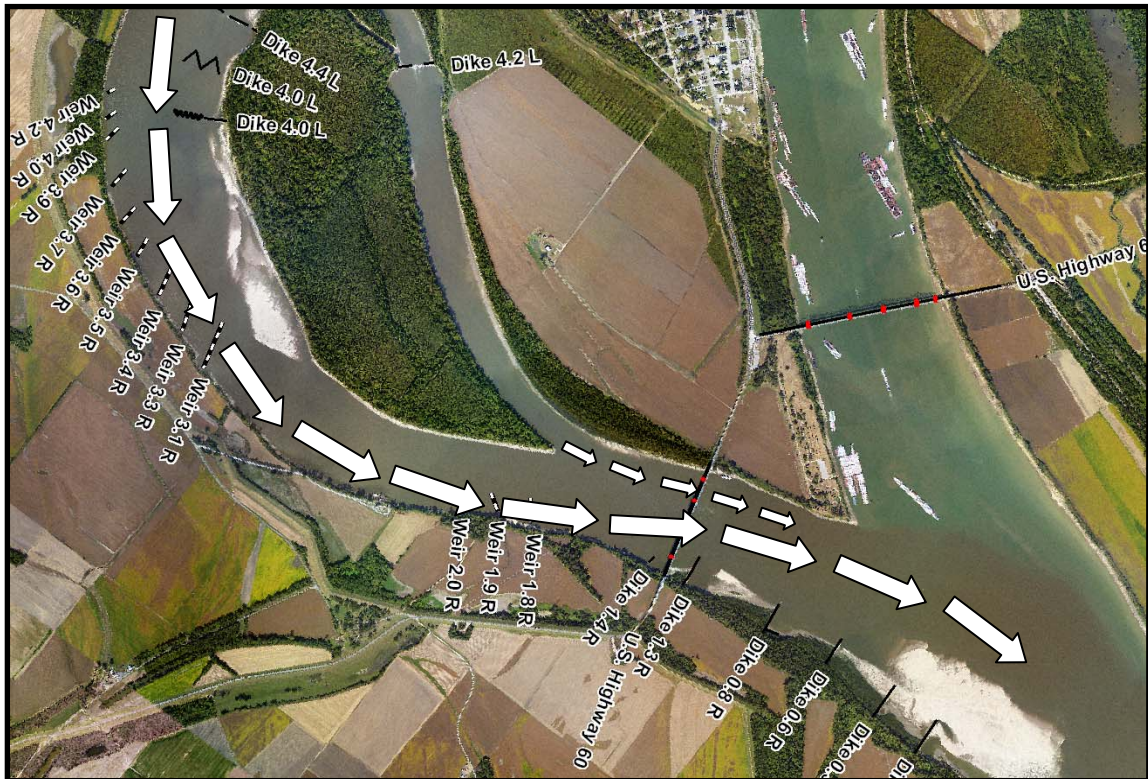
Graphic 1: Study Reach with General (Normal) Flow Trends as Indicated by Pilot Interviews and ADCP Surveys

After thoroughly investigating the model reach through tow pilot interviews and ADCP surveys, it was determined that the study reach was very sensitive to the flows through Angelo Chute. Graphic 1 (Normal Flow) and Graphic 2 (High Flow) describe generalized flow conditions. Starting near RM 4.2, the velocities were dispersed evenly across the channel as a result of the RM 4.2 to RM 3.1R weir field. The flow increased upon exit of the weir field and constriction of the channel near RM 2.8. As the flow passed over the small weir field from RM 2.0 to RM 1.8R, the planform and weirs dispersed the energy and forced the direction of flow towards the center of the channel. At normal flows, the flow exiting Angelo Chute stayed near the LDB. The main channel flow was slightly angled towards the LDB as it passed through the bridge span. However, at high flows the velocities exiting the chute were strong enough to redirect the main channel flow towards the RDB as it passed through the bridge span. As a result, an alignment and slight outdraft problem existed near the bridge piers of the navigation span. Even at high flows, navigation through the bridge was not an area of concern for experienced pilots. However if pilots are not familiar with the reach, they may not know how to account for the flows exiting Angelo Chute. Accidents and difficulties navigating through this stretch of river have occurred when pilots unfamiliar with the reach underestimated the flows exiting the chute.

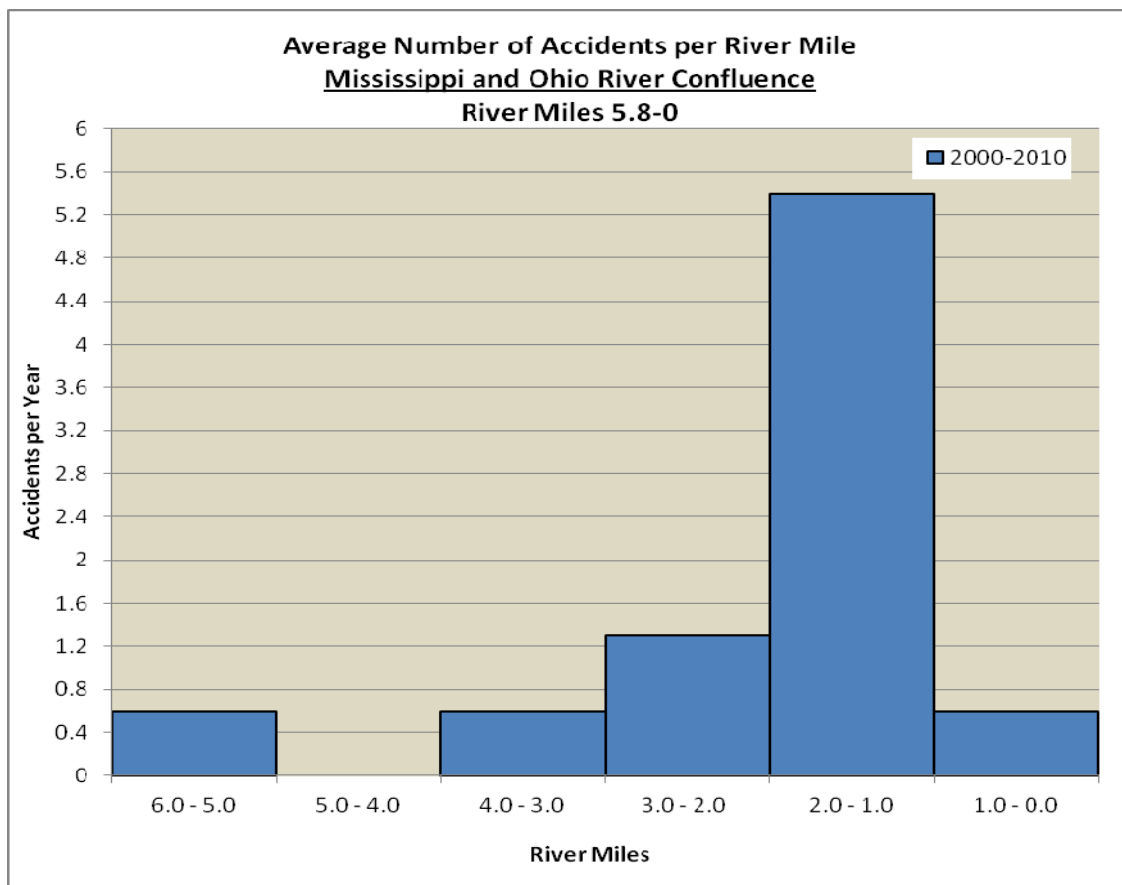
Graph 2: Study Reach Accident Data

During higher Mississippi River discharges, barge tow pilots have reported that flow exiting Angelo Chute directs the main channel flow towards the RDB pier of the navigation span. This has been shown to be a safety hazard. The available accident data for RM 3.0 to RM 0.0, provided by Coast Guard District 8, reveals that the average number of accidents per year is 5.4 near RM 1.0 (Graph 2). These accidents are associated with the U.S. - 60/62 Bridge.
