Technical Report M3

**SIDE CHANNEL SEDIMENTATION STUDY OF THE  
MISSISSIPPI RIVER  
MARQUETTE CHUTE/CAPE BEND  
RIVER MILES 51 TO 47**

**HYDRAULIC MICRO MODEL INVESTIGATION**

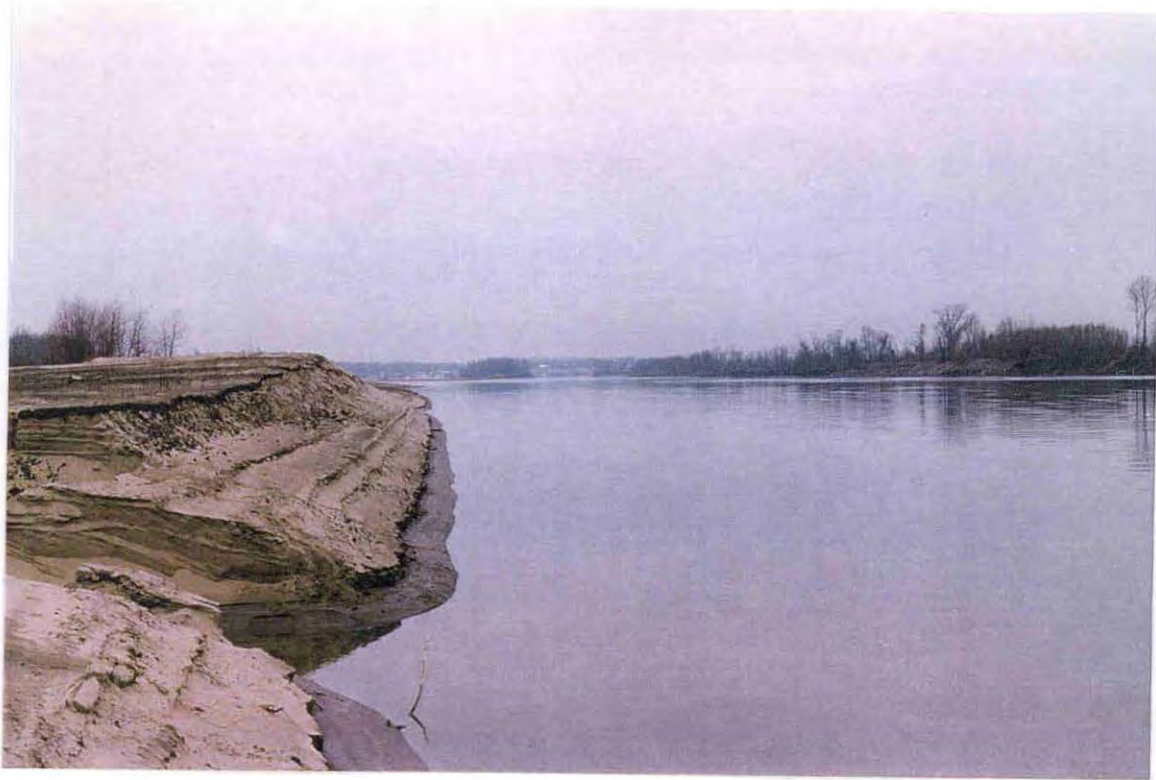
A site inspection was performed by Robert Hetrick in January of 1997. Photos were taken and are shown in Plates 6 and 7. The river stage at Cape Girardeau was approximately 20.7 which was slightly above mid-bank. Plates 8, 9, and 10 show aerial photographs that were taken by LTRM personnel on May 1<sup>st</sup> when the river stage at Cape Girardeau was approximately 2 feet above flood stage. It is important to note the relatively large area and amount of sediment that was still above the water surface.

Photograph of Marquette Chute

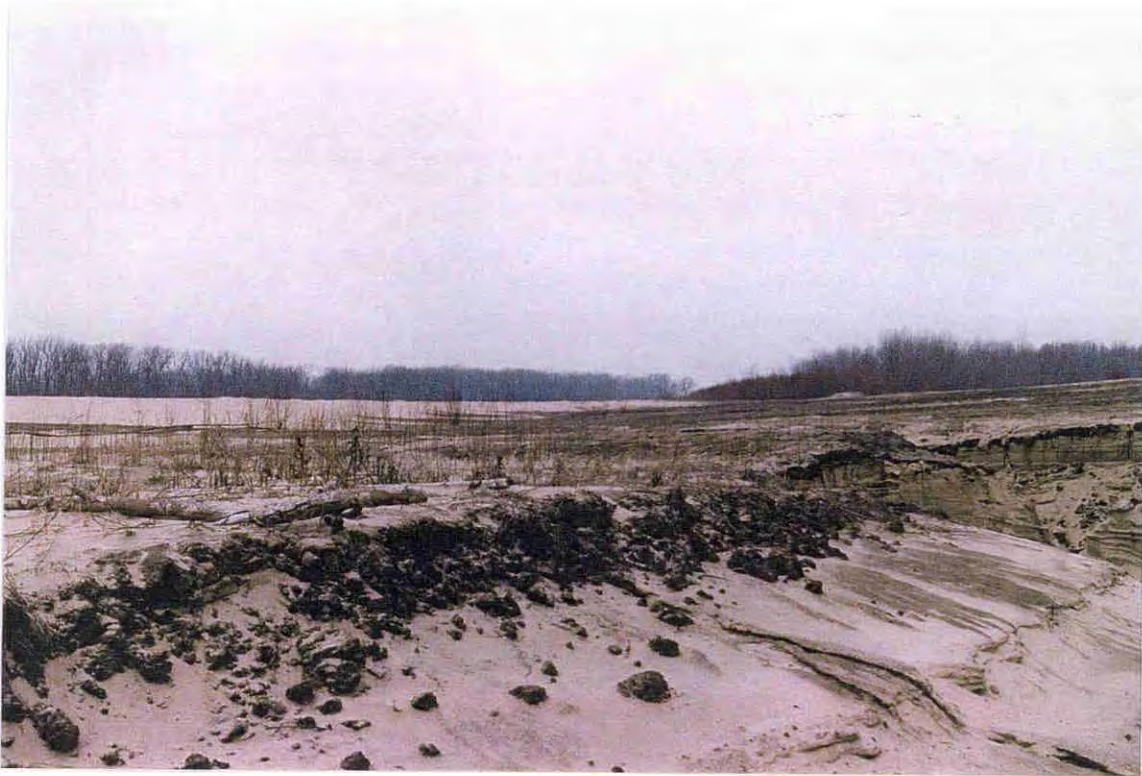
7

Photograph of Marquette Chute

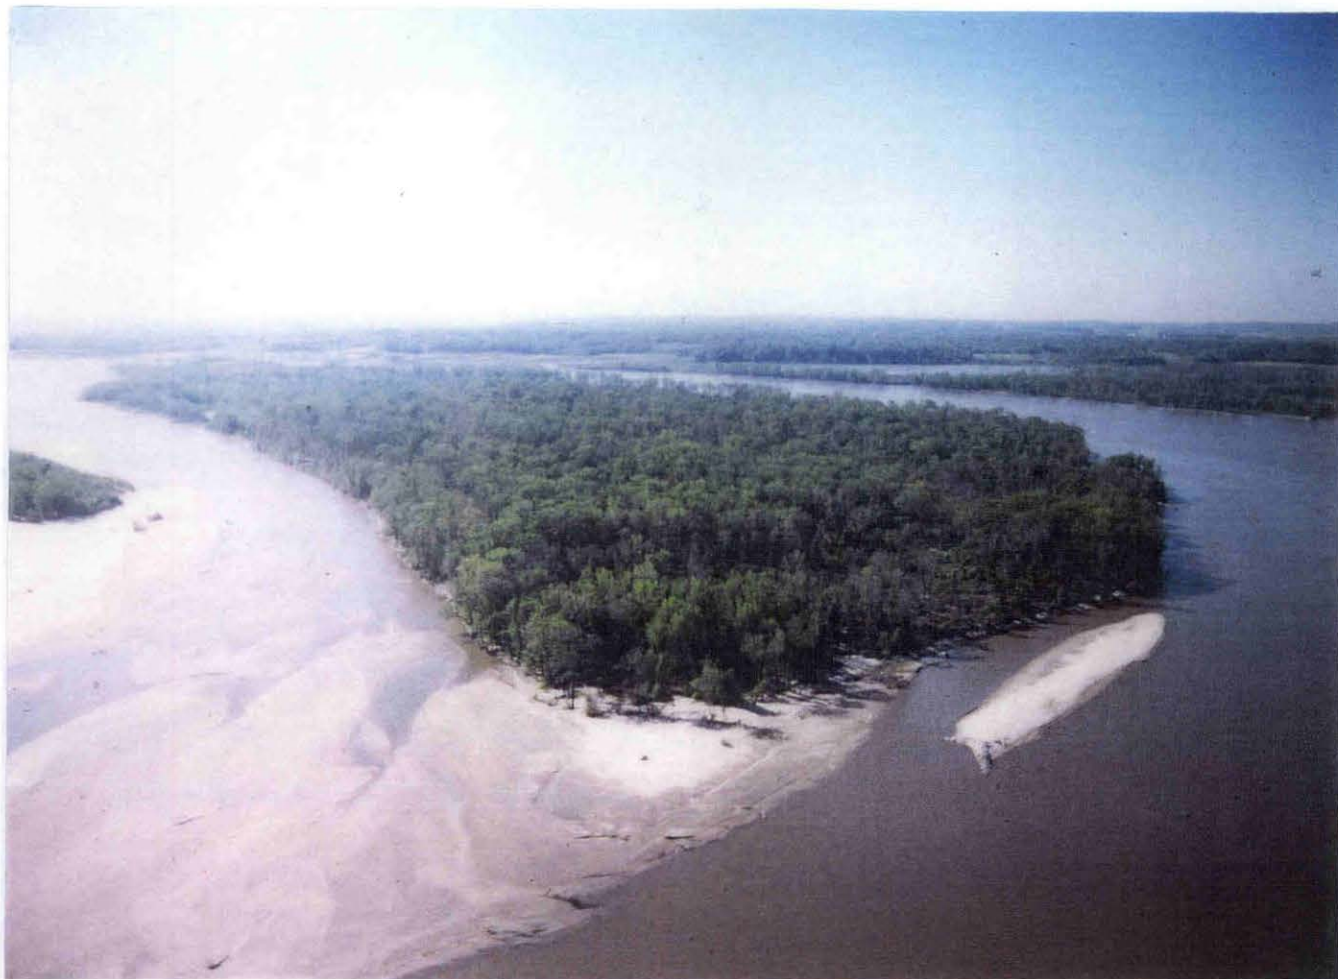
8

Photograph of Marquette Chute

- The placement of the three chevrons in alternative C did not significantly change the bed characteristics of the bar. There is very little sediment transport energy in the side channel near Marquette Island. This is evident in the photographs of the side channel during high water (Plates 8, 9, 10).

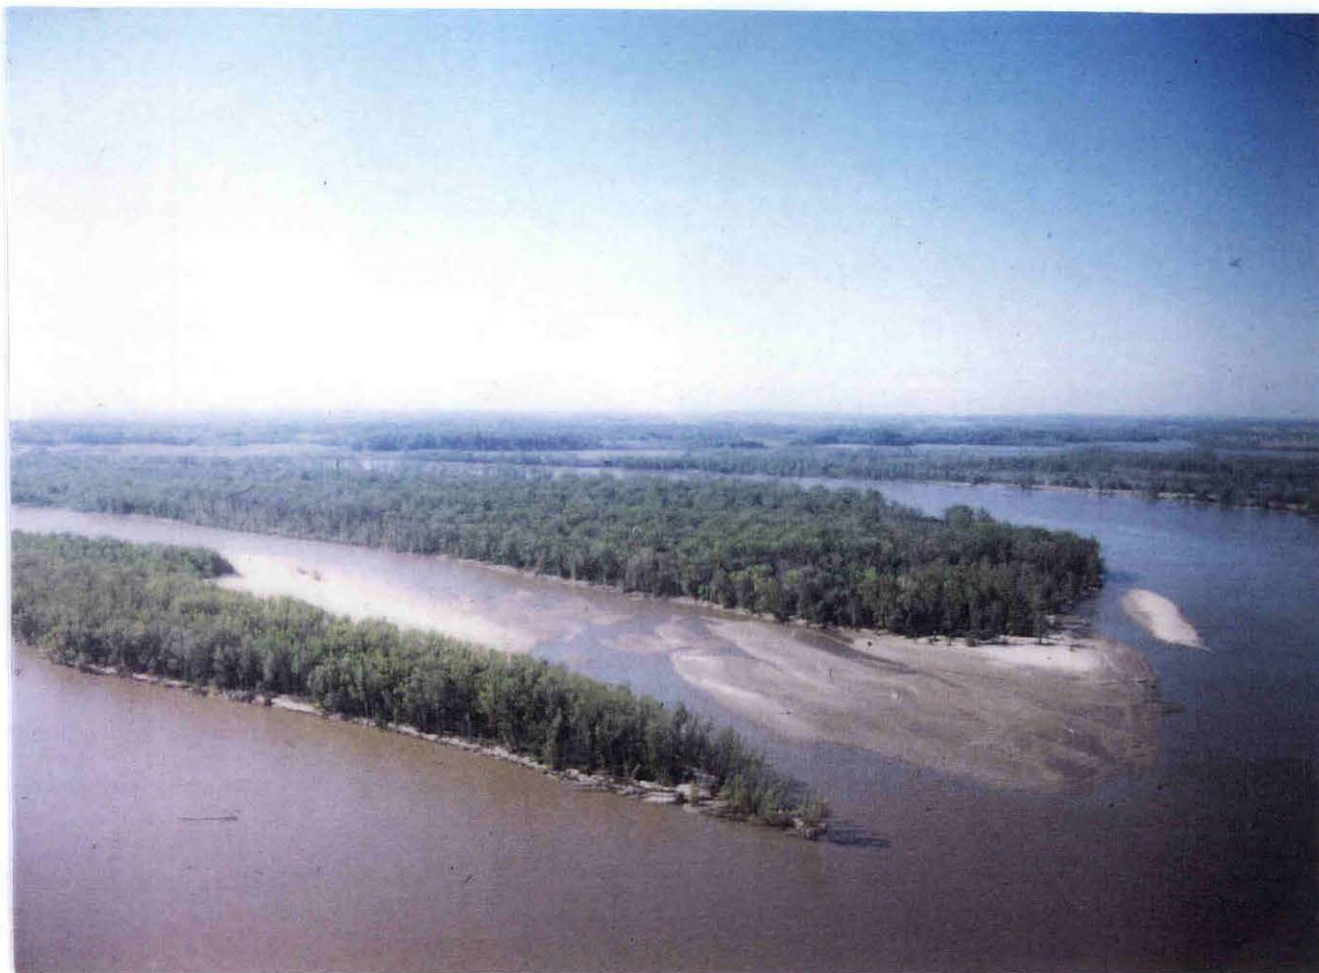
9

Photograph of Marquette Chute

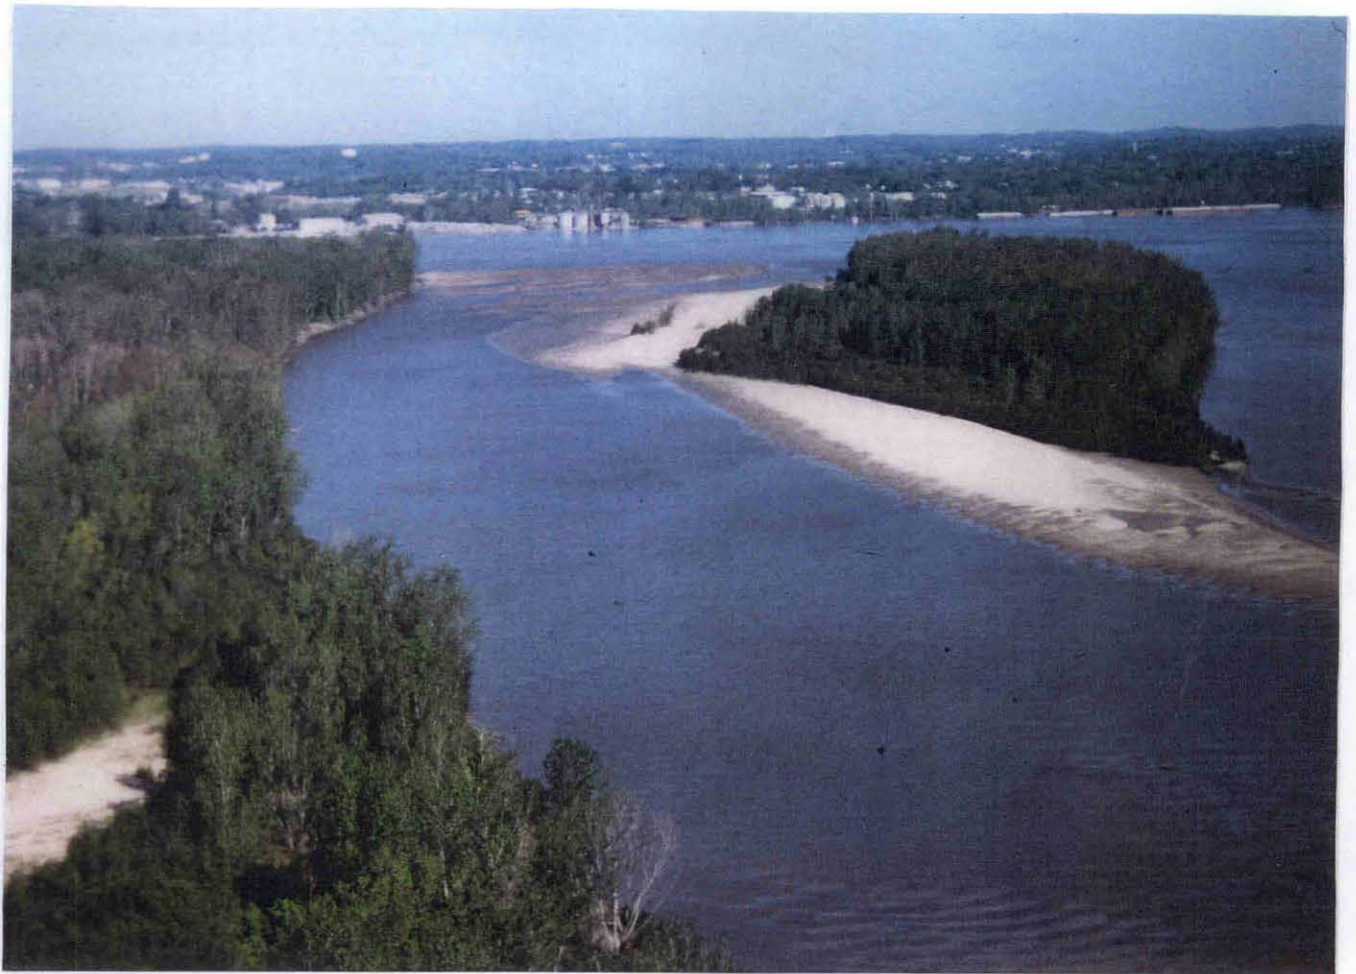
10

Photograph of Marquette Chute

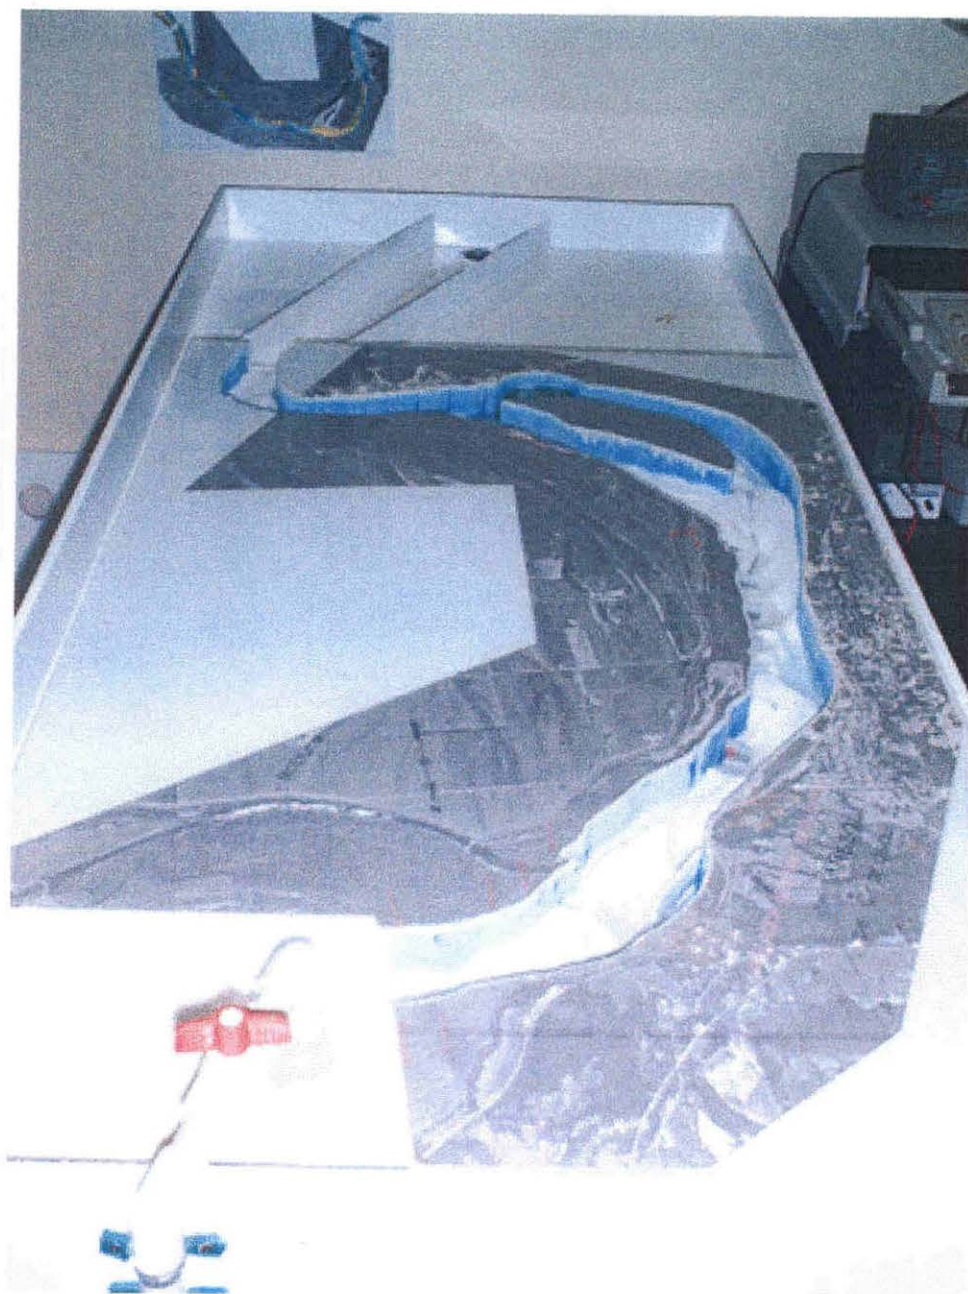
Plate 13 is a photograph of the hydraulic micro model used in this study. The model insert encompassed the river channel between River Miles 56 and 45. Entrance and exit conditions in the model were adjusted. The actual study reach was between river miles 53 and 47. The scales used were 1 inch = 800 feet, or 1:9600 horizontal and 1 inch = 65 feet, or 1:780 vertical for a 12.3 distortion ratio. This distortion supplied the necessary forces required for the simulation of sediment transport conditions similar to the prototype. The bed material was granular plastic urea, Type II, with a specific gravity of 1.23.
