Technical Report M16

**SEDIMENTATION STUDY OF THE  
MIDDLE MISSISSIPPI RIVER AT SALT LAKE CHUTE,  
RIVER MILES 141 TO 133  
HYDRAULIC MICRO MODEL INVESTIGATION**

Final Report – October 2001

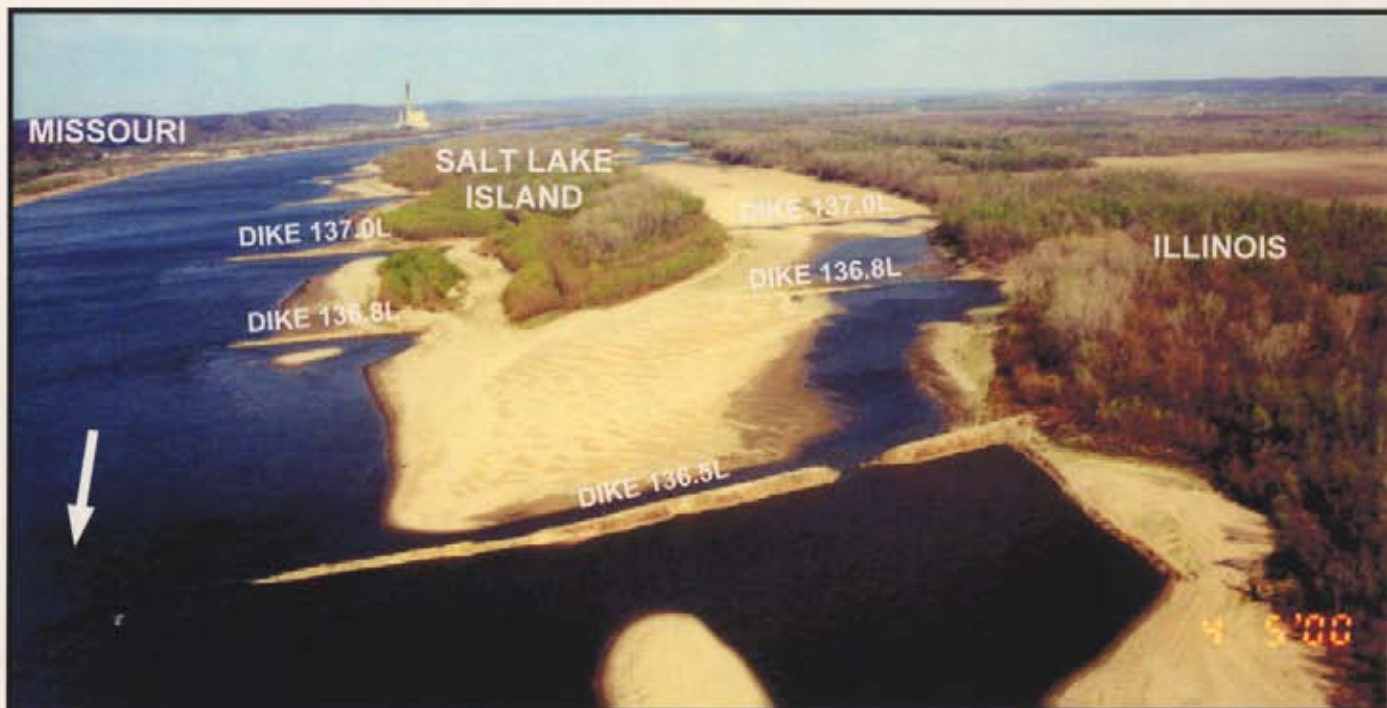
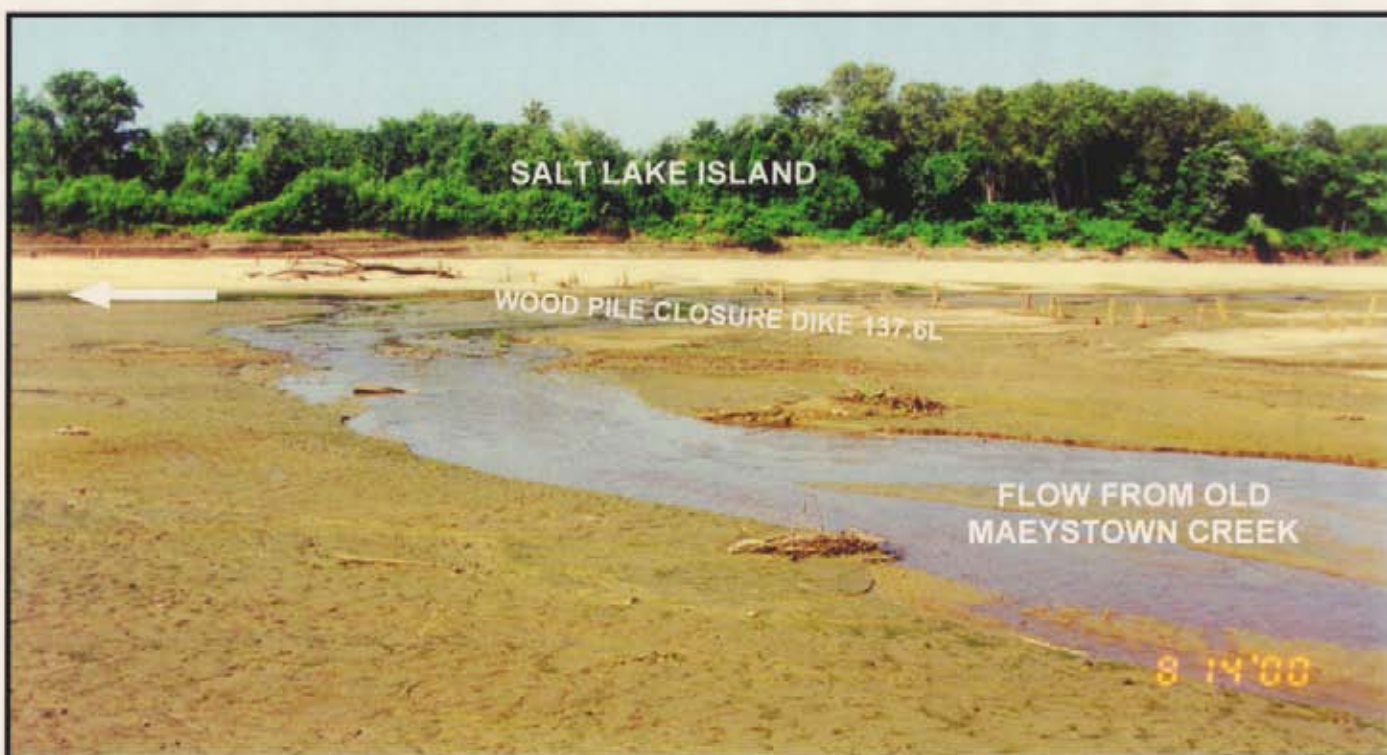
TOP PHOTO: Downstream View  
of Salt Lake Chute

BOTTOM PHOTO: Interior Photo  
of Salt Lake Chute

The bed configuration within Salt Lake Chute is rather homogenous, consisting mostly of sandy flat areas. The elevations of the bed within the chute are relatively high. Plates 3 and 4 show oblique aerial photos near the entrance and exit of the chute. The pictures show the elevation of the bed of the chute relative to the main channel of the river. Plates 4 and 5 show ground level photos of the chute during low flow conditions on the river when the chute is dry from bank to bank. These high bed elevations indicate that there is little to no flow of water in the side channel during periods of low flow in the river.

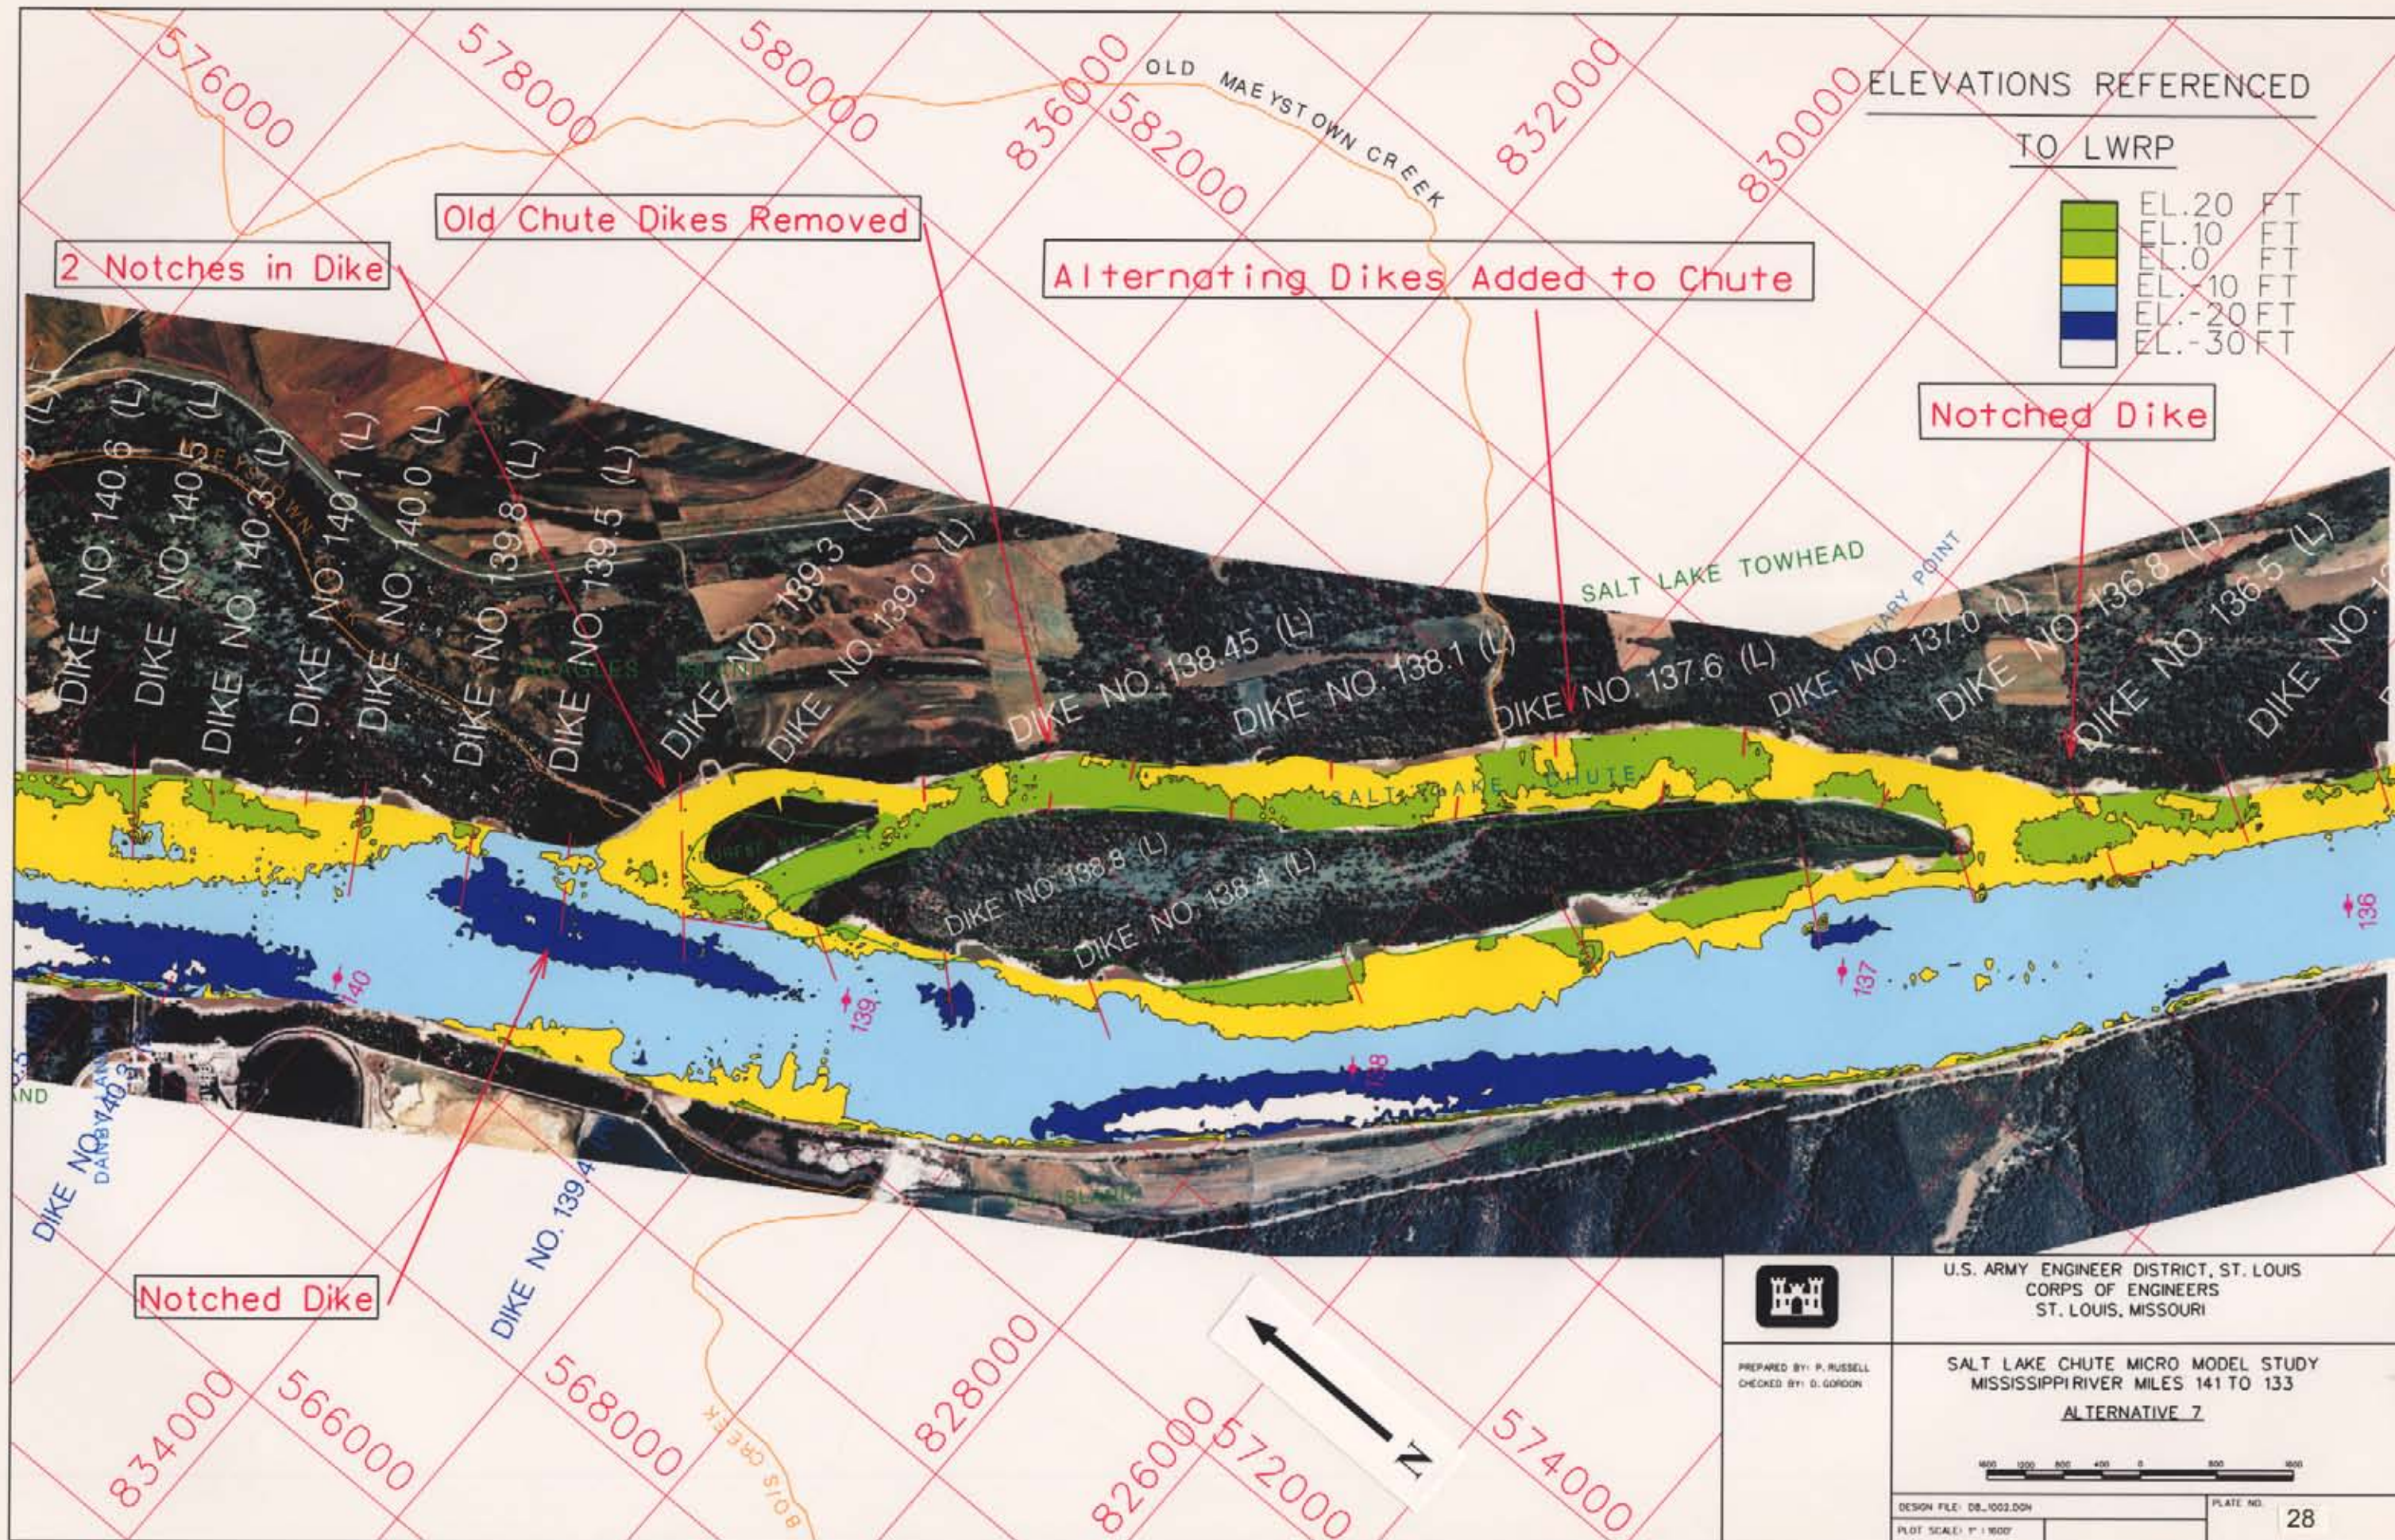
PLATE NO. 28

Plate 28 is a plan view contour map of the resultant bed configuration of Alternative 7. Results indicated that this design had minimal effect on the bathymetry of both chute and the main channel. The depth of the scour holes off the ends of Dikes 139.8L and 139.5L were reduced by 10 feet. A minor shoaling area appeared along the right descending bank between Miles 139.5 and 139.0. The notches in Dike 139.3L caused a very slight increase in depth within the chute on the Illinois side of Durfee Bar. The notches also resulted in a depth increase immediately downstream of the dike and near the longitudinal closure structure. The minor increases in depth near the additional dikes were caused by the physical insertion of the structures into the model. The removal of the closures resulted in insignificant changes in depths throughout the chute. The notch in the Dike 136.5L caused minor localized increases in depth along the left descending bank both upstream and downstream of the dike.

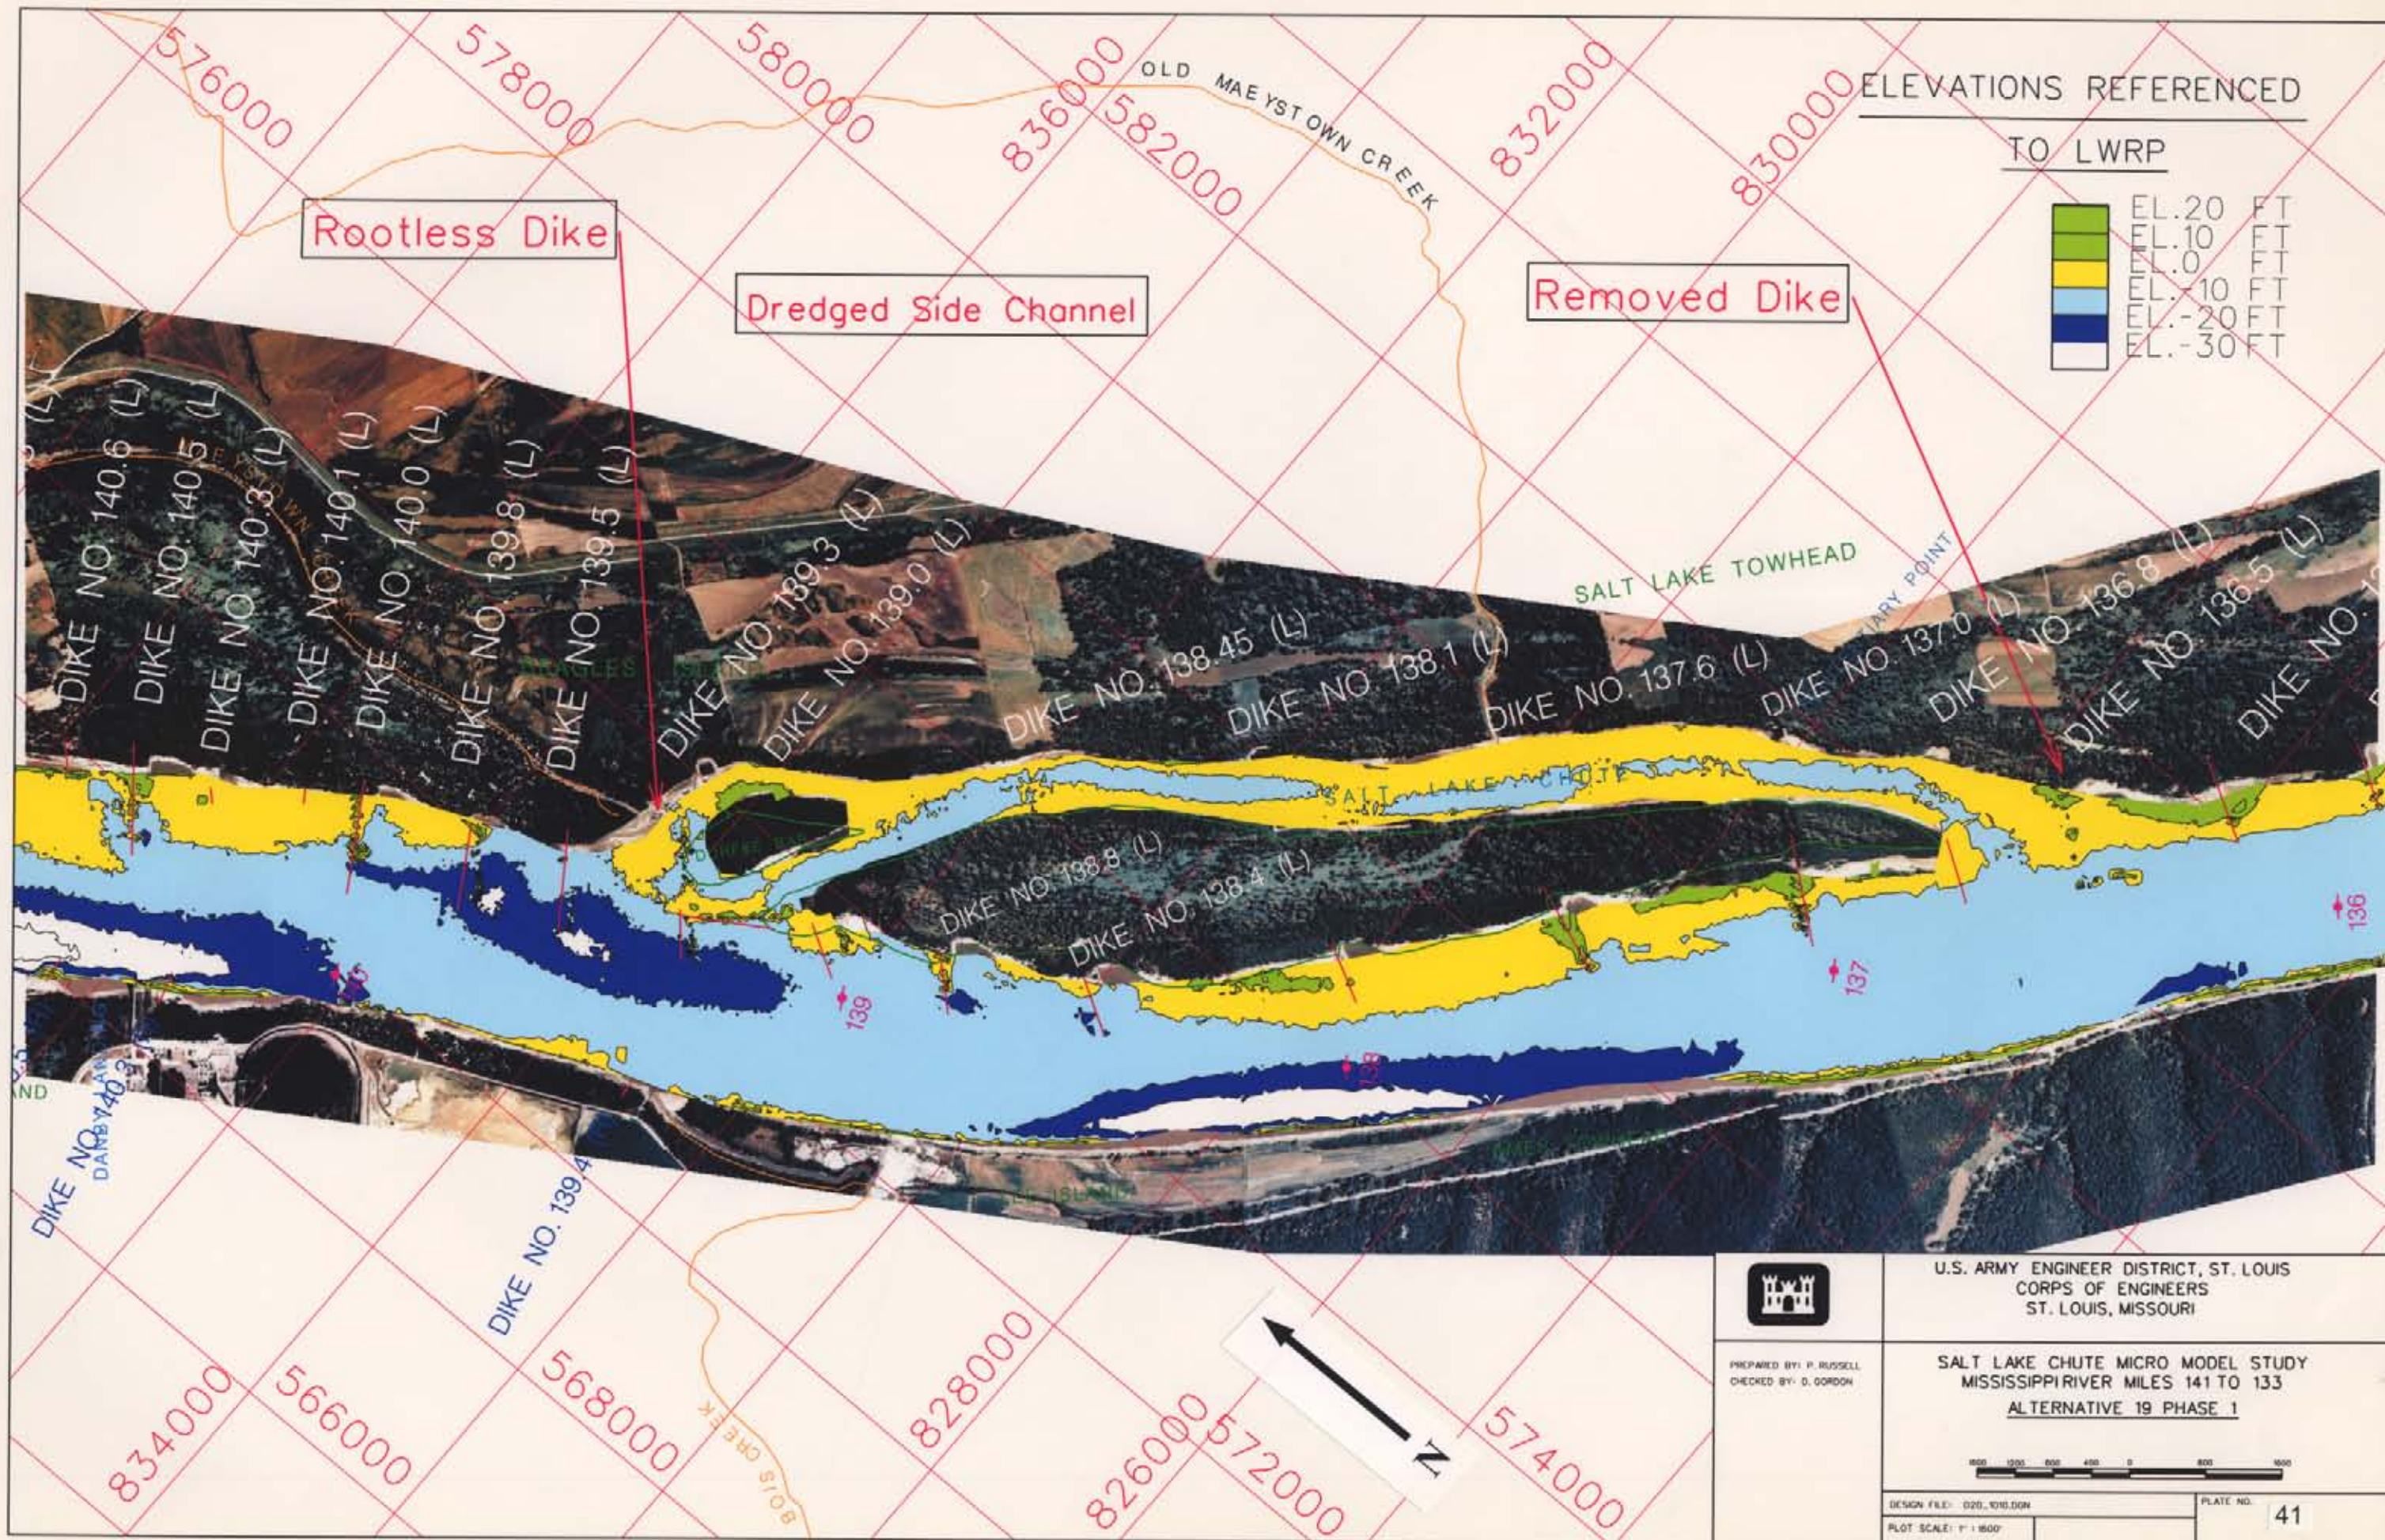
PLATE NO. 40

Plate 39 is a plan view contour map of the initial dredged bed configuration of Alternative 18. Plate 40 is a plan view contour map of the resultant bed configuration of Alternative 18. The results of this test show deposition within the artificial dredge cut in the side channel. The downstream portion of the chute appeared to shoal more rapidly than the upper portion. The time scale for deposition of sediment back to the original elevations in the chute is unknown.
