CARROLL ISLAND MICRO MODEL STUDY RIVER MILES 273.0 TO 263.0

HYDRAULIC MICRO MODEL INVESTIGATION

Technical Report M37

Final Report – MAY 2006

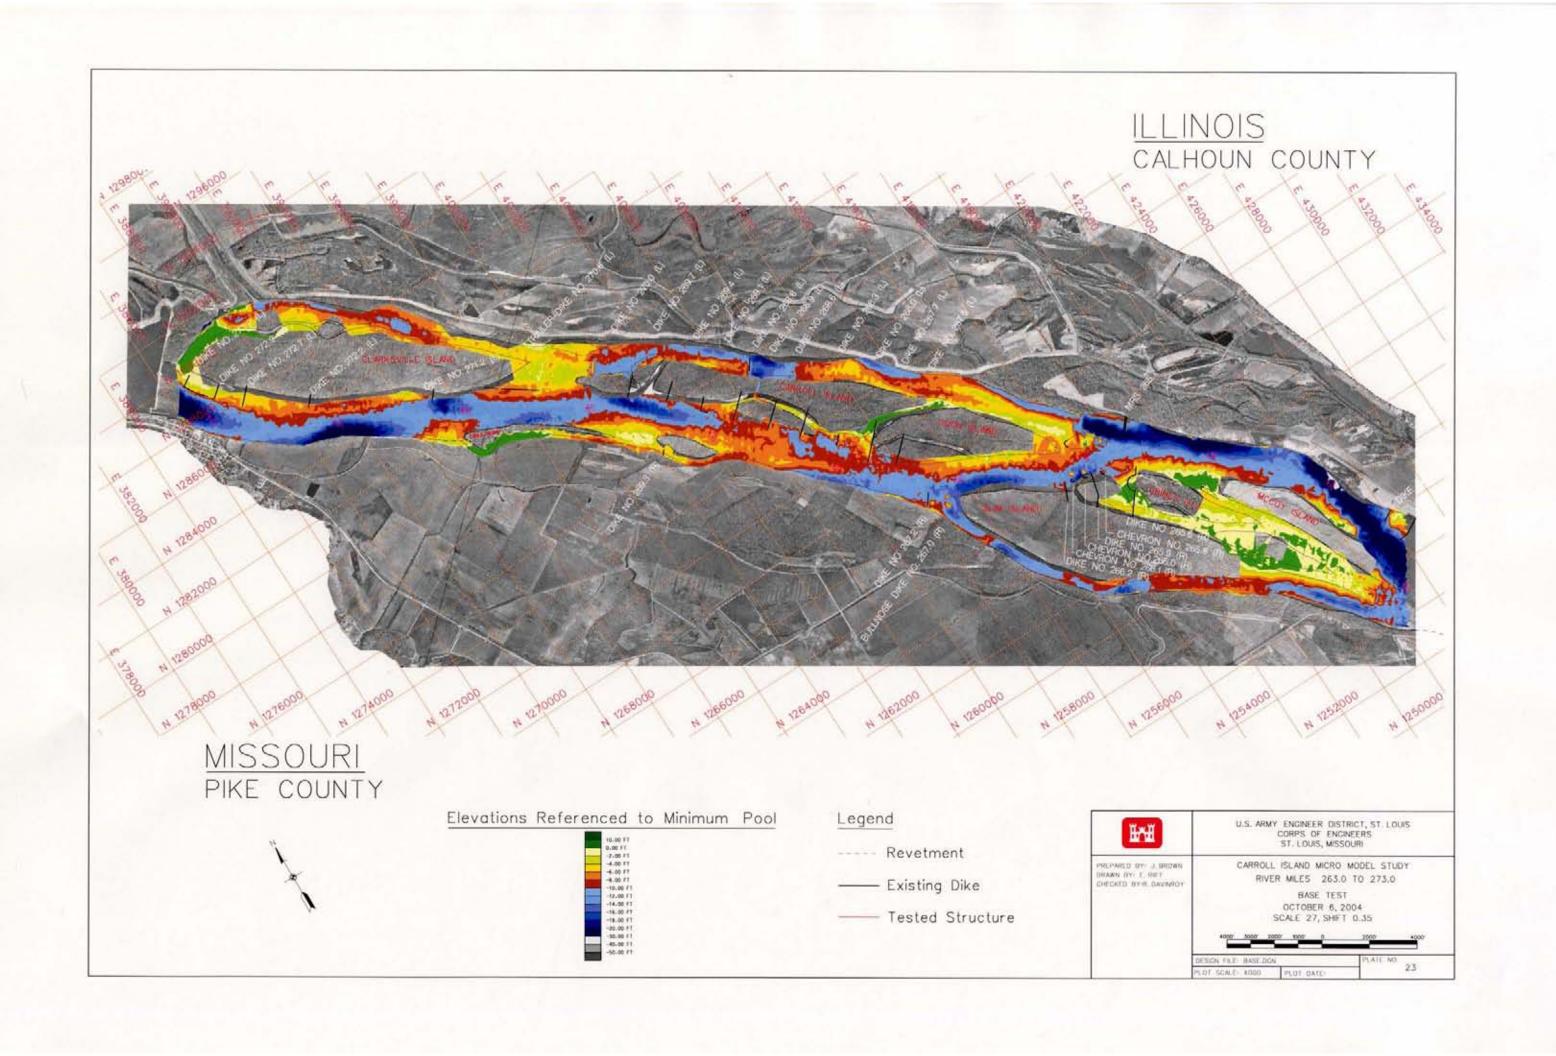
Plate 23 shows the resultant bed configuration of the micro model base test. The base test was developed once bed stability was reached and a similar bed response was achieved as compared with prototype surveys. This survey then served as the comparative bathymetry for all design alternative tests.

Results of the micro model base test bathymetry and a comparison to the 1993 through 1999 prototype surveys indicated the following trends:

- Between Mile 273.0 and 270.0, the main channel bathymetry and thalweg location match the prototype. The bar formation at Mile 271.0 along the RDB was slightly larger and shallower (+2 ft) than in the prototype. Also, the middle section of Clarksville Chute was deeper in the model when compared to the most recent (1993) prototype survey that included the Clarksville Chute.

Overall, the trends of the model as observed in the base test were similar to those observed from the prototype surveys, especially in the reaches of river just upstream and just downstream of the repetitive dredging areas adjacent to Carroll Island.

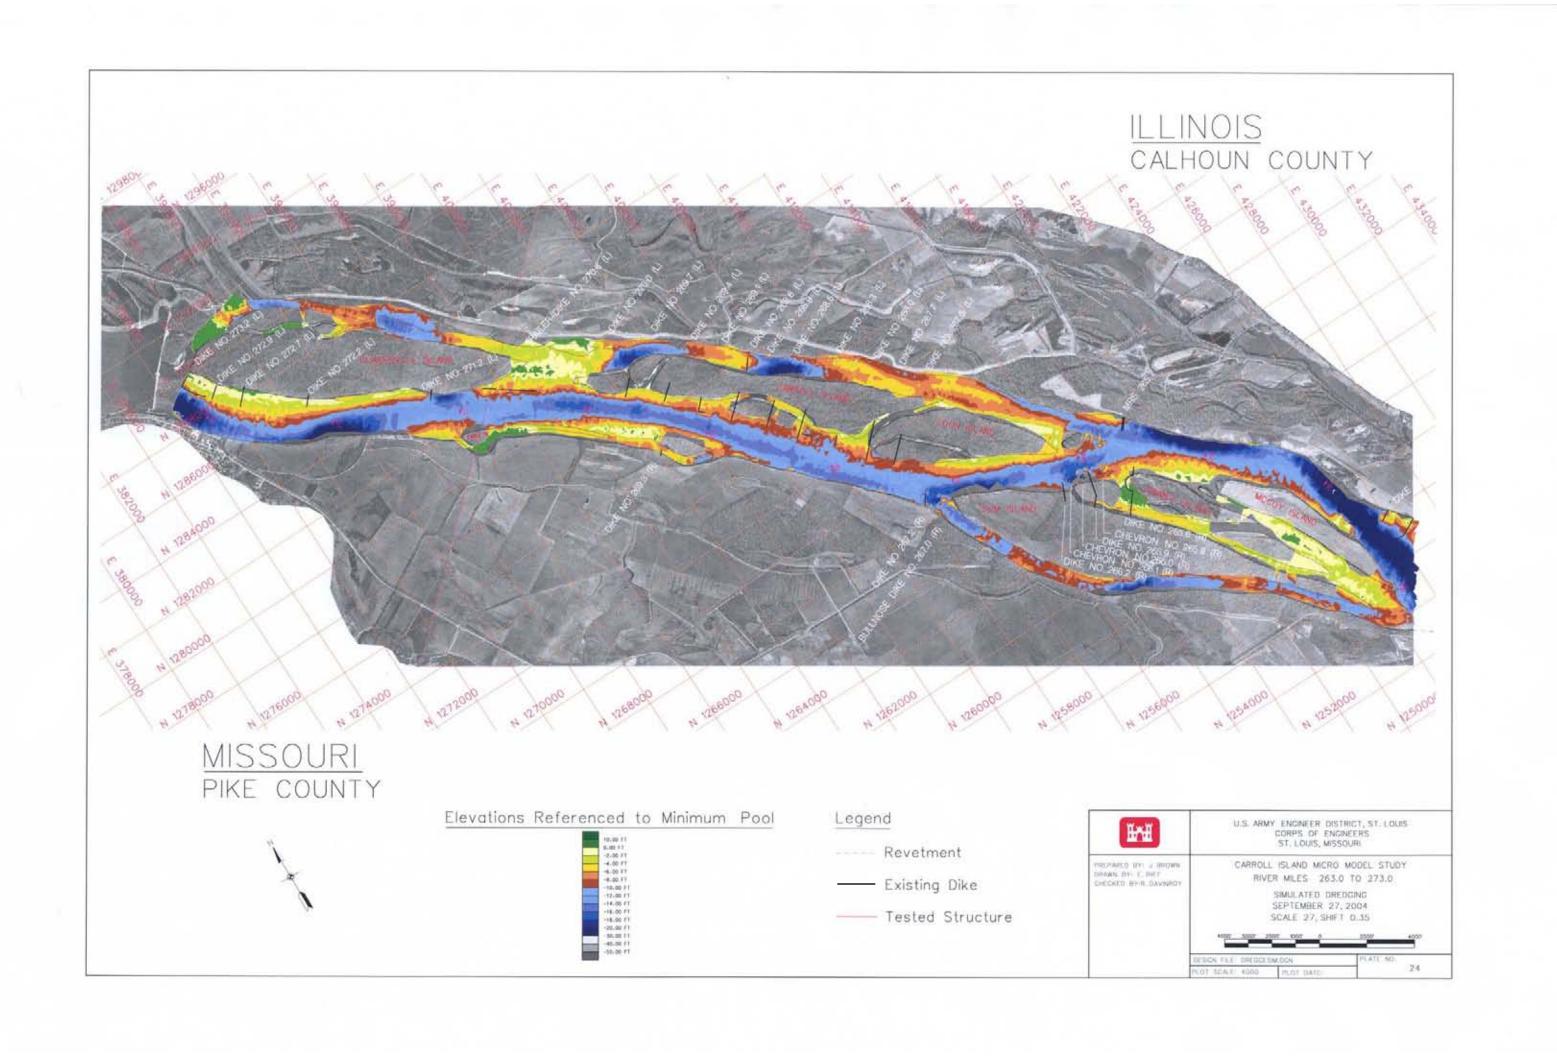
prototype bathymetry's ultimate bed response with no dredging. Shallow water, - 8 ft MP and shallower, is prevalent from Mile 269.0 and downstream for approximately 1.0 miles. Plate 24 shows the simulated dredging condition in the model. The thalweg was placed artificially near the center of the channel in both dredging locations similar to the artificial thalweg placement in the prototype.

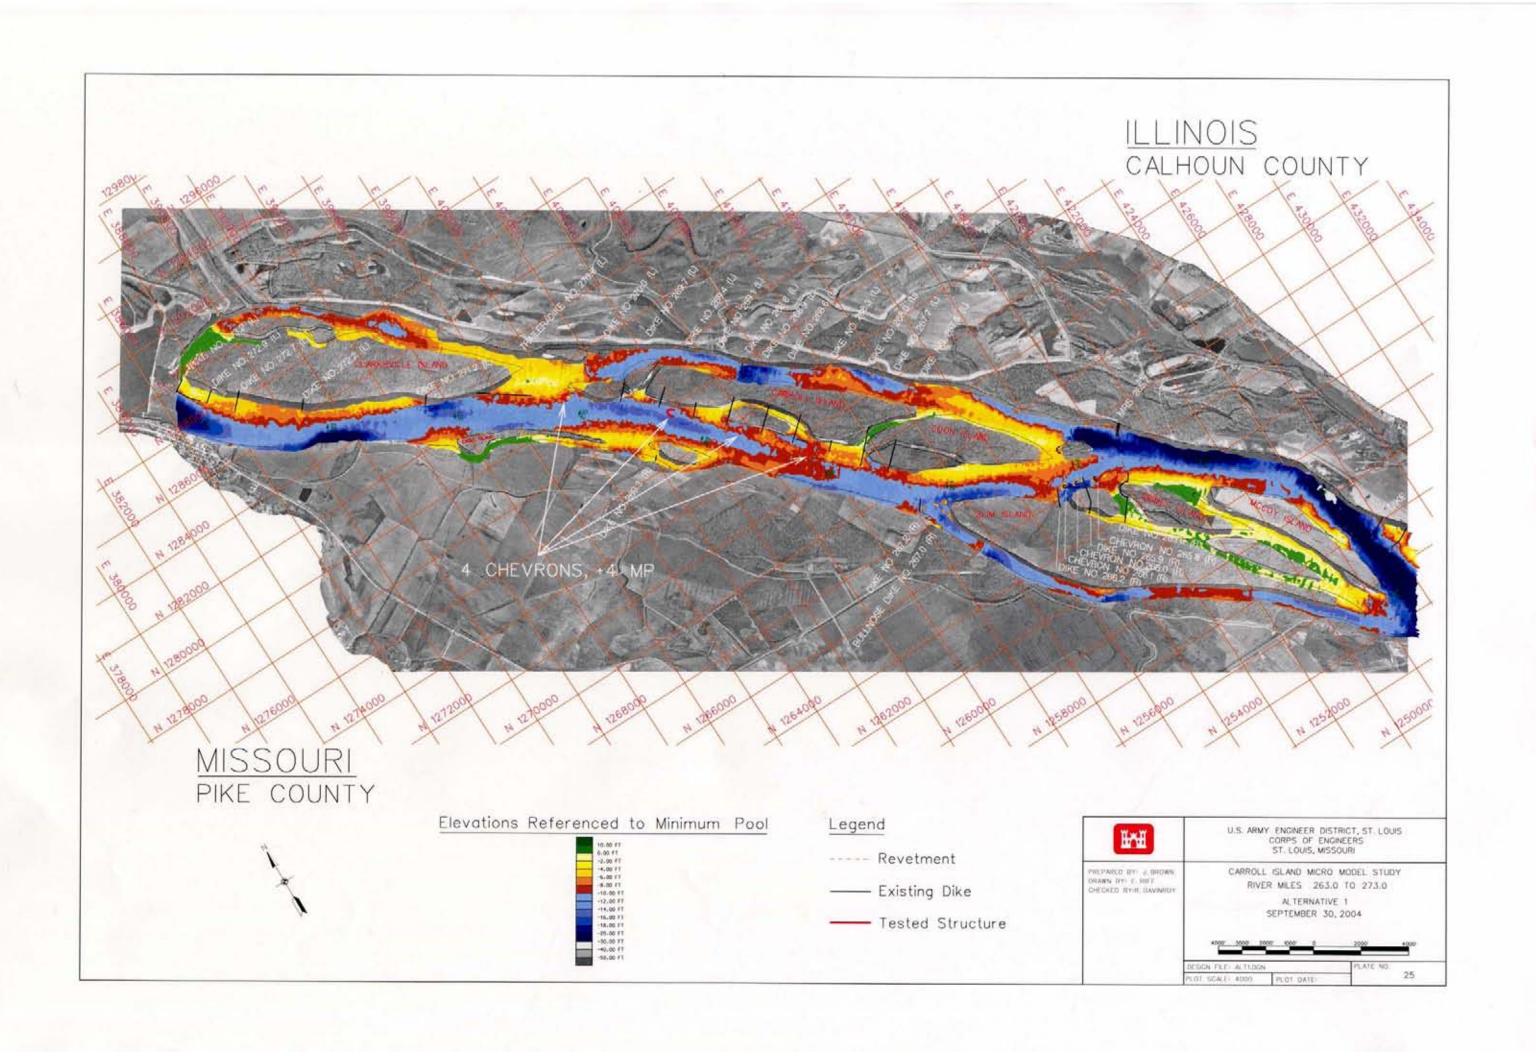
Alternative 1: (Plate 25)

Type of Structure	Number of Structures	Miles	LDB or RDB	Dimensions in Feet	Height in Feet
Chayrana 4		270.1	RDB		+4
	4	269.3	RDB	300 x 300	
Chevrons	4	268.8	RDB	300 X 300	+4
		268.2	RDB

Effect on	Effect on	Effect on	
Dredging at Mile	Dredging at Mile	Carroll Island	Additional Comments
270.0-268.0	267.0-266.0	Chute	
			This test improved the upstream dredging reach, although it did not
Increased Depths	Decreased Depths	None	completely open a channel suitable for navigation. The downstream dredging reach was worsened by this alternative, becoming shallower at Mile 266.2.

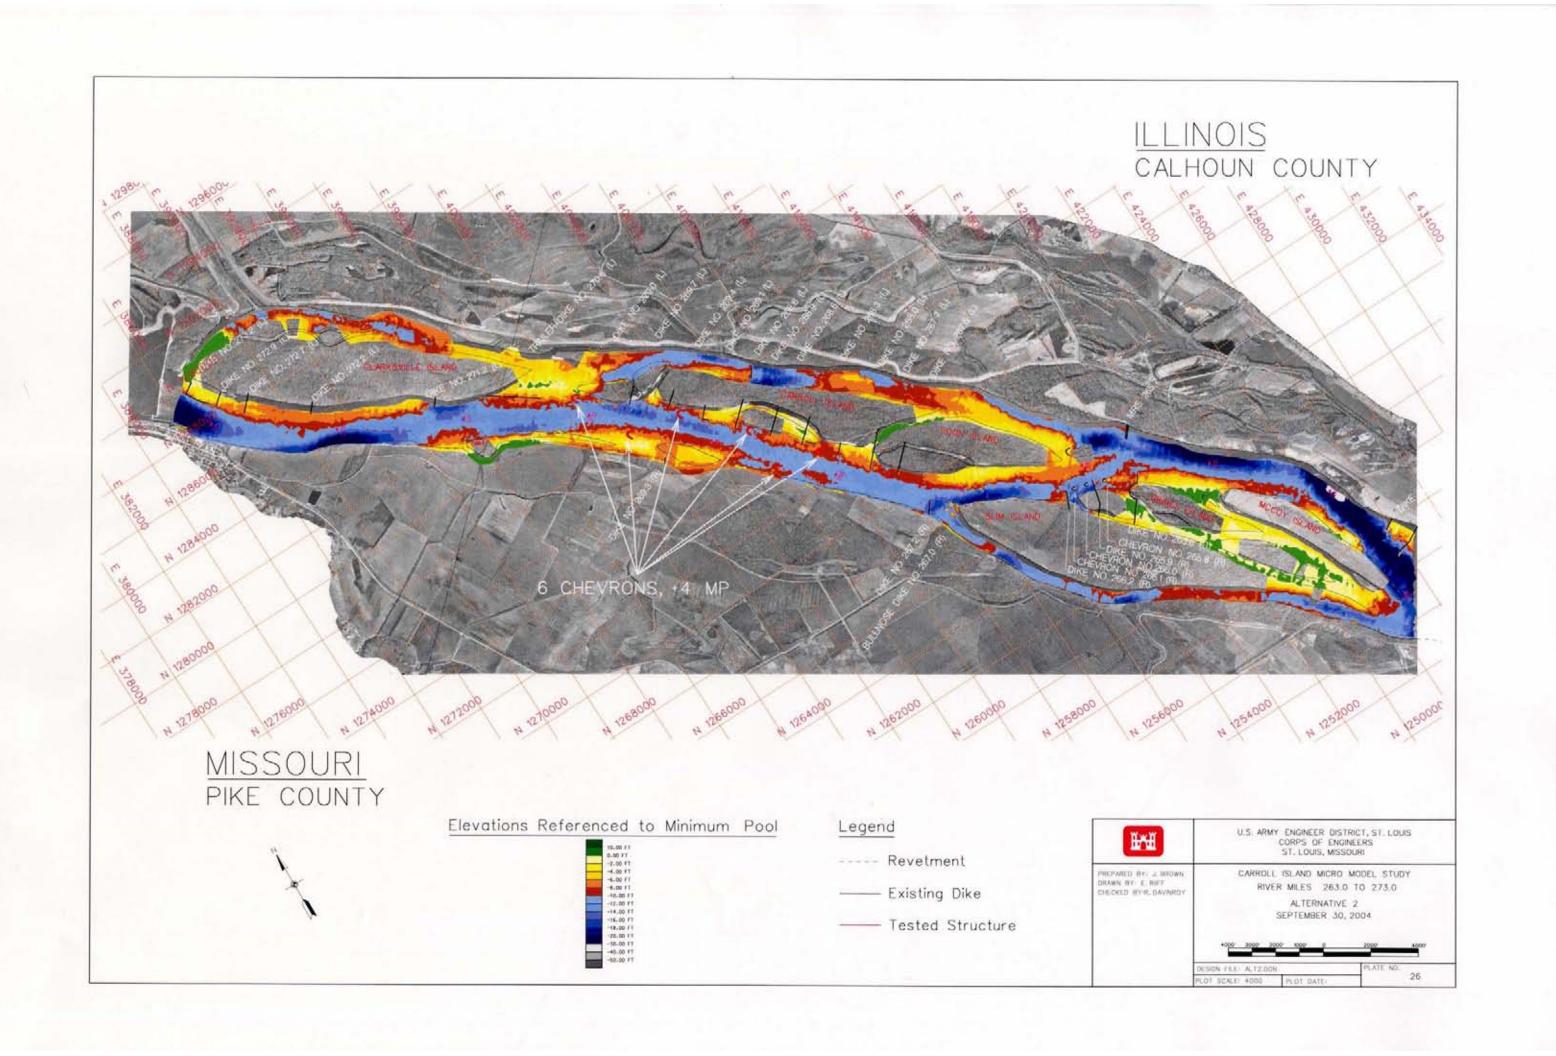
Alternative 2: (Plate 26)

Type of Structure	Number of Structures	Miles	LDB or RDB	Dimensions in Feet	Height in Feet
		270.1	LDB		
		269.6	RDB	300 x 300	+4
Chayrana	6	269.3	LDB		
Chevions	Chevrons 6	268.8	LDB		
	268.4	RDB			
		268.2	LDB

Effect on Dredging at Mile 270.0-268.0	Effect on Dredging at Mile 267.0-266.0	Effect on Carroll Island Chute	Additional Comments
Increased Depths	Decreased Depths	None	This test improved the upstream dredging reach, completely opening a channel suitable for navigation. The downstream dredging reach was worsened by this alternative, becoming shallower at Mile 266.2.

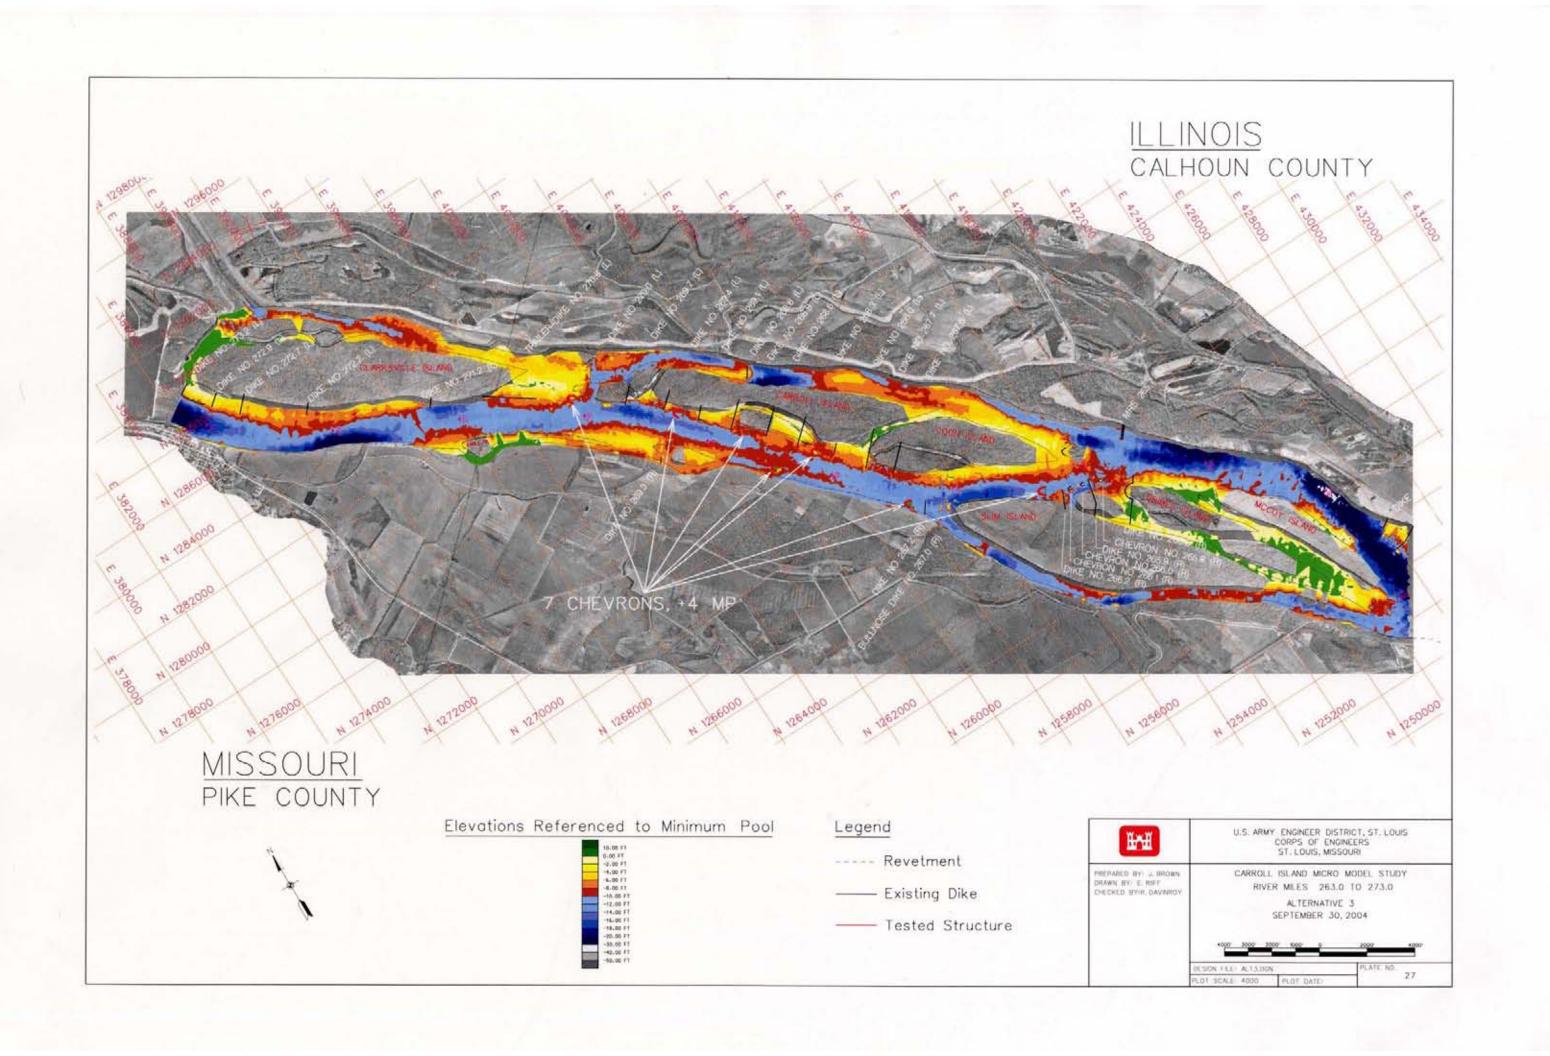
Alternative 3; (Plate 27)

Type of Structure	Number of Structures	Miles	LDB or RDB	Dimensions in Feet	Height in Feet
		270.1	LDB		
		269.3	LDB		
		268.8	LDB		
Chevrons	7	268.4	RDB	300 x 300	+4
		268.2	LDB		
		267.3	RDB		
		266.3	RDB

Effect on	Effect on	Effect on	
Dredging at Mile	Dredging at Mile	Carroll Island	Additional Comments
270.0-268.0	267.0-266.0	Chute	
Increased Depths	Decreased Depths	None	This test improved the upstream dredging reach, although it did not completely open a channel suitable for navigation. The downstream dredging reach worsened by this alternative, becoming shallower at Mile 265.9.

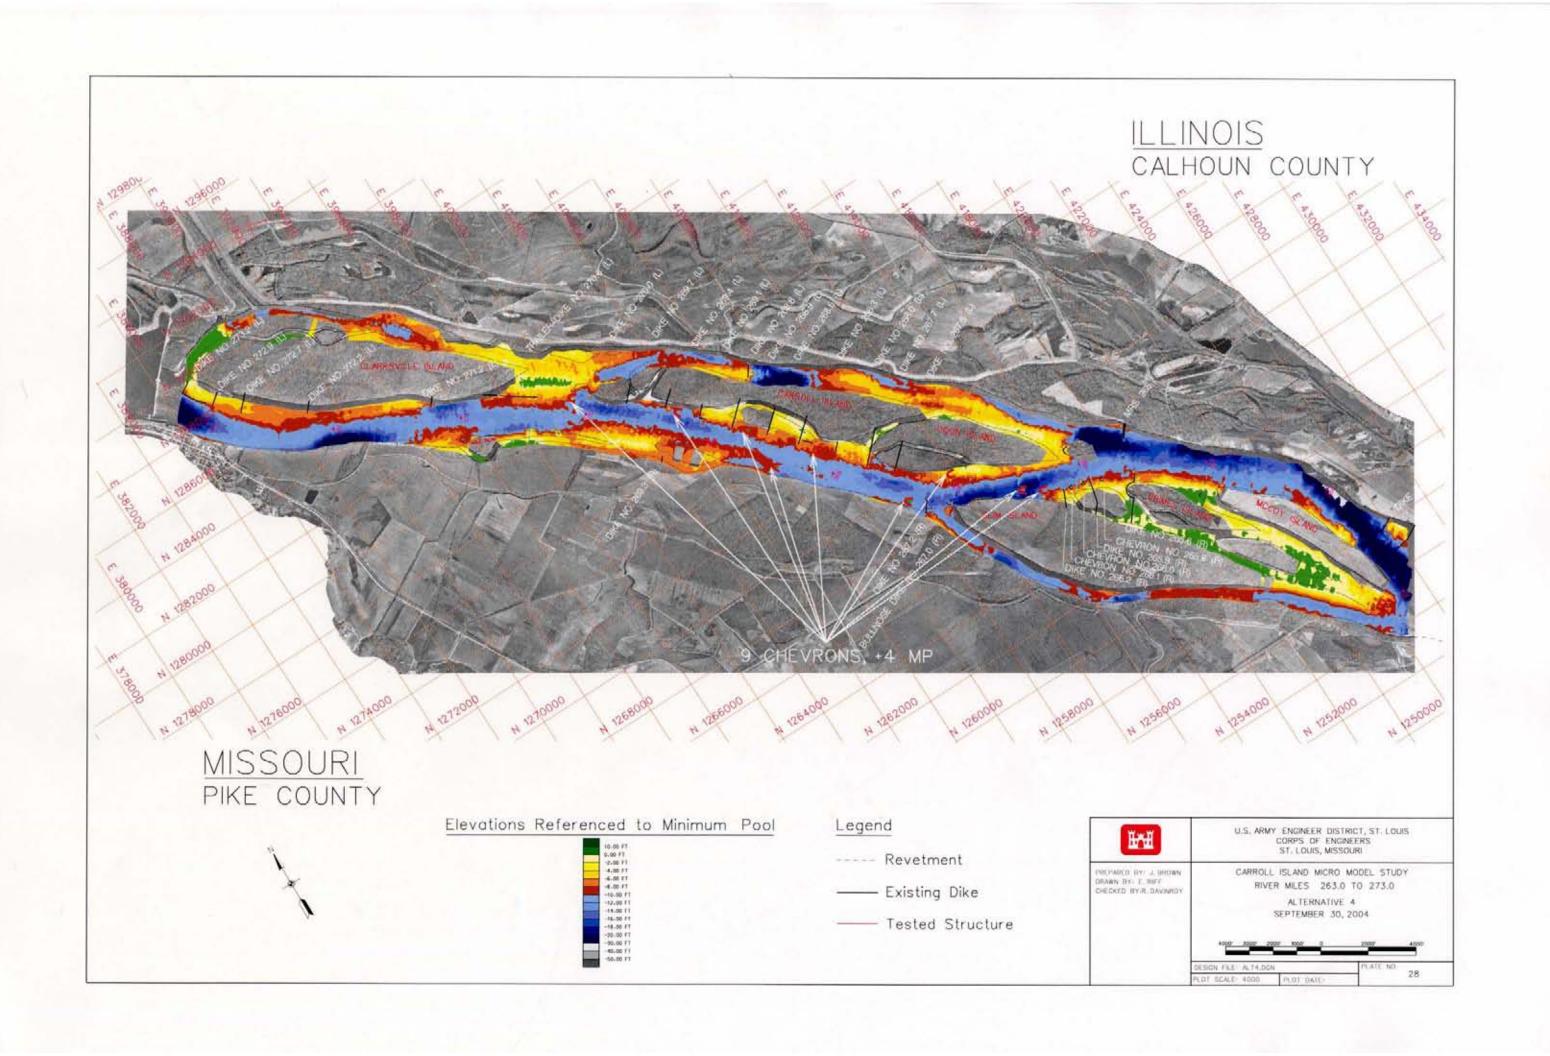
Alternative 4: (Plate 28)

Type of Structure	Number of Structures	Miles	LDB or RDB	Dimensions in Feet	Height in Feet
		270.1	LDB		
		269.3	LDB		
		268.8	LDB		
		268.4	RDB		
Chevrons	9	268.2	LDB	300 x 300	+4
		267.3	RDB		
		267.0	LDB		
		266.5	RDB		
		266.4	RDB

Effect on	Effect on	Effect on	
Dredging at Mile	Dredging at Mile	Carroll Island	Additional Comments
270.0-268.0	267.0-266.0	Chute	
			This test improved the upstream
			dredging reach, completely
			opening a channel suitable for
		navigation. The downstream	
Increased	Increased Double	None	dredging reach was improved by
Depths	Increased Depths, Narrow Width		this alternative, becoming deeper
Бериіз	Narrow Width		throughout. This alternative would
			be restrictive in navigation channel
		width, however, with a nav	width, however, with a navigable
			channel width of only 400 ft. at Mile
			266.5.

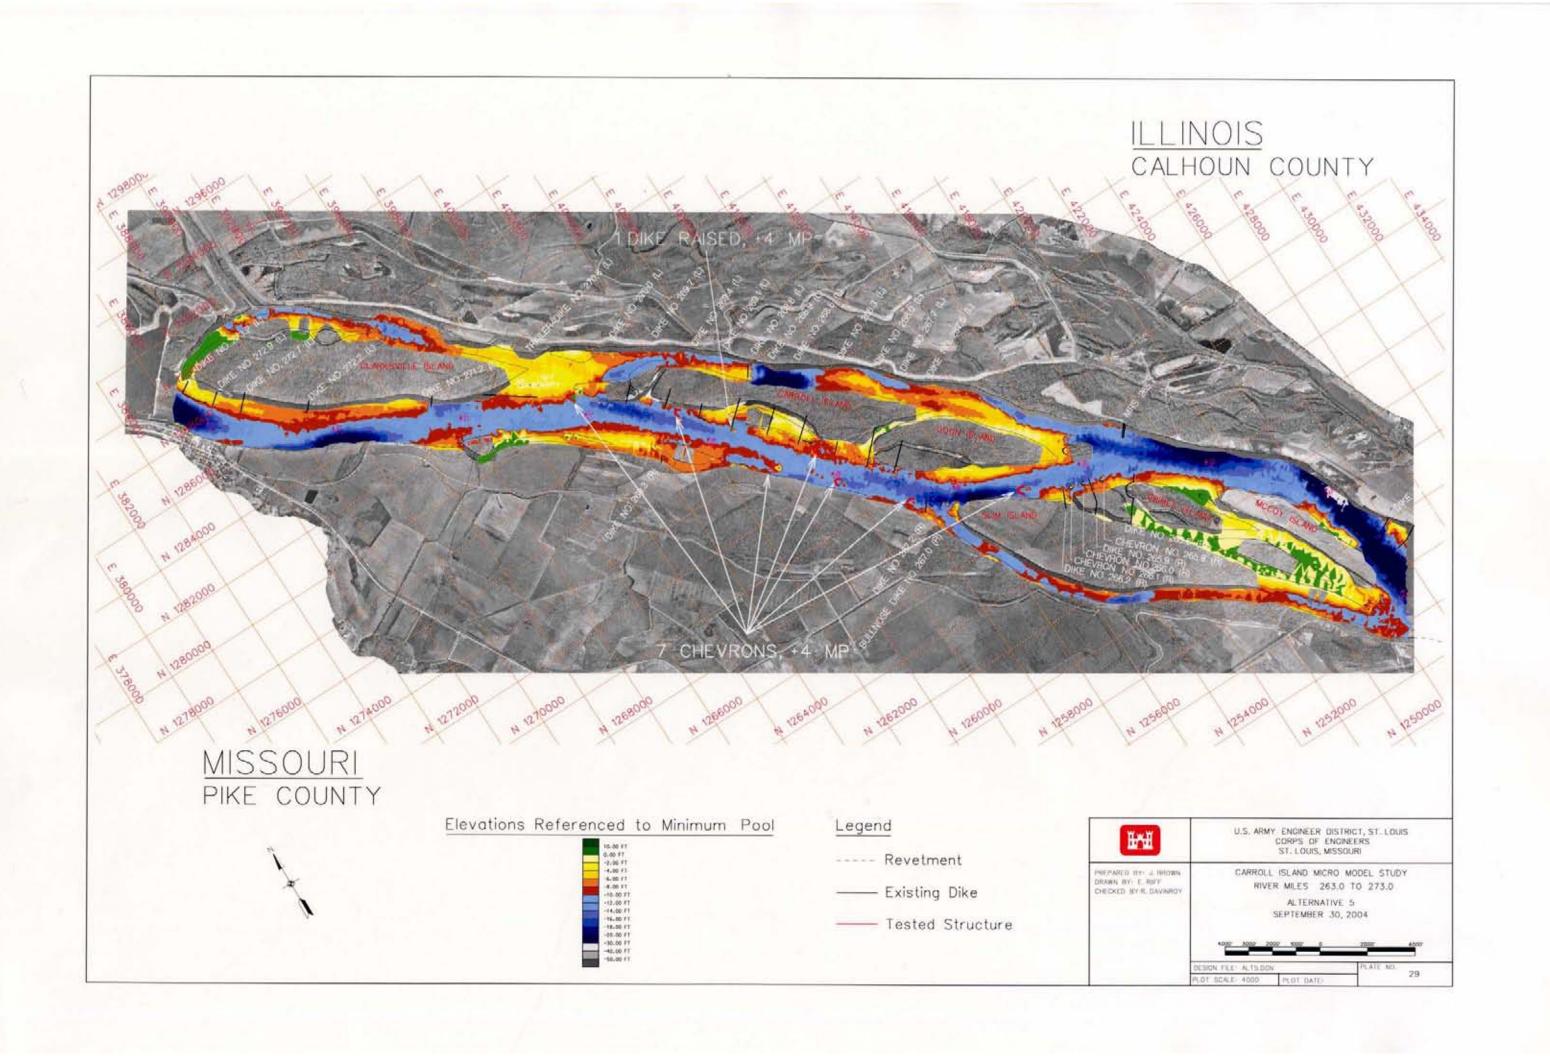
Alternative 5: (Plate 29)

Type of Structure	Number of Structures	Miles	LDB or RDB	Dimensions in Feet	Height in Feet
Chevrons	6	270.1 269.3 268.4 268.2 268.0 267.3 266.5	LDB LDB LDB RDB RDB RDB	300 x 300	+4
Raised Dike	1	268.9		530	+4

Effect on Dredging at Mile 270.0-268.0	Effect on Dredging at Mile 267.0-266.0	Effect on Carroll Island Chute	Additional Comments
Increased Depths	Increased Depths	None	This test improved the upstream dredging reach, completely opening a channel suitable for navigation. The downstream dredging reach improved with this alternative, with a 10 ft. navigation channel opened up throughout.

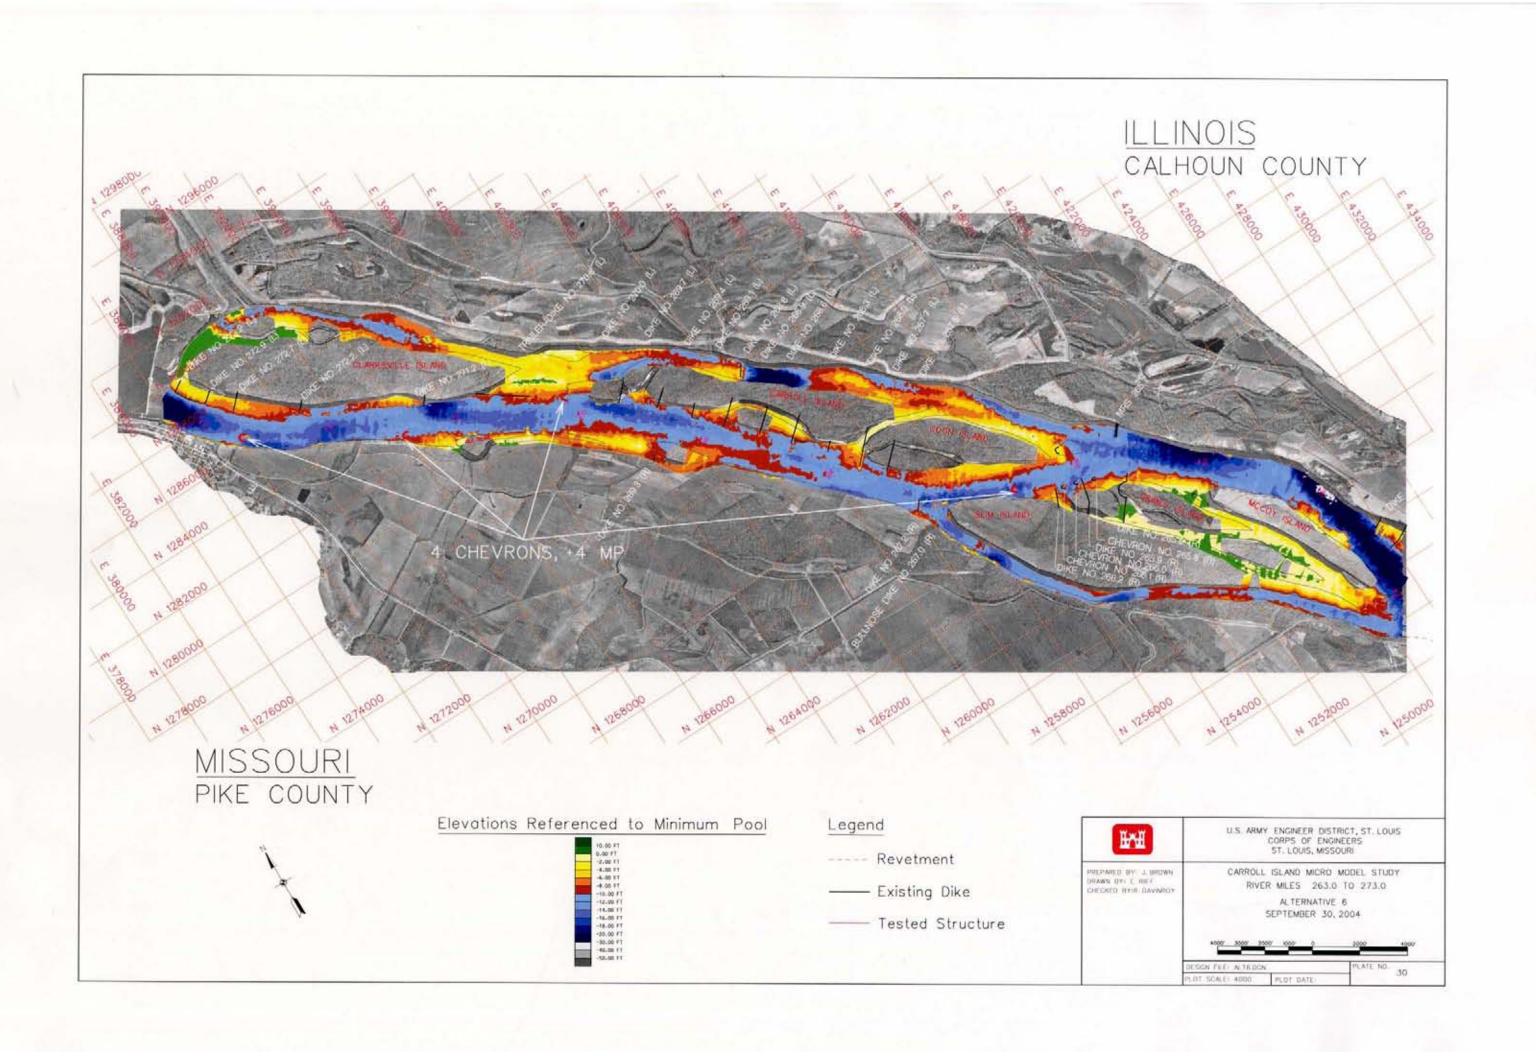
Alternative 6: (Plate 30)

Type of Structure	Number of Structures	Miles	LDB or RDB	Dimensions in Feet	Height in Feet
		272.6	RDB		
Ch ay mana	4	271.4	RDB	300 x 300	+4
Chevrons	4	270.1	LDB	300 X 300	+4
		266.4	RDB

Effect on Dredging at Mile 270.0-268.0	Effect on Dredging at Mile 267.0-266.0	Effect on Carroll Island Chute	Additional Comments
Increased Depths	Increased Depths	None	This test improved the upstream dredging reach, although it did not completely open a channel suitable for navigation. The downstream dredging reach was improved by this alternative, resulting in a narrow (300 ft) but adequately deep (-10 ft MP) navigation channel.

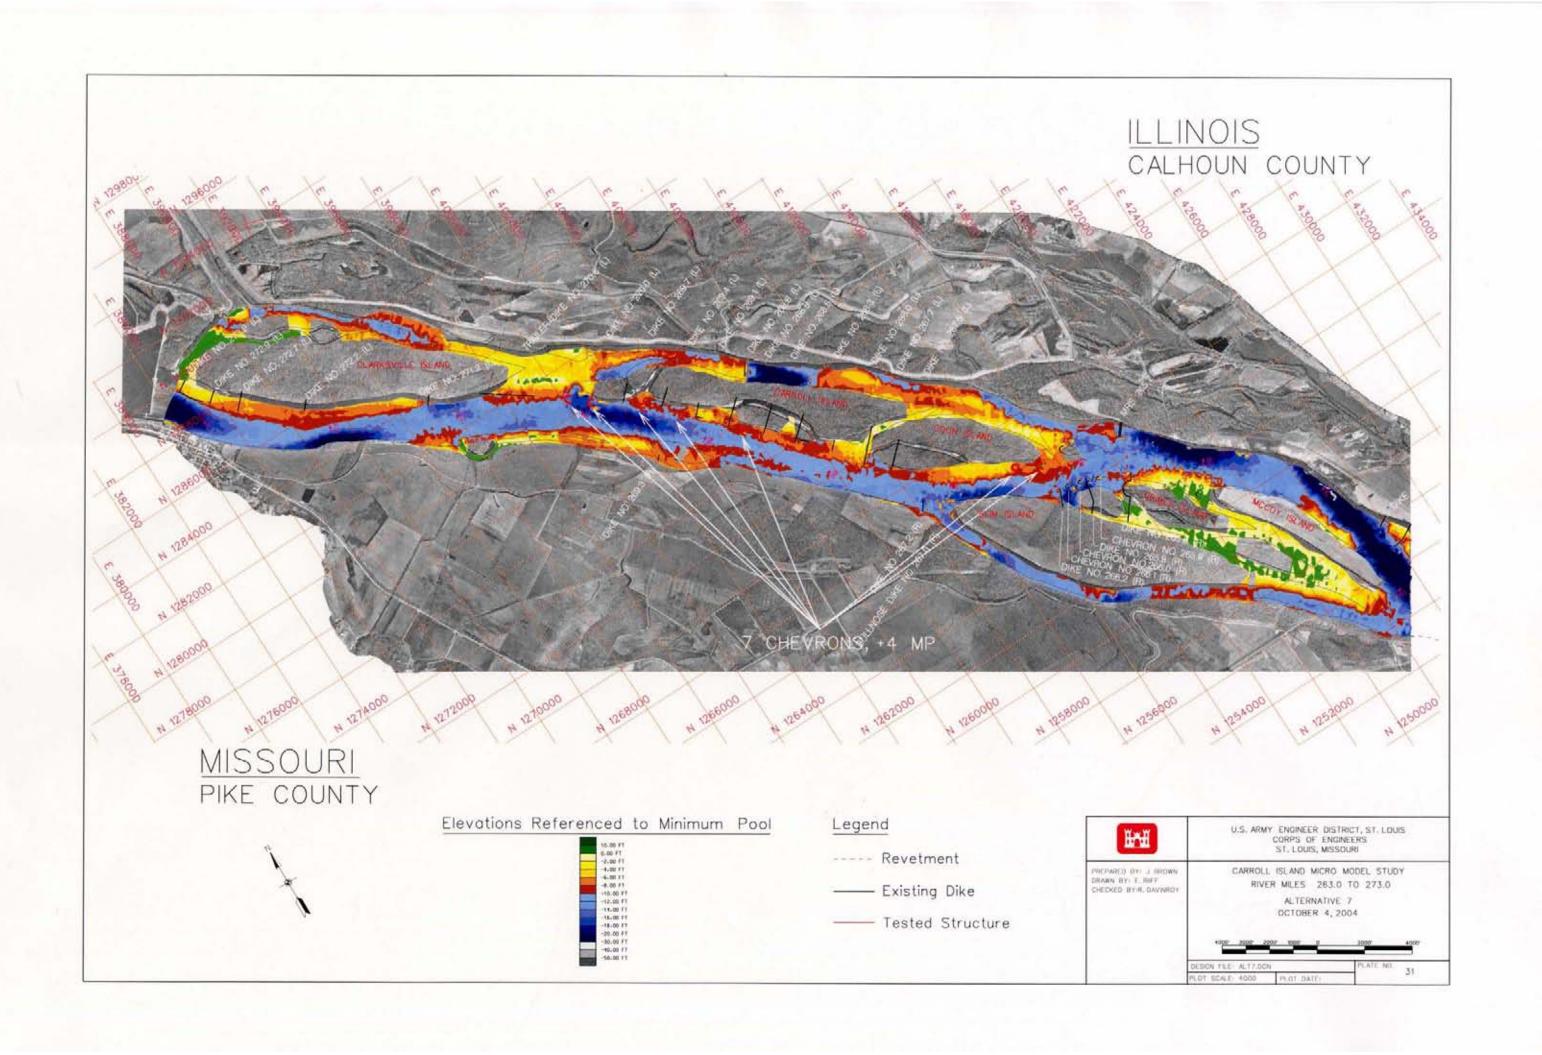
Alternative 7: (Plate 31)

Type of Structure	Number of Structures	Miles	LDB or RDB	Dimensions in Feet	Height in Feet
		270.1	LDB		
	7	270.0	LDB		+4
		269.6	LDB	300 x 300	
Chevrons		269.3	LDB		
		268.8	LDB		
		266.2	LDB		
		266.4	LDB

Effect on	Effect on	Effect on	
Dredging at Mile	Dredging at Mile	Carroll Island	Additional Comments
270.0-268.0	267.0-266.0	Chute	
			This test improved somewhat the
	None		upstream dredging reach, almost
Increased		None	completely opening a channel
Depths		none	suitable for navigation. The
			downstream dredging reach was not
			affected by this alternative.

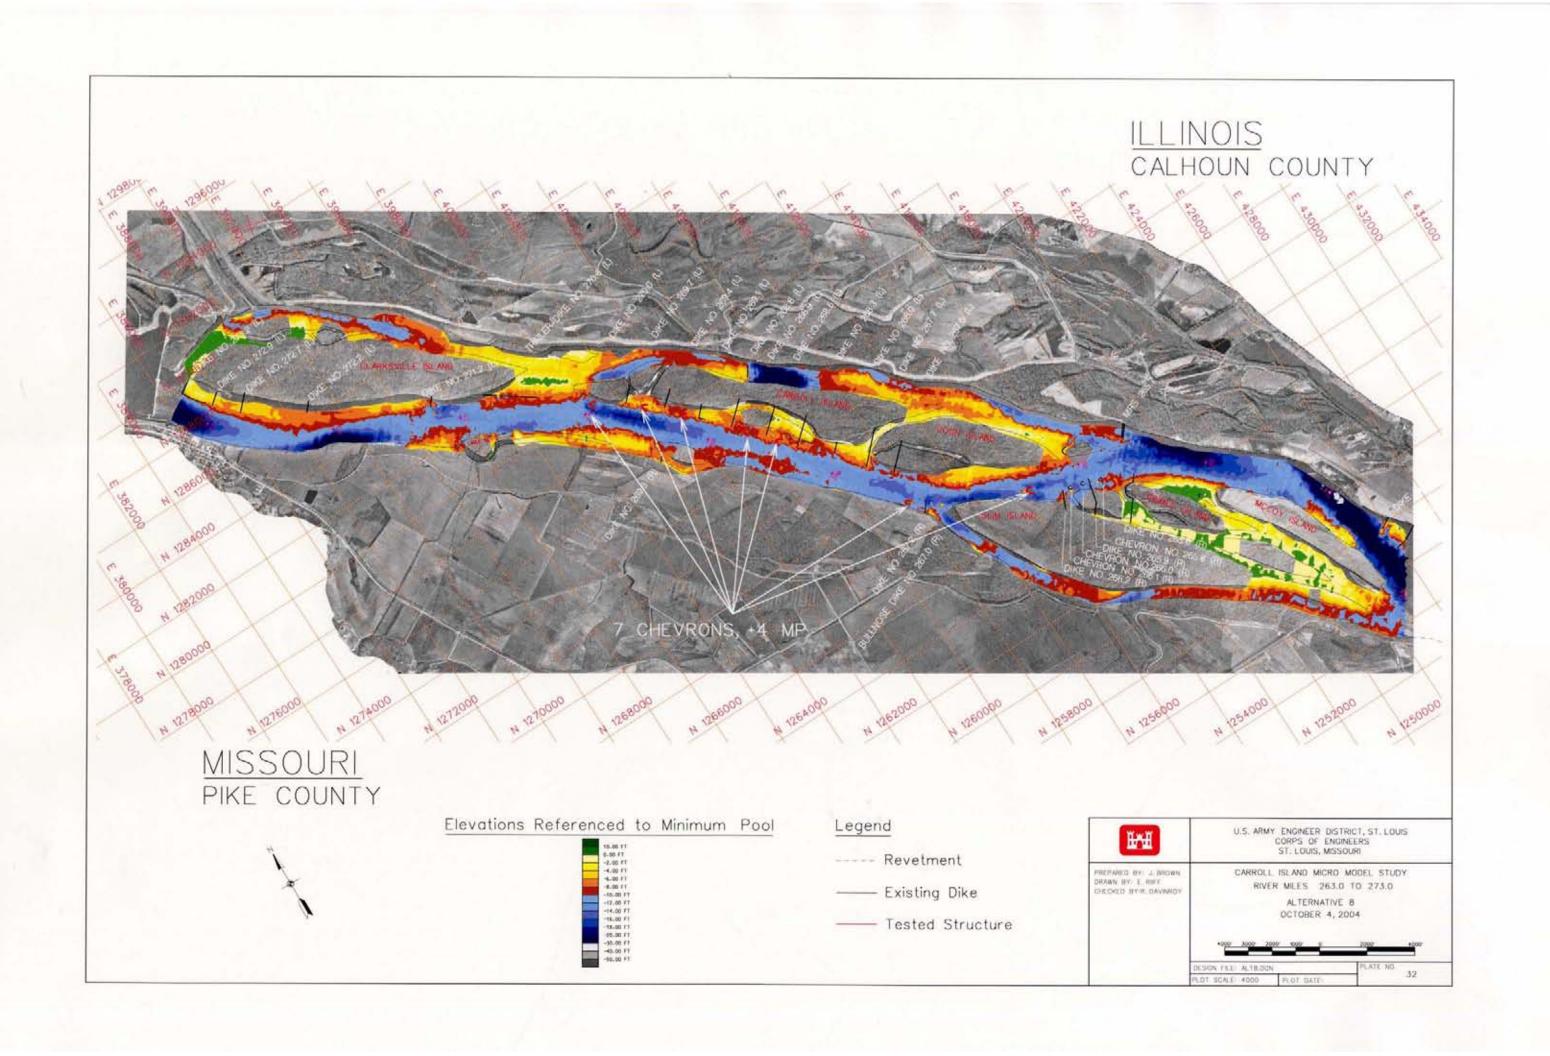
Alternative 8: (Plate 32)

Type of Structure	Number of Structures	Miles	LDB or RDB	Dimensions in Feet	Height in Feet
		270.0	LDB		
	7	269.6	LDB		+4
		269.3	LDB	300 x 300	
Chevrons		268.8	LDB		
		268.4	LDB		
		267.4	RDB		
		266.4	RDB

Effect on	Effect on	Effect on		
Dredging at Mile	Dredging at Mile	Carroll Island	Additional Comments	
270.0-268.0	267.0-266.0	Chute		
			This test improved the upstream	
			dredging reach somewhat, nearly	
			completely opening a channel	
Increased	Increased		suitable for navigation. The	
Depths	Depths	None	downstream dredging reach was	
Бериіз	Беріпѕ		improved by this alternative,	
			becoming deeper throughout with a	
			narrow passage past the chevron at	
			266.4R.

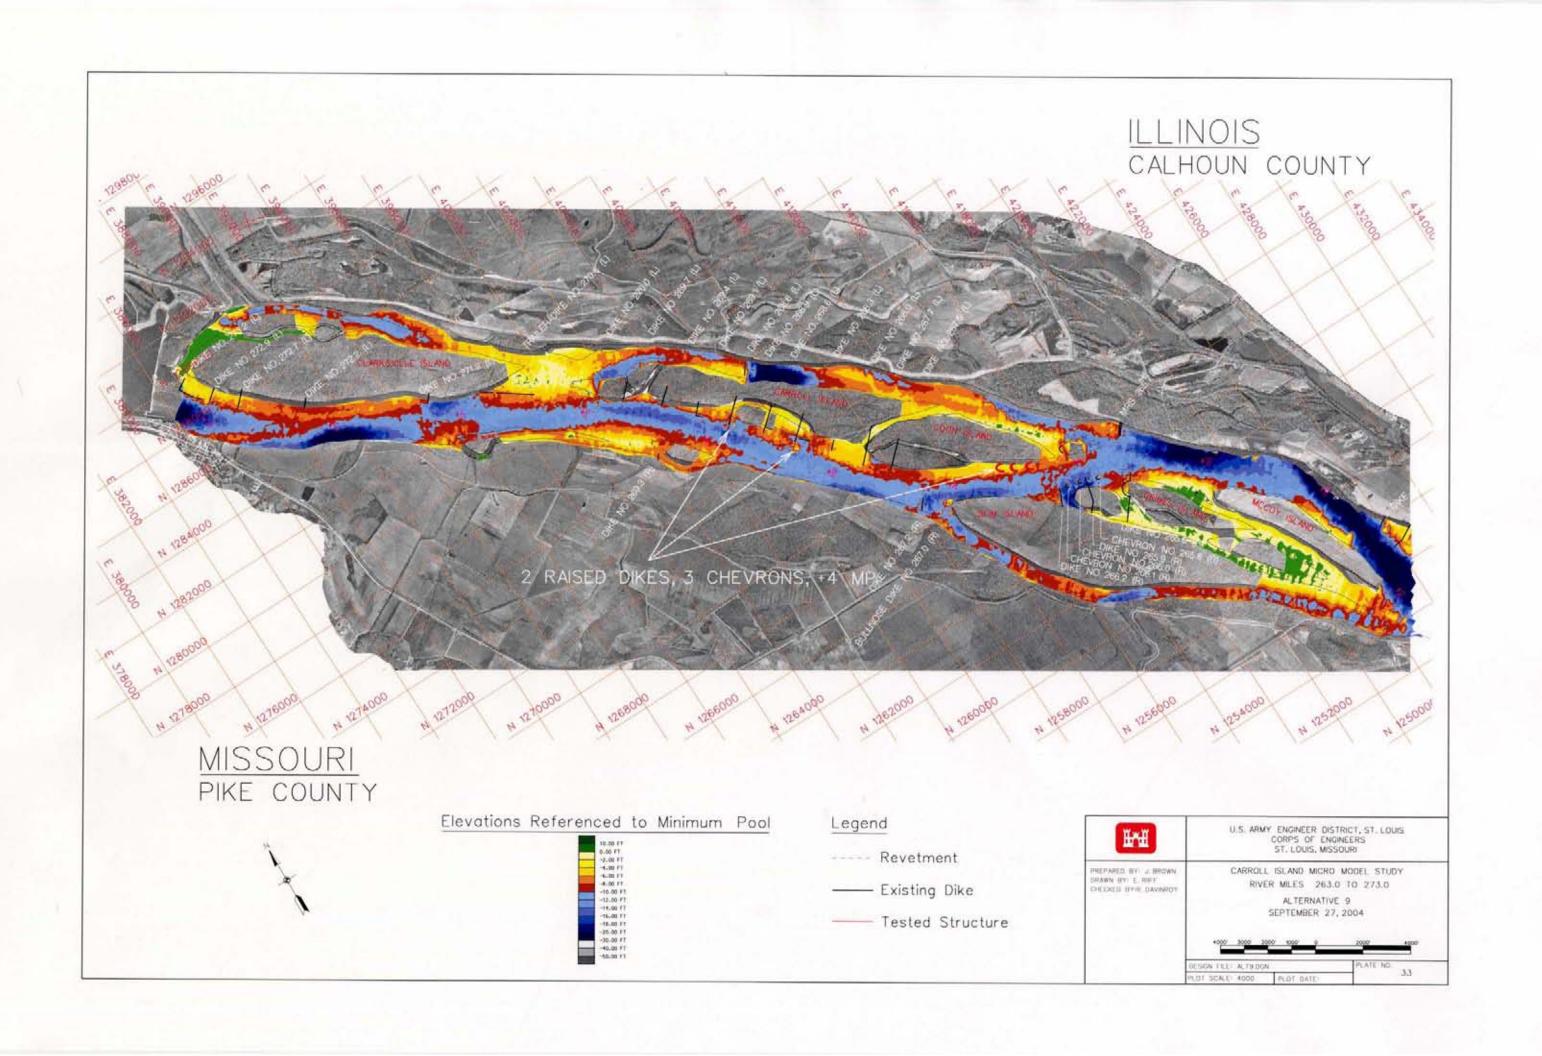
Alternative 9: (Plate 33)

Type of Structure	Number of Structures	Miles	LDB or RDB	Dimensions in Feet	Height in Feet
Chevrons	3	266.4 266.5 266.6	LDB LDB LDB	300 x 300	+4
Raised Dike	2	268.4 268.9	LDB LDB	625 500	+4

Effect on	Effect on	Effect on		
Dredging at Mile	Dredging at Mile	Carroll	Additional Comments	
270.0-268.0	267.0-266.0	Island Chute		
	None		This test improved the upstream	
		None	dredging reach somewhat,	
Increased depths			completely opening a channel	
Increased depths			suitable for navigation. The	
			downstream dredging reach was	
			not improved with this alternative.
