TECHNICAL
REPORT
M27

FINAL REPORT—SEPTEMBER 2003

**US Army Corps
of Engineers**
St. Louis District

HEADCUTTING INVESTIGATION UPSTREAM OF THE KASKASKIA RIVER NAVIGATION PROJECT, ILLINOIS

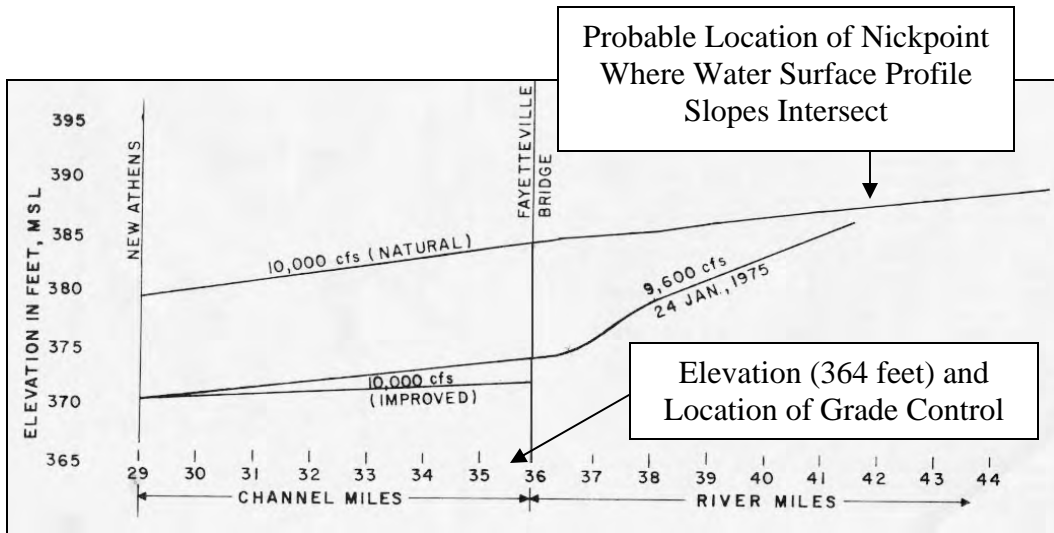
Using the water surface profile figure from Denzel and Strauser, the approximate location of the original nickpoint was determined. This explained why the placement and elevation of the grade control structure would not have been able to arrest the upstream migration of the headcut. The captions on the figure indicate that the grade control could not possibly have corrected the difference in water surface profile slopes that was occurring approximately 6 miles upstream of its location.

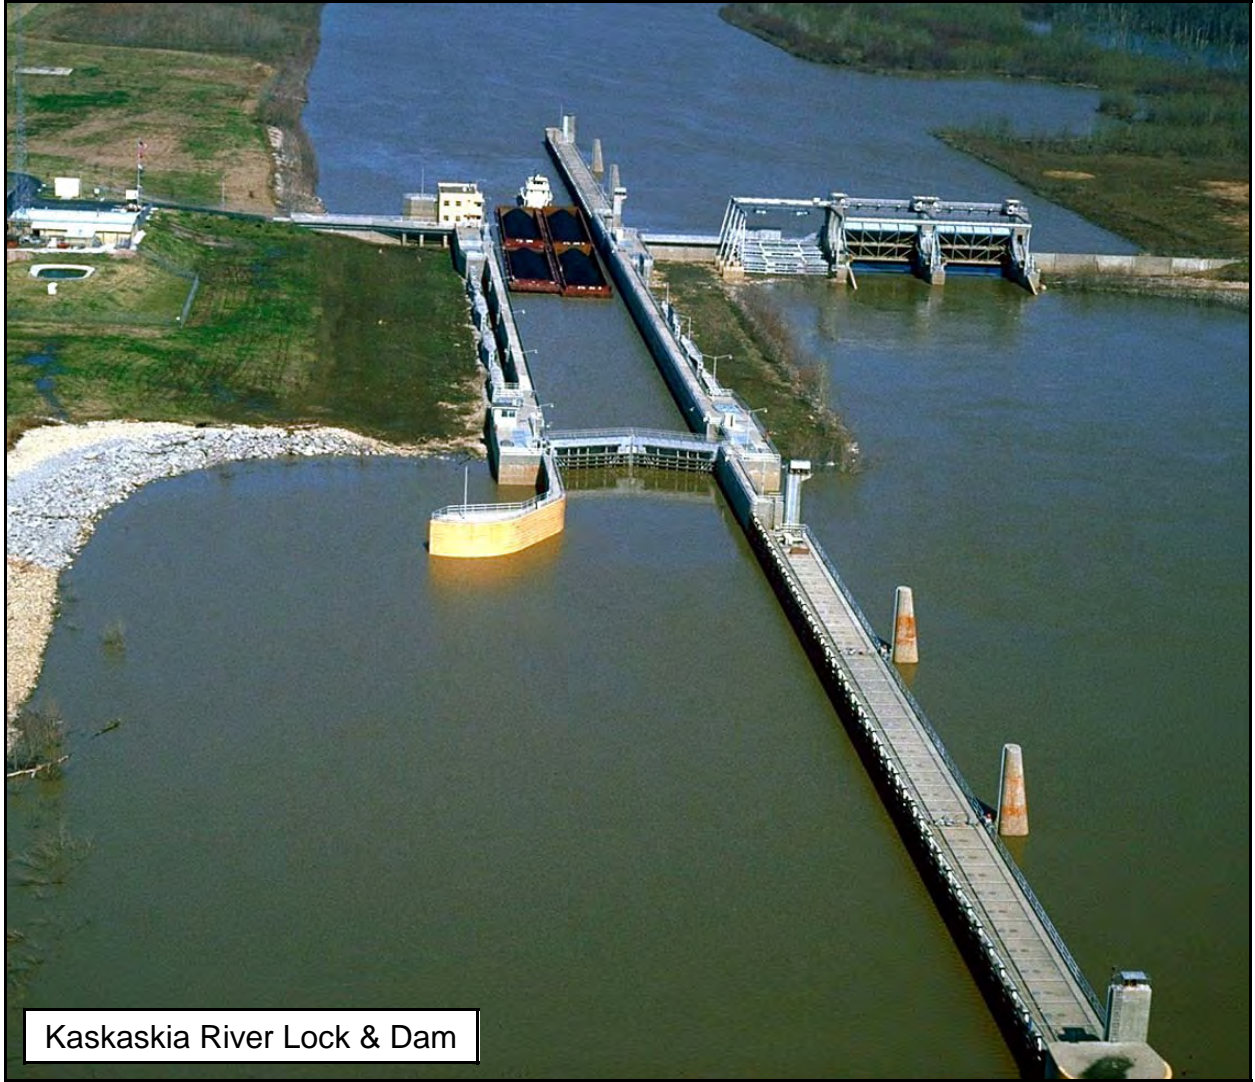
Figure 3

Near Mile 1.5 and Bend 137
(Photo taken in the 1970's)

The Lock and Dam (Figure 3), completed in 1974, consists of a single lock, 600 feet long by 84 feet wide. A 130 foot long gated spillway with two 60-foot-wide control gates is utilized to regulate a maximum regulated navigation pool of 368.0 NGVD. (A pool deviation of +0.8 feet has been in use since May of 1988 to address shallow water conditions in the mouths of the numerous remnant channels).

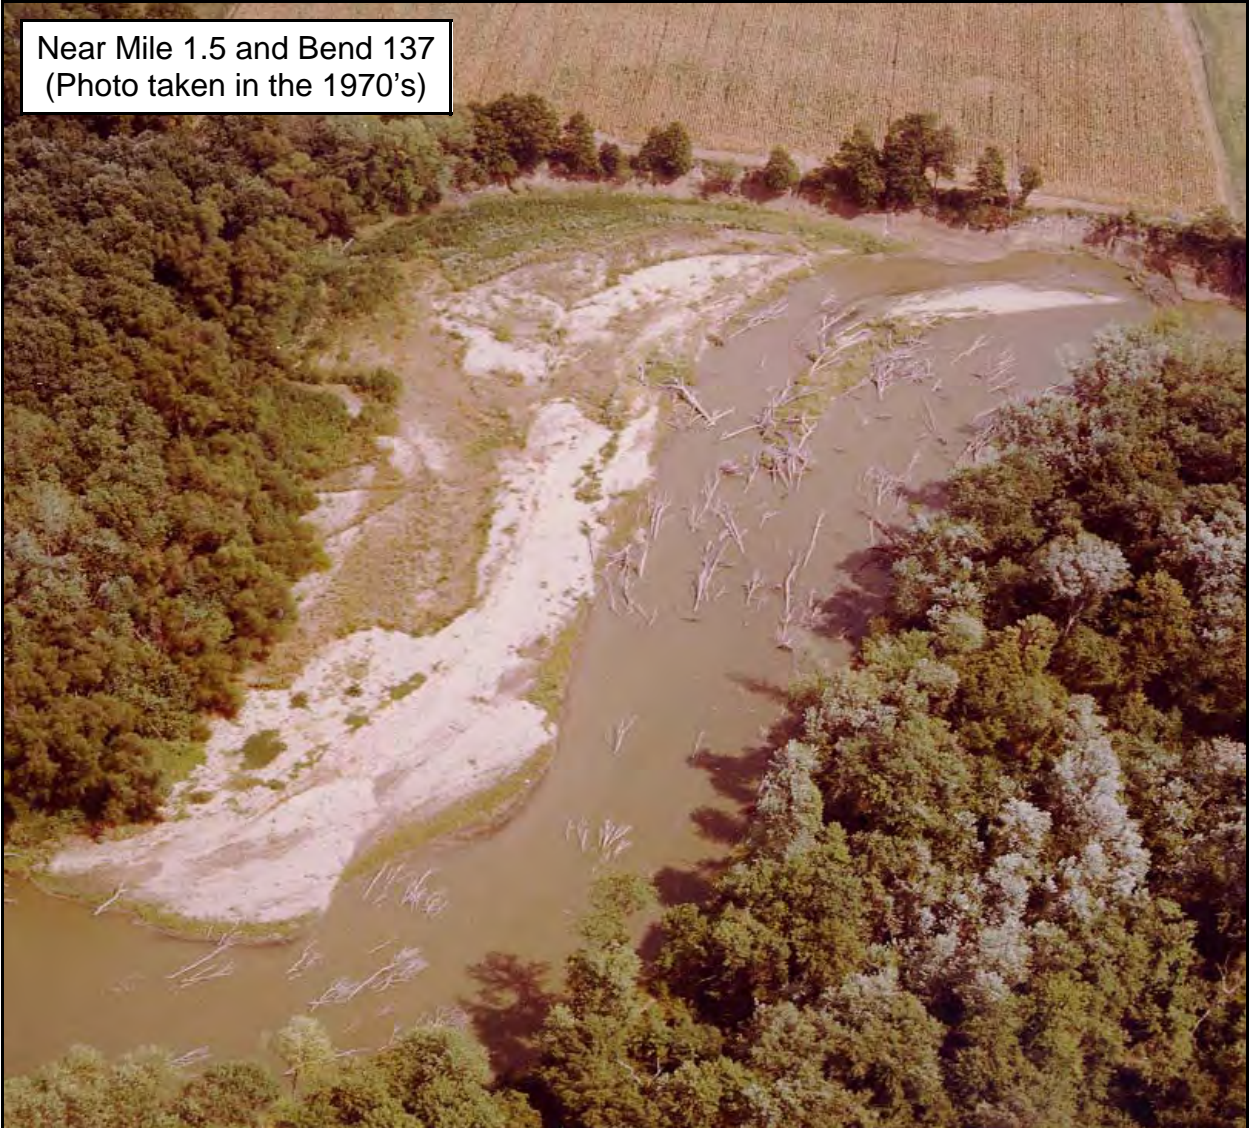
Figure 4

Damage Induced by Degradation of the "Natural" Kaskaskia River Channel Upstream
of Fayetteville in the 1970's

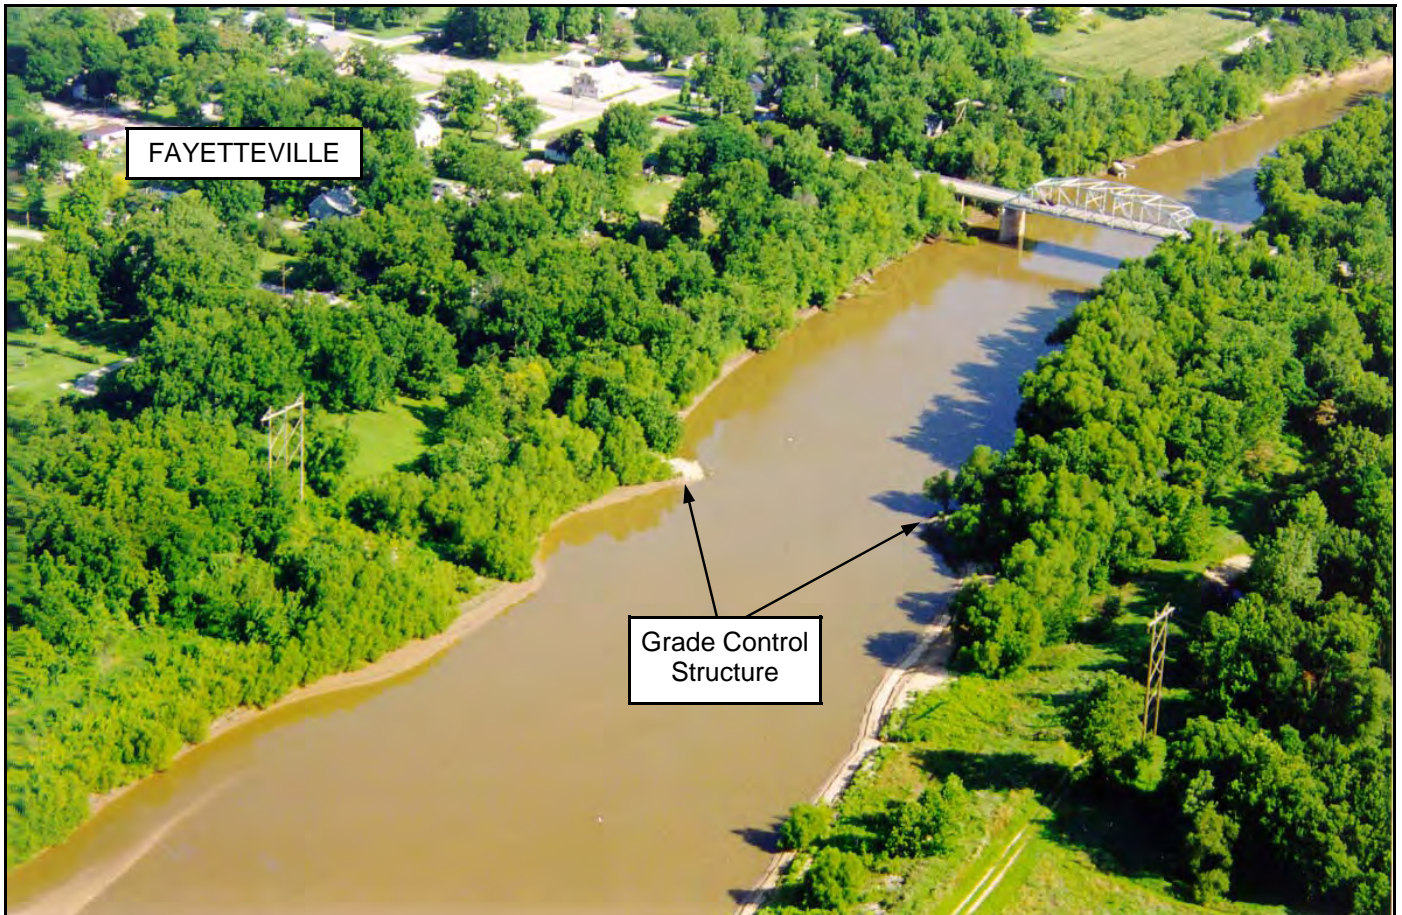
Figure 5

FAYETTEVILLE, ILLINOIS

EXISTING GRADE CONTROL STRUCTURE AND START OF THE NAVIGATION PROJECT

The St. Louis District began a project in 1981 to construct the grade control structure at the head of the navigation channel and about 700 feet downstream from the U.S. Highway 460 Bridge at Fayetteville, in St. Clair County, Illinois. The structure was completed at 100 percent federal cost at RM 35.9 in 1982 (Figure 5). The purpose of the grade control structure was only to prevent the generation a secondary headcut upstream of the navigation channel so the Project would function as initially intended. The structure was not intended to arrest the original headcut that had traveled upstream and off of Project lands.

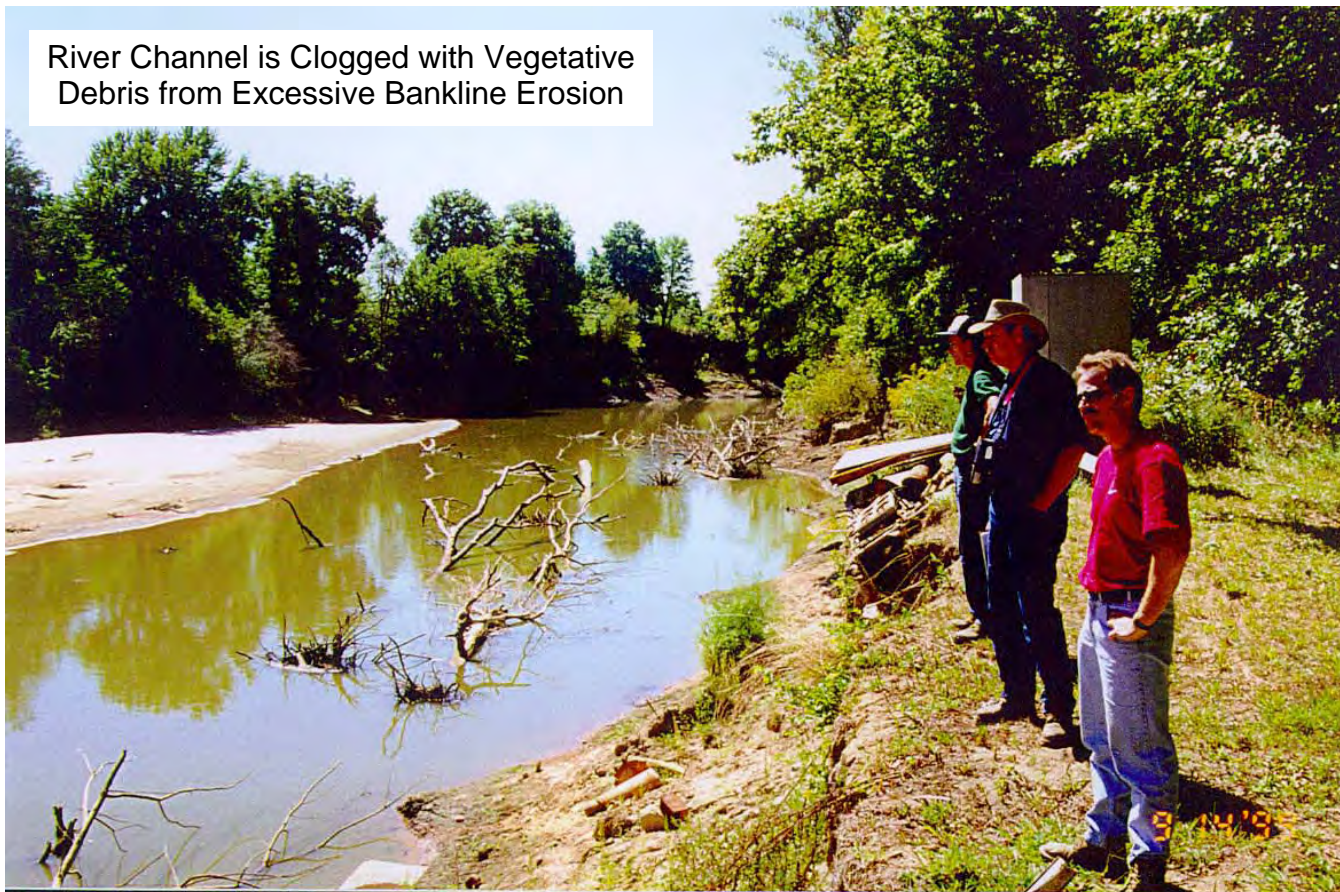
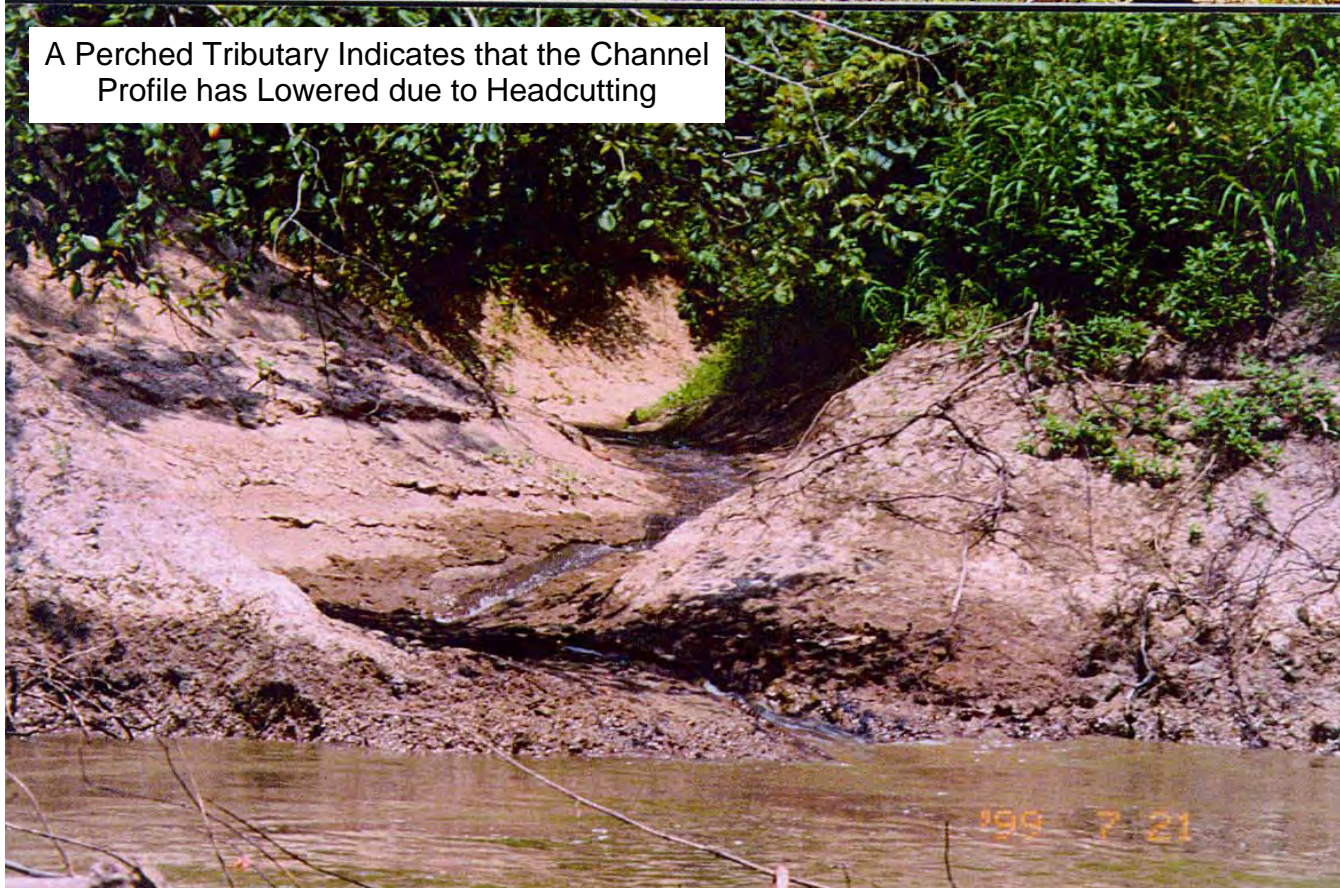
Figure 9

River Channel is Clogged with Vegetative Debris from Excessive Bankline Erosion

A Perched Tributary Indicates that the Channel Profile has Lowered due to Headcutting

During the 1999 field investigations, engineers documented that major adverse impacts were continuing on the river as a result the original headcut induced by the Kaskaskia River Navigation Project. From observations of bank erosion and excessive debris in the channel, it was determined that the headcutting wave had continued to migrate upstream of the navigation channel at Fayetteville, Illinois to a possible nickpoint located approximately 14 miles above the Project, just above Bend 100 (Figure 8). Within this 14-mile reach, channel degradation, excessive bank erosion, channel widening, major deposition, abundant fallen trees, perched tributaries, and property damage were clearly evident within the channel (Figures 9 and 10). Bank erosion between Carlyle and the nickpoint was observed to be low to moderate and was mainly the result of localized tree removal along the riverbanks for agricultural purposes in selected areas. Although the exact location of the nickpoint could not be distinguished in the channel, a probable location was determined by observing increases in debris, bank height, and erosion. The channel width near the probable nickpoint was approximately 125 feet. The channel width in the first bend below the nickpoint (Bend 100) was approximately 175 feet, and the width in the second bend (Bend 101) was approximately 250 feet.

Probing of the riverbed was conducted in the thalweg at selected straight reach cross sections within the headcutting reach. The probing indicated that in most cases the bottom of the channel had scoured down to hard bottom clay. The general lack of sand in the thalweg further verified that channel degradation due to headcutting had occurred.

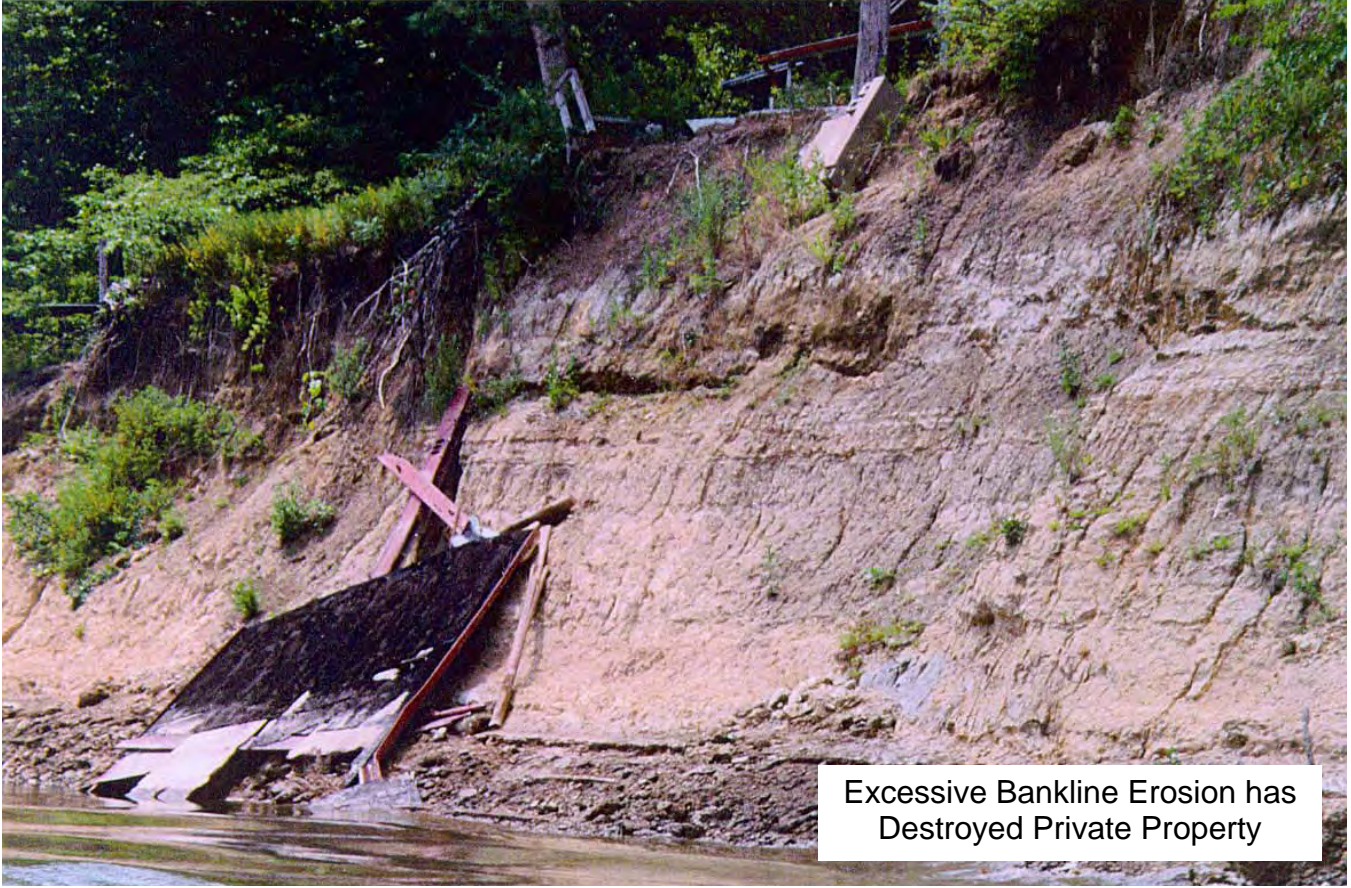
Figure 10

The Channel Profile has Lowered due to Headcutting which has Induced Excessive Bankline Erosion

Excessive Bankline Erosion has Destroyed Private Property

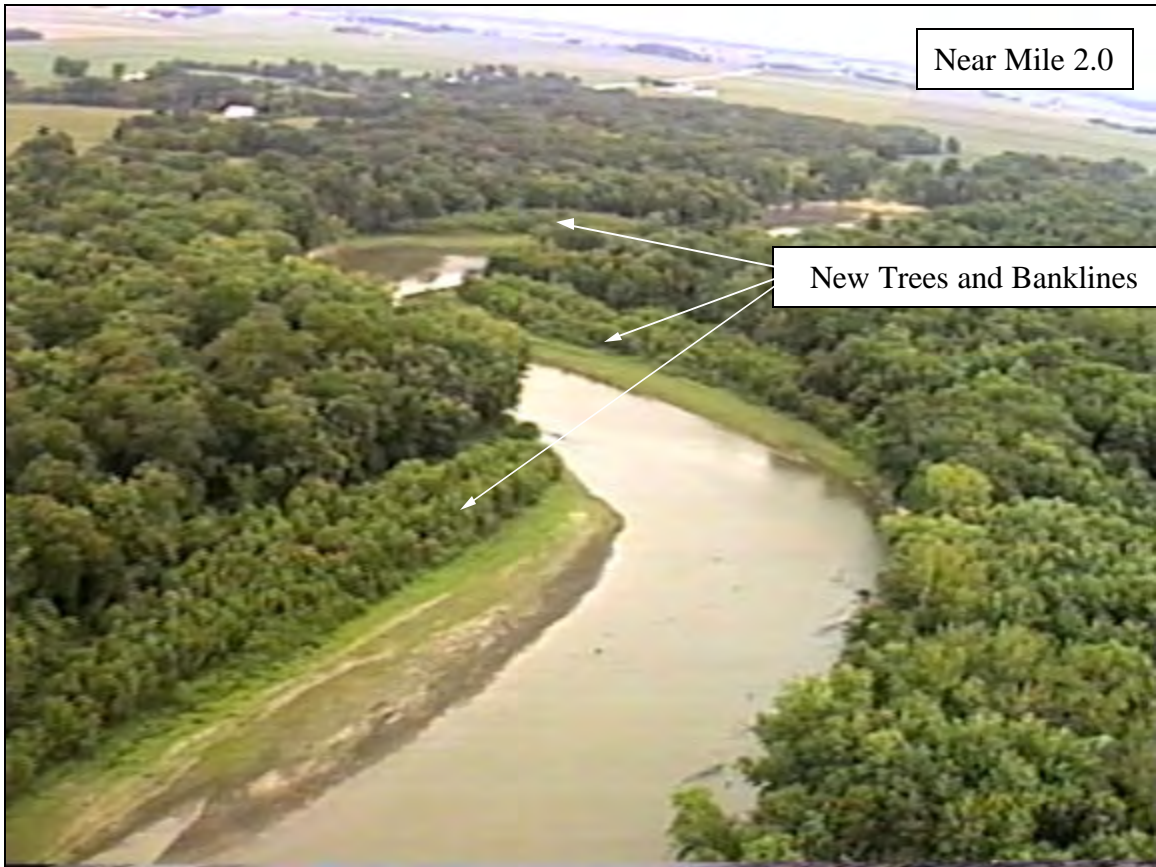
Figure 12

In a short reach just upstream of Fayetteville, between Miles 0 and 3 or Bends 140 and 130, the channel appears to be naturally reestablishing its morphology and aggressively healing itself. Signs of this were evident in several areas where large sections of the undersized trees have clearly established new banklines and a new, lower elevation floodplain (Figure 12).

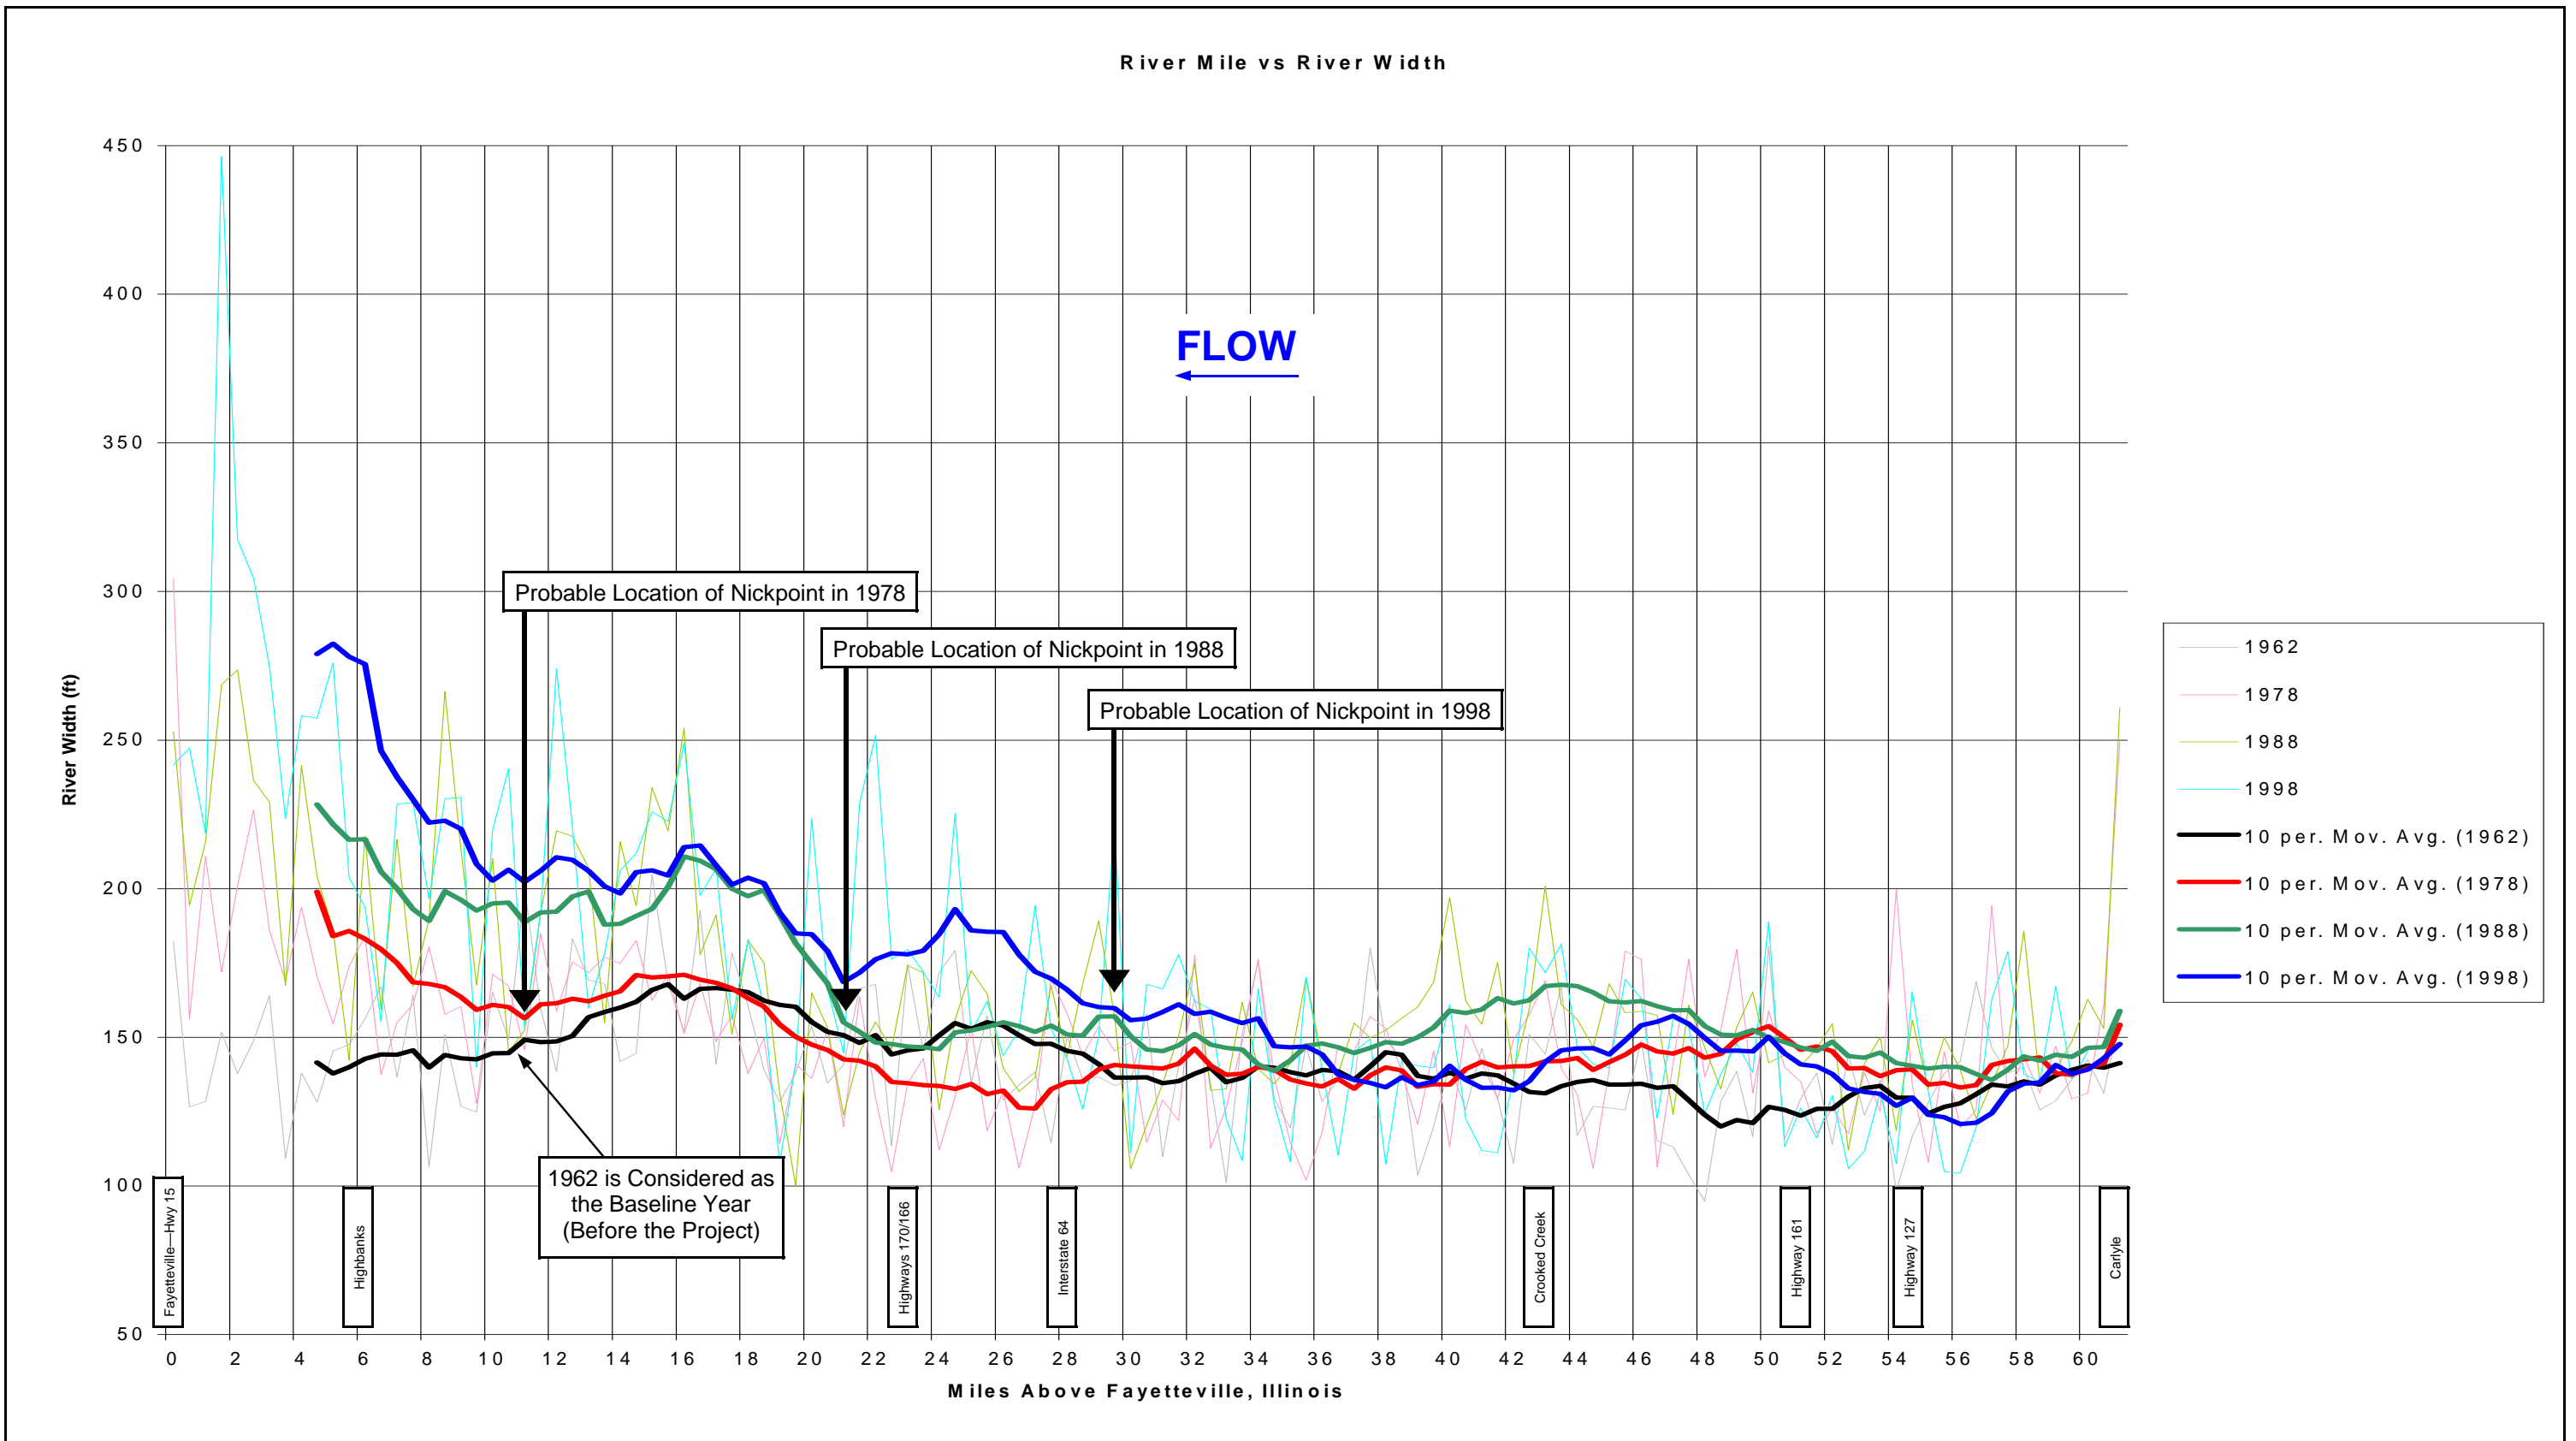
Figure 15: River Mile vs. Bank Width (1962, 1978, 1988, and 1998)

The aerial photo bank width analysis shows that the headcut could be advancing upstream at a rate of about 1 mile per year. This rate has been constant since construction began. If left unimpeded, at this rate the initial headcut will reach the Crooked Creek confluence by 2010 and the Lake Carlyle Dam by 2030. The river morphology as well as the aquatic and terrestrial environments along these remaining 30 miles of river will be irreparably damaged. The headcut will also travel up the unaffected tributaries, namely Crooked Creek.
