Summary Report

Lock and Dam 24 Physical Model, Upstream Scour

By: Timothy J. Lauth
Hydraulic Design Section
US Army Corps of Engineers St. Louis District
1222 Spruce St.
St. Louis, MO 63103-2833

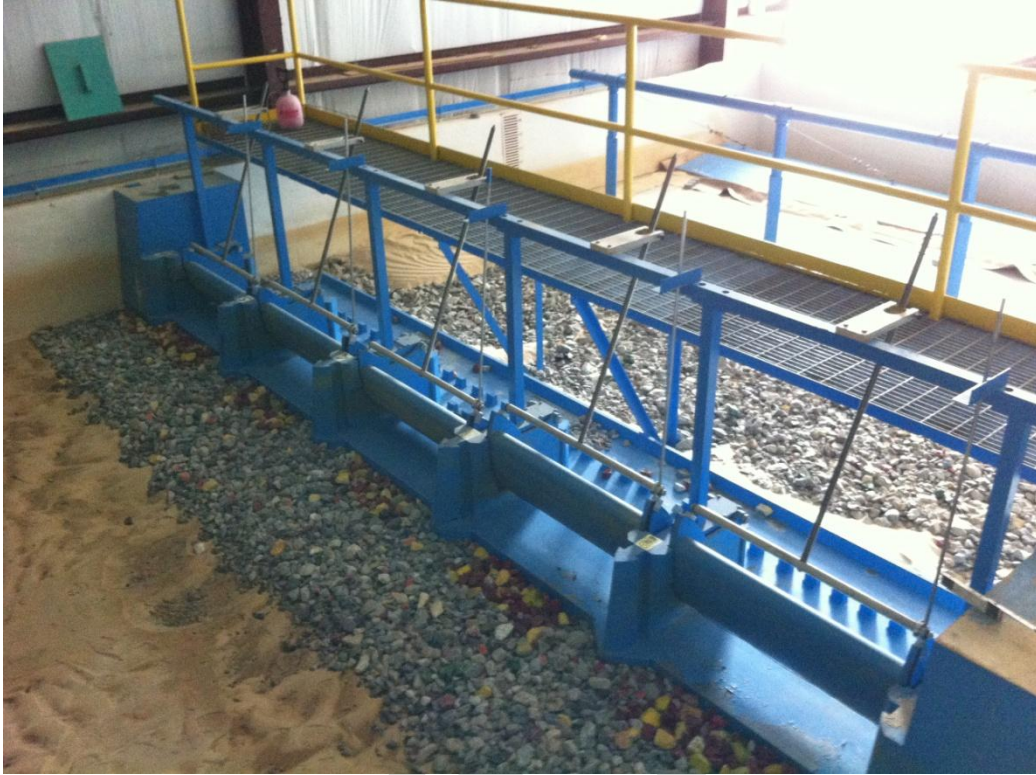
Figure 3 - The model gate structure and walkway viewed from upstream

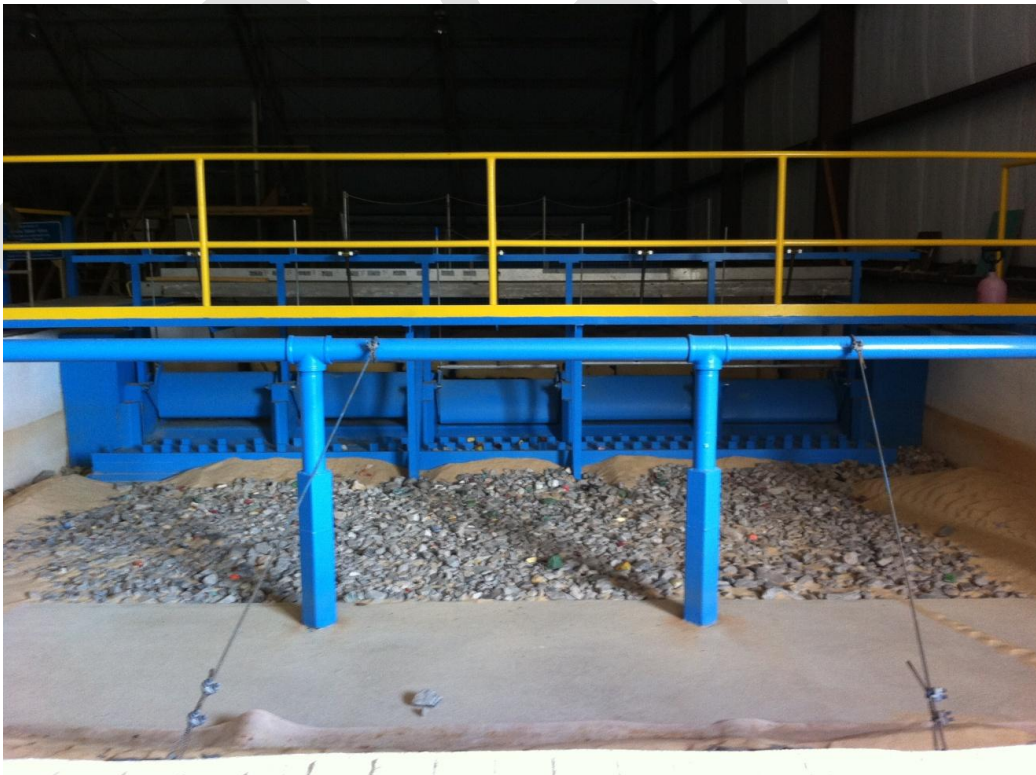
Stone cobbles were used below the spillway to dissipate the velocity of the flow through the gates (**Figure 4**). The tailwater and upriver pool elevations were measured with rulers set to scale in both portions of the model. The flow into the flume is supplied by 12-inch and 20-inch diameter pipes from a constant head tank fed by multiple pumps. The maximum flow possible into the flume is 40 cfs. A gate was used at the end of the flume to maintain the tailwater pool elevation.

Figure 4 - The model gate structure and walkway viewed from downstream

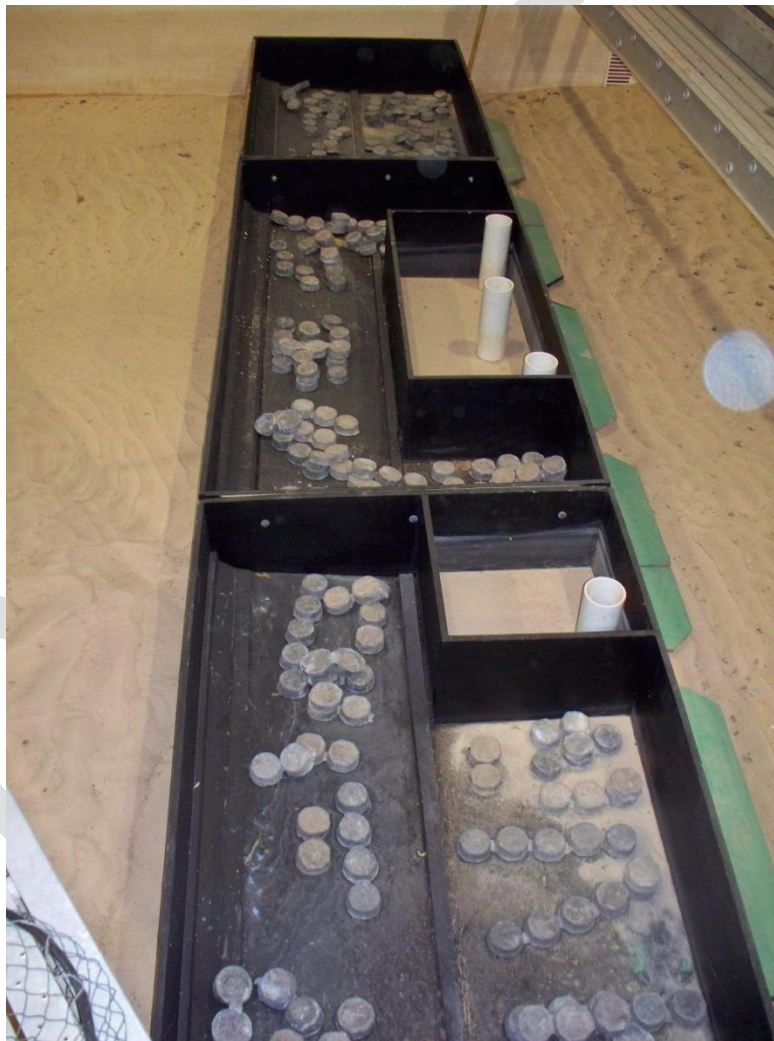
Ice development was simulated using a 21ft x 4ft x 1.2 ft wooden raft built in three sections to facilitate installation and removal (**Figure 5**). The bottom of a raft was sloped and lined with chicken wire to simulate the natural friction of the ice. The draft was controlled by adding or removing lead weights. Initially, walled cutouts were made in three of the sections to allow use of an underwater camera, lighting, and a 2D acoustic Doppler velocimeter (ADV) used to take velocity measurements underneath the ice raft. After later tests suggested that the panels were exaggerating the scour, the cutouts were covered and PVC shafts were installed in the raft to allow for the continued use of the ADV.

Figure 5 - Wooden raft used to simulate upstream ice
