May 2013

# DRY BAYOU – THOMPSON BEND

# DRY BAYOU – THOMPSON BEND REPORT

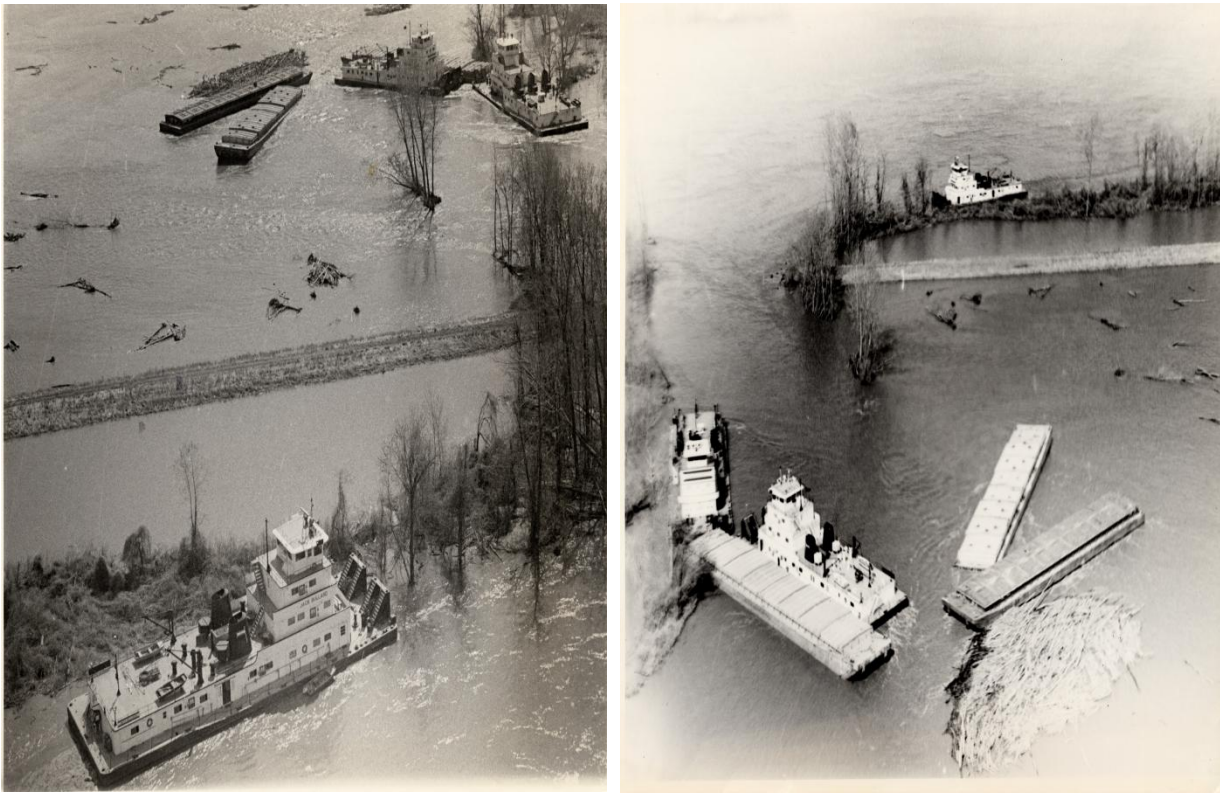
Figure 4: Recovery Efforts of Barge Accident in 1982

A high water event occurred in 1982 while the study process for the initial report was ongoing. During this high water event, some barges broke loose from their tow. They went through the bank line and the private levees. Not only was damage done to the bank line and private levee, but the propeller wash from the recovery efforts also scoured interior farmland.

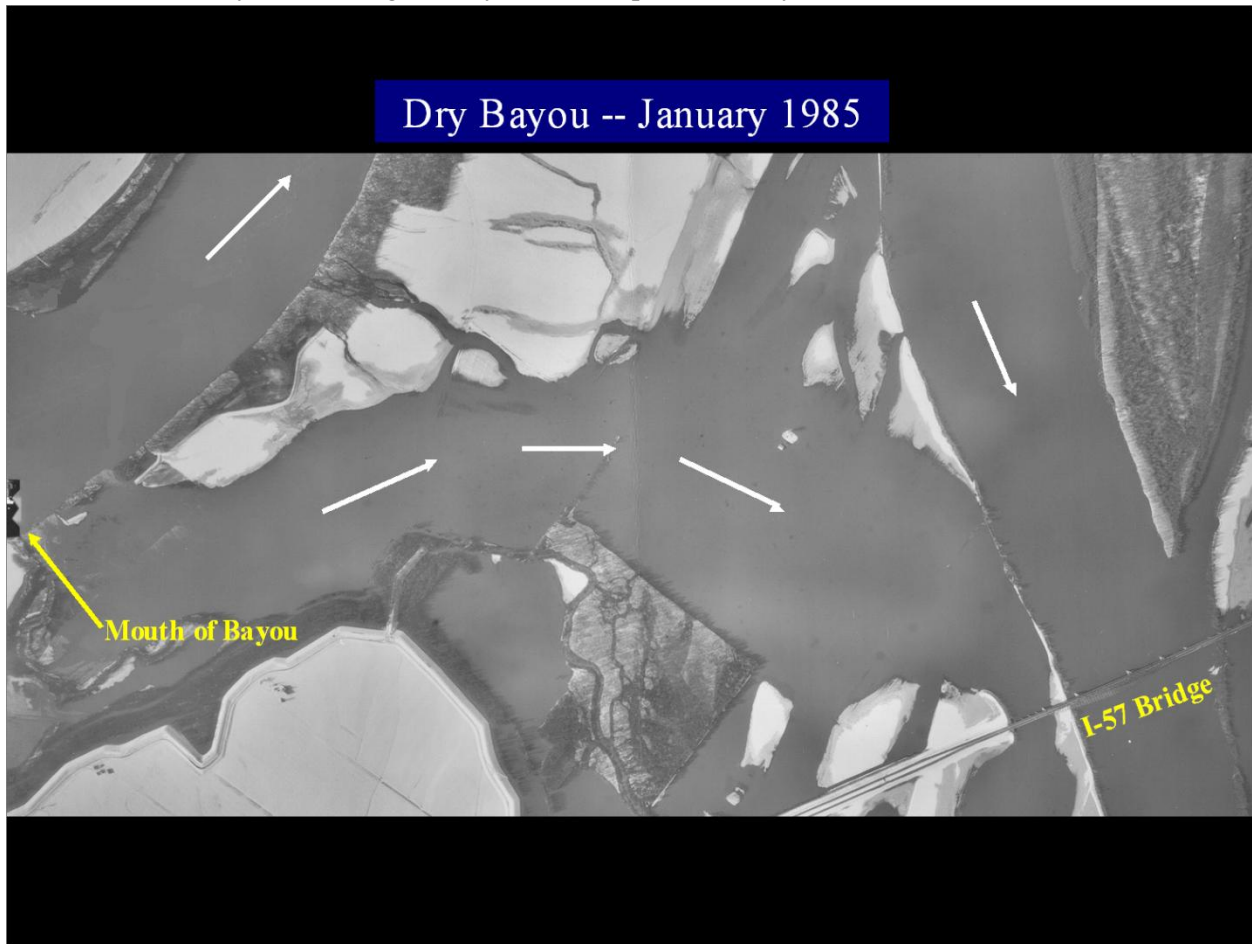
**Figure 7: Aerial Photo of Thompson Bend-Dry Bayou During Flood (Jan 1985)**

The aerial photographs taken in January 1985 show that, upon entering the bend, portions of the flow take separate paths. A portion of the flow passes through the I-57 relief opening. The other portion flows across the bend and reenters the river between miles 7.5 and 10.0. These ideas are reinforced by the photographs taken in February and March. Additional photos taken in March and April reveal the scour patterns downstream of the control structure and private levee breach, downstream of the access road into Thompson Bend, and in the vicinity of the I-57 relief opening.

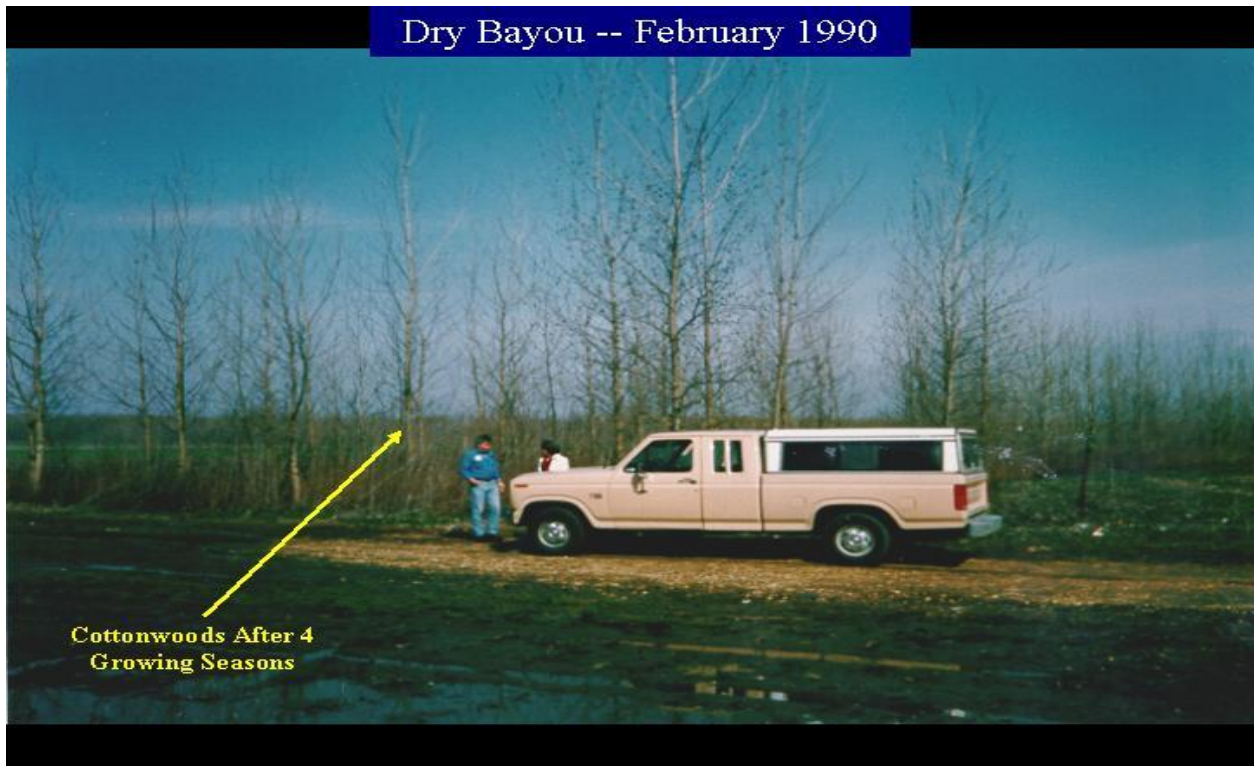
Figure 9: Tree Growth in Dry Bayou

The flood of 1990 was very similar to the flood of 1986 but very little of the flood drift found its way into the bend and the erosion and damage to the project area was minimal. The trees had grown to an average height of 25 to 30 feet. The erosion and damage to the project area after the flood was minimal.

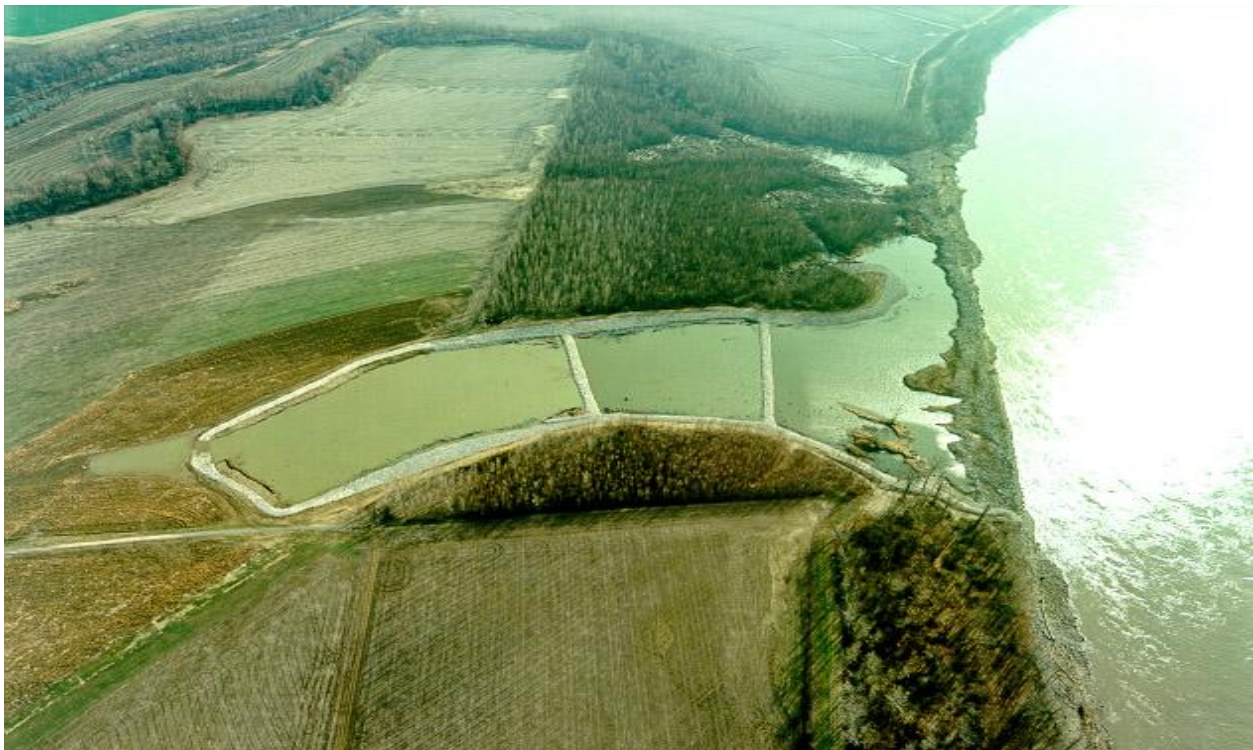
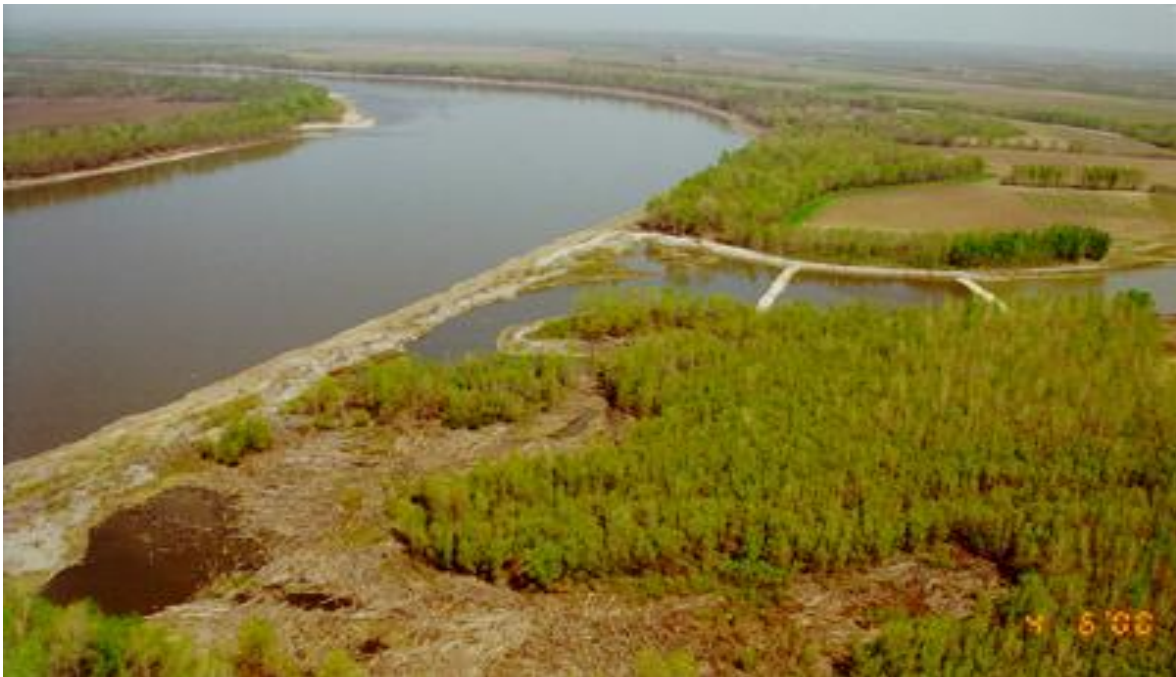
**Figure 26: Tree Screens and Baffles at Upper and Lower Dry Bayou Scour Holes in 2000**

After the floods of the 1990s it became clear that the planting efforts undertaken by local entities were not sufficient to address the issues facing the project area. The St. Louis district again partnered with the landowners to plan and implement a vegetation control plan. The Corps of Engineers began purchasing permanent, restrictive easements from the land owners. See Plate 2. Since 2000 the Corps has purchased more than 1153 acres in easements, implemented easement management plans, and has designed and constructed additional revetment and other rock features in the project area. See Figures 25 -31. The Corps has also planted more than 274,000 trees and other vegetation on more than 600 acres of easements in the project area to reduce erosion caused by overland flows. The remaining acreage is either reserved for access and roads, labeled “Road Easements” in Plate 2, or already had forests existing which just needed to be maintained and managed. The specifics of these tree plantings are presented in Table 1.
