Technical Report M1

**SEDIMENTATION STUDY OF THE MISSISSIPPI RIVER  
SANTE FE CHUTE, DOOLAN CHUTE  
HYDRAULIC MICRO MODEL INVESTIGATION**

September 1996

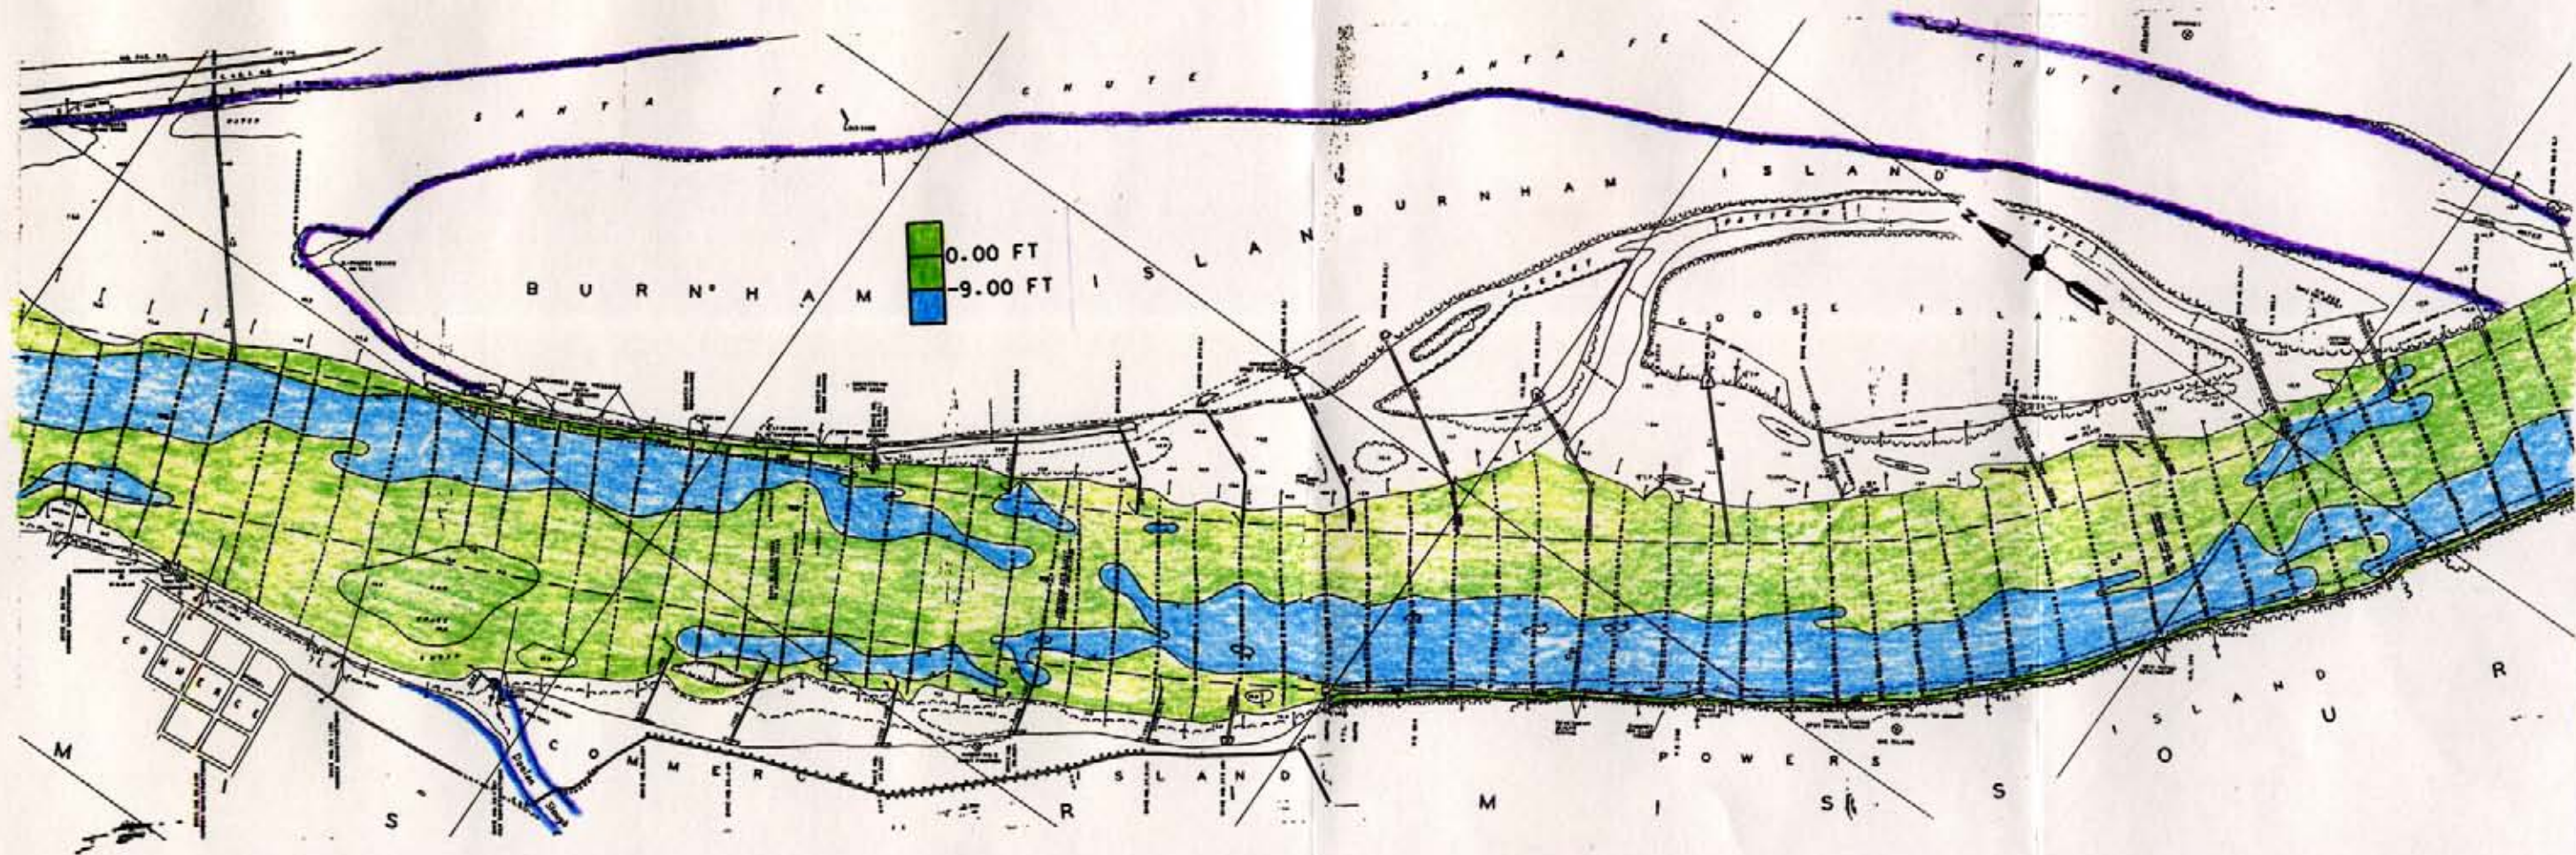
PLANT SCALE: 1" = 1000' PLANT DATE: 24 Sep. 1958	
		3

U.S. ARMY ENGINEER DISTRICT, ST. LOUIS CORPS OF ENGINEERS ST. LOUIS, MISSOURI	
	Santa Fe/Doolan Chute Micro Model Study Mississippi River Miles 40 - 35	
	1958 PROTOTYPE SURVEY

Plate 3 depicts the historical condition of the chute in 1958. The entrance of the chute occurred on the right descending bank at mile 38.9. The entrance width was approximately 600 feet. The channel depth in this area was approximately 0 feet relative to the Low Water Reference Plane (LWRP), or approximately +5 at the Cape Girardeau gage. Although vegetation markings in the chute just downstream of the entrance indicate that the channel was probably as high as the normal vegetation growth line.
