#### **Technical Report M67**

# MORO CHUTE HSR MODEL RIVER MILES 125.00 – 117.00

# HYDRAULIC SEDIMENT RESPONSE MODEL INVESTIGATION

Final Report – March, 2013

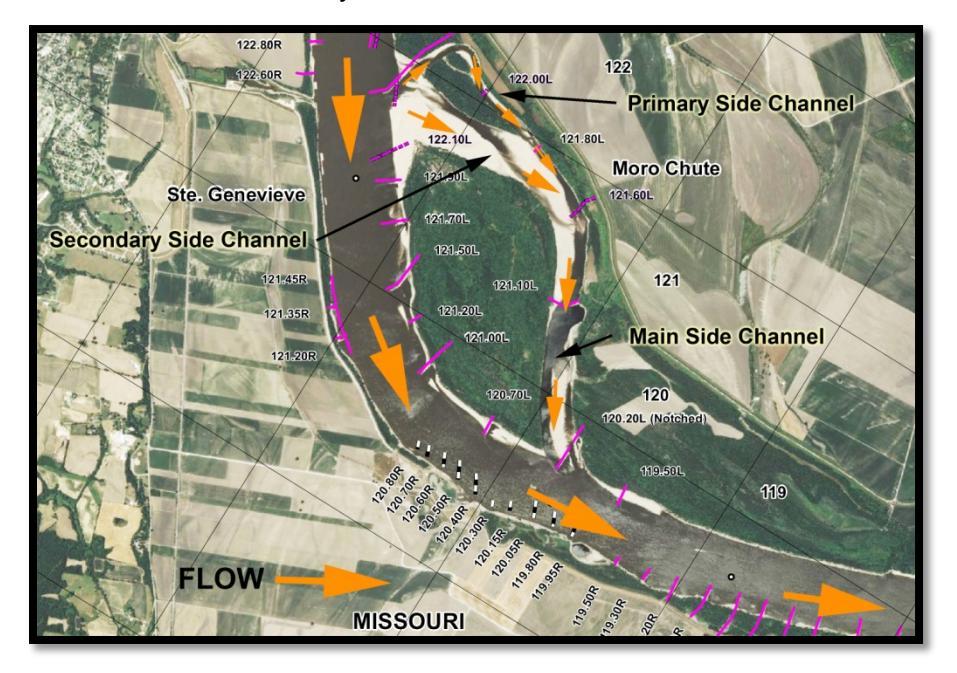
Figure 1: Moro Chute Reach with Flow Trends

At low water there were many structures that prevented flow from passing through Moro Chute. However, if water levels were greater than +15 feet LWRP flow was able to pass through Moro Chute. Approximately 7 months of the year the side channel was dry, leaving exposed sandbars. See Figure 1 for a generalized schematic of the existing flow mechanics in the study reach.

The main channel near Moro Chute has been sufficient for navigation with depths that were at least -10 feet Low Water Reference Plane (LWRP). However, the dike field along the LDB at Moro Island has caused a lack of bathymetric diversity. The sandbar located along the LDB against Moro Island, from RM 122.50 to RM 119.50, had an average width of 400 feet and an average elevation of +5 feet LWRP. The side channels experienced deposition, which provided limited connectivity to the main channel and very little bathymetric diversity. However, there was a plunge pool with depths greater than -30 feet LWRP in the main side channel caused by Dike 121.10L.

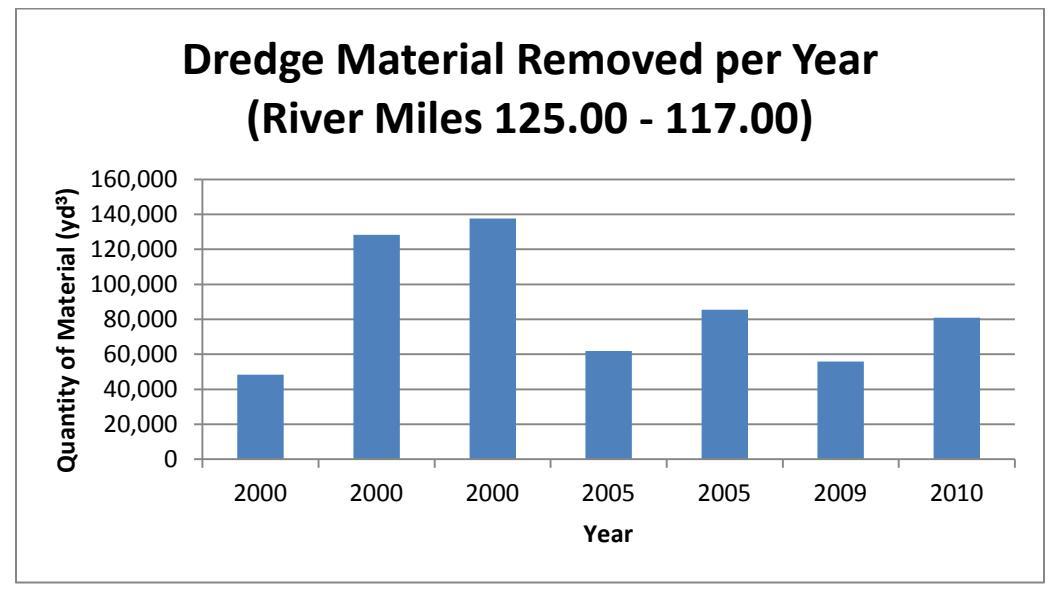
Figure 2: Study Reach Dredge Removal Data

There were many sandbars located along the LDB between the dike fields. Dikes 124.45R, 121.35R, and 121.20R, located along the RDB, were constructed to align the bankline and to protect against erosion. See photograph 1 on Plate 13. To maintain the navigation channel from 2000 to 2010 between RM 123.00 and RM 120.00, approximately 600,000 cubic yards was dredged at a cost of \$1.4 million. Figure 2 shows the dredge material removed per year and Plate 24 displays the dredge areas and dredge disposal locations.

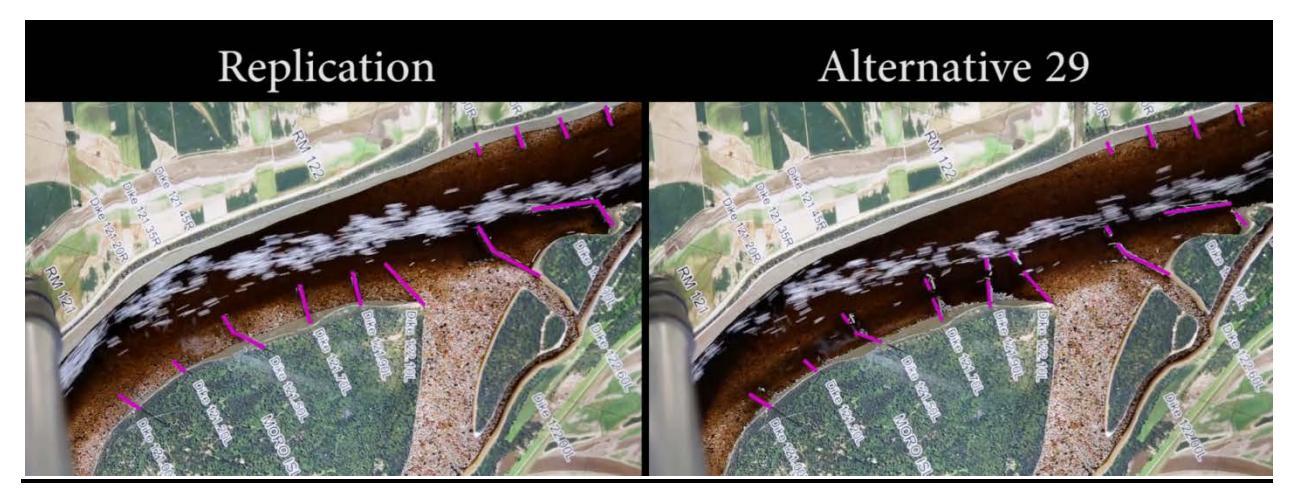
#### Figure 4: Flow Visualization

The flow exited a bend at RM 122.00 and about to cross over to the RDB just upstream of Figure 4's extents. As seen in the snapshot of the existing conditions, the resultant flow was concentrated along the LDB in Figure 4. Immediately downstream, flow crossed over to the RDB and began to disperse across the channel. No sediment movement as observed in the side channels. All structures are highlighted in pink for increased visibility.

The first condition recorded was the replication test, or existing conditions as seen in Figure 4 below.

The next condition recorded was post construction with the recommended alternative (Alternative 29) for constructing rootless dike extensions and shortened dikes that would create a secondary channel and provide habitat diversity adjacent to Moro Island.

Again, the flow exited a bend at RM 122.00 and about to cross over to the RDB just upstream of Figure 4's extents. As seen in the snapshot of the post construction conditions, the flow split sending the majority of the flow through the main channel. A secondary side channel was created between the notch structures. Compared to the existing conditions, there was increased flow and sediment transport along the LDB.
