Project Information Report
PL 109-148 Rehabilitation of Damaged
Hurricane/Shore Protection Projects

GRAND ISLE AND VICINITY, LOUISIANA

JEFFERSON PARISH, LA

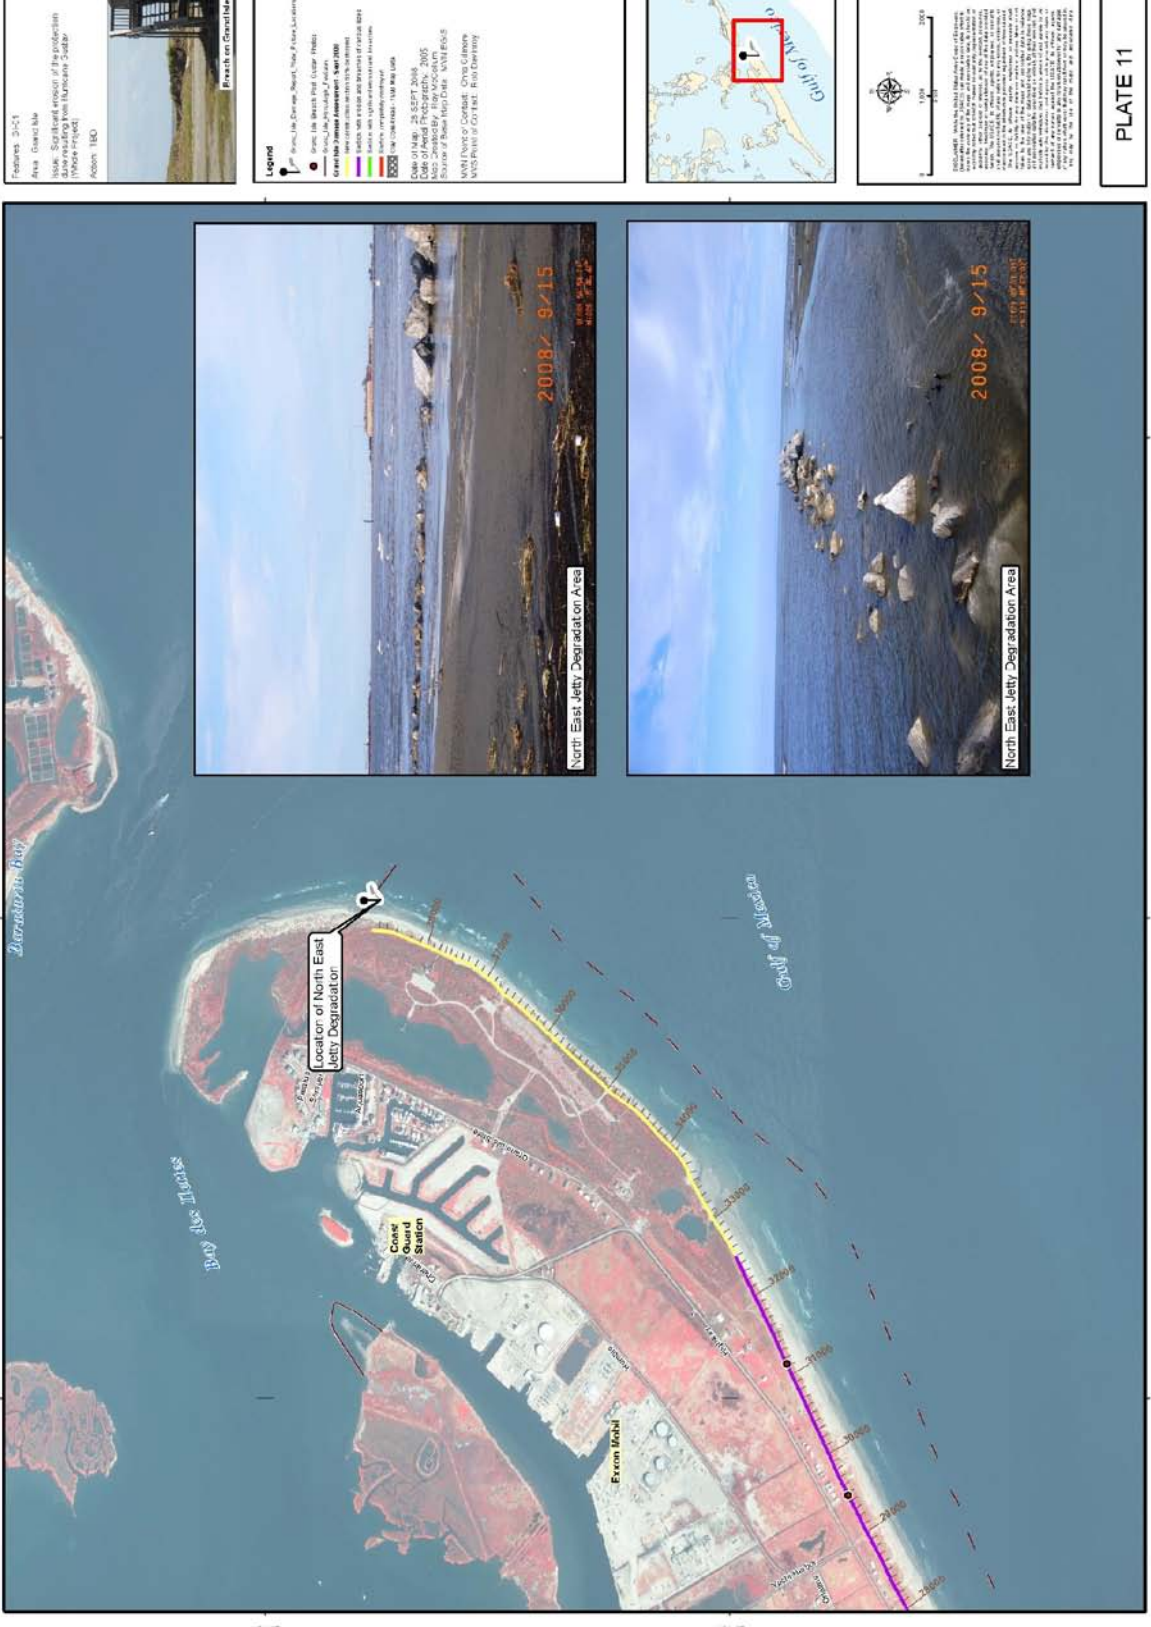
PLATE 11

The rock jetties on the gulf side of both ends of the island were degraded from the storms. Storm surge wave action removed several feet of rock in the near shore section of the east jetty. Half of the west jetty (gulf side) was degraded down several feet. The degradation of both jetties could have been from either rocks tumbling down from the top, or from scour and launching or slumping of jetty section.

MVS HURRICANE GUSTAV RECOVERY MAP: GRAND ISLE- NE JETTY DEGRADATION AREA

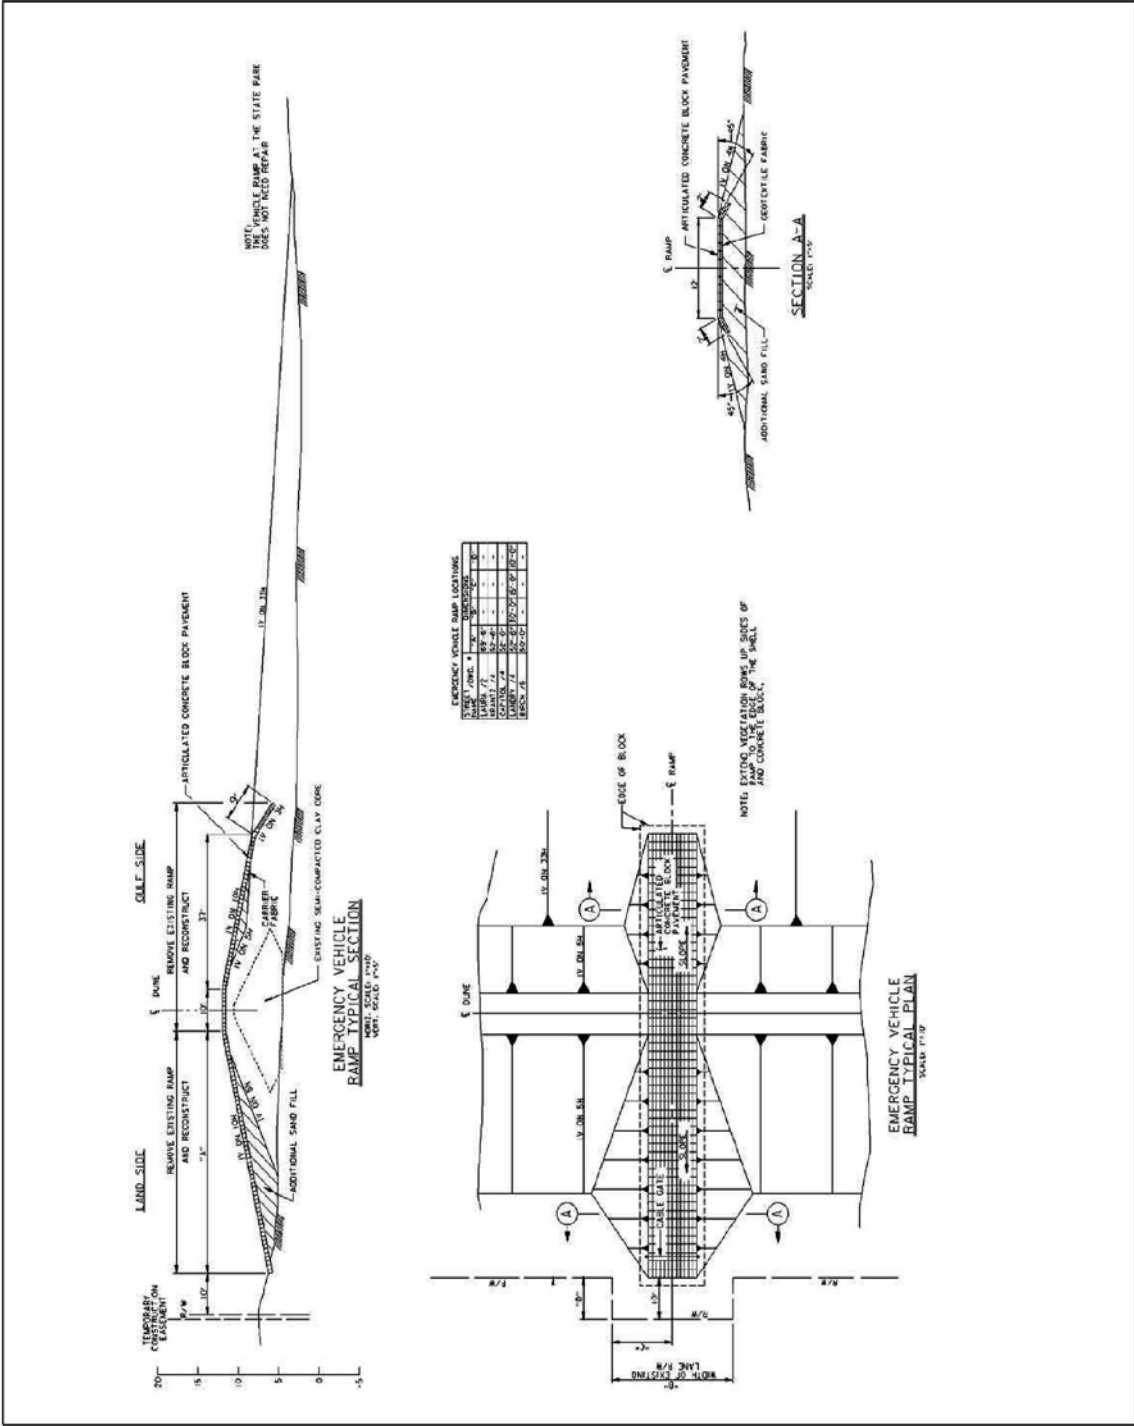
PLATE 15

MVS HURRICANE GUSTAV RECOVERY MAP: GRAND ISLE VEHICLE ACCESS DESIGN

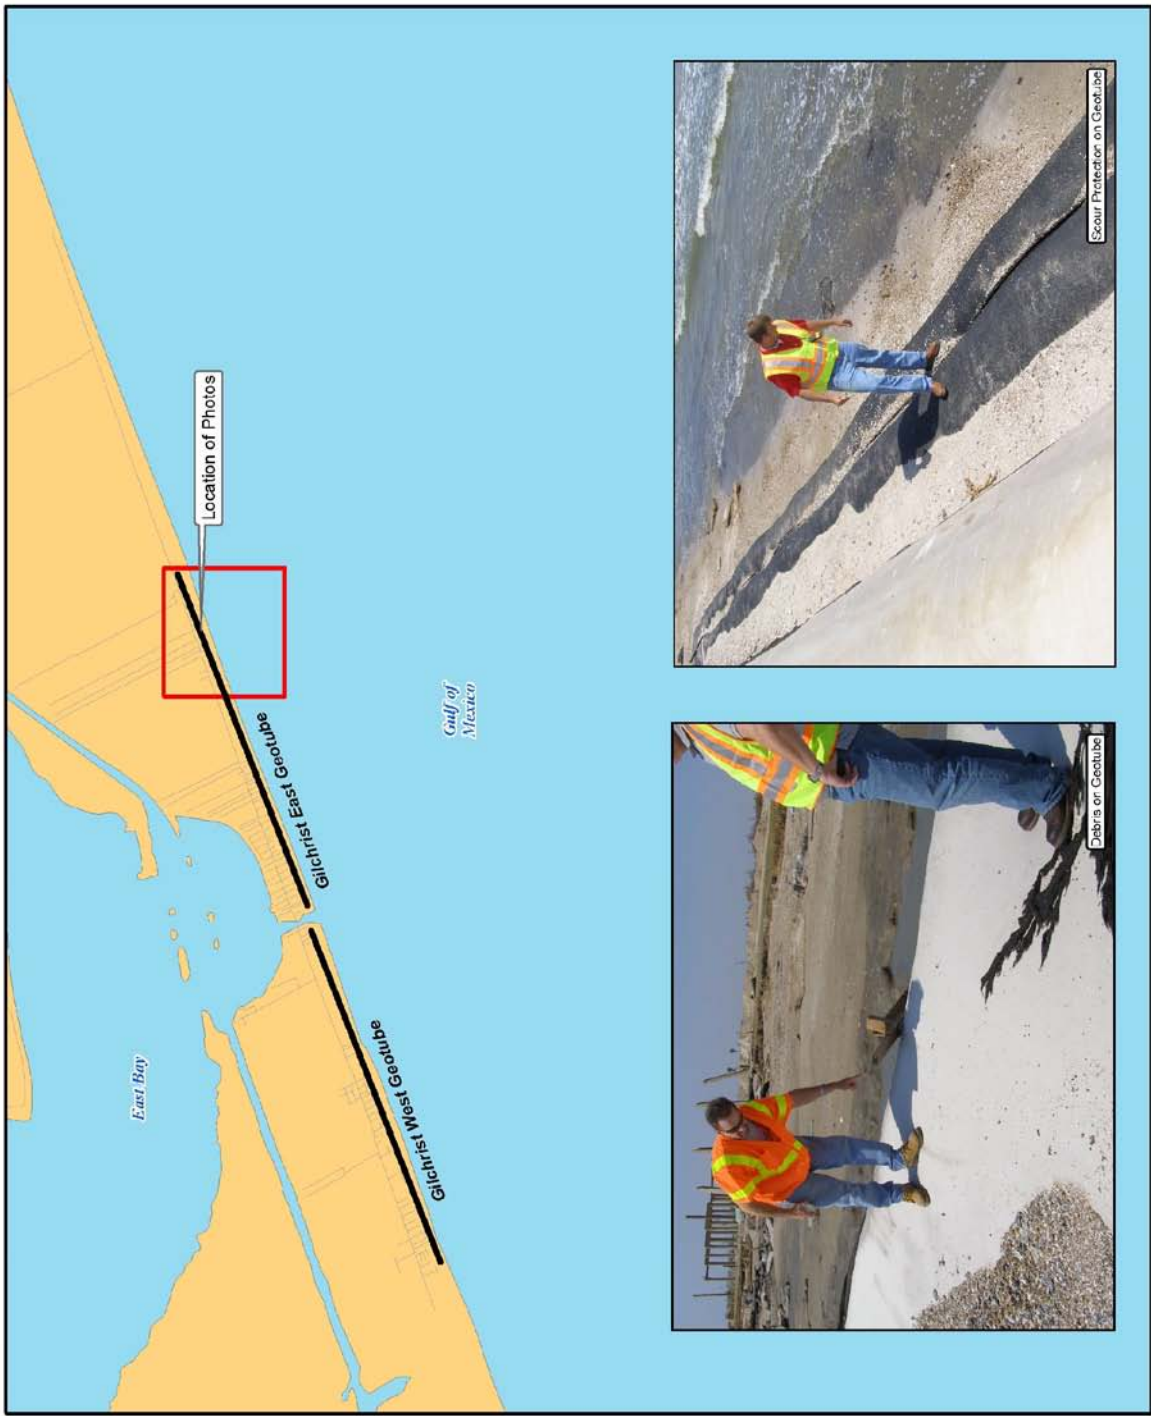
PLATE 22

Upon arriving at the eastern end of the geotube line, the team immediately noticed that all sand cover was removed by the storm. The geotube was left exposed to the elements. Most of the UV protection was still in place, but was damaged in several areas. Broad scour depressions (~50'-75' in width) were noted immediately inland of the geotube line. The ground was littered with a cover of small, brittle shells with sharp edges. Very little debris was seen at the eastern end of the geotubes. The team

Most of the geotube line had not moved laterally. However, some breaches of varying lengths were noted. The breaches appeared to have been caused by rips or tears in the geotubes. In all cases, the broken geotubes were pointed out toward the gulf. Geotube connection points did not appear to have been more vulnerable to failure than midlength sections. It was also noted that no breaches in the geotube were oriented inland of the original geotube line. This led the team to suspect that the surge wave flow back toward the gulf from the bay was strong and could possibly have been the ultimate cause of several or all geotube failure points. Further evidence of strong gulfward return flow from the bay was that all grass was laid down in the direction of the gulf.

MVS HURRICANE GUSTAV RECOVERY MAP: GEOTUBE IN GILCHRIST, TEXAS

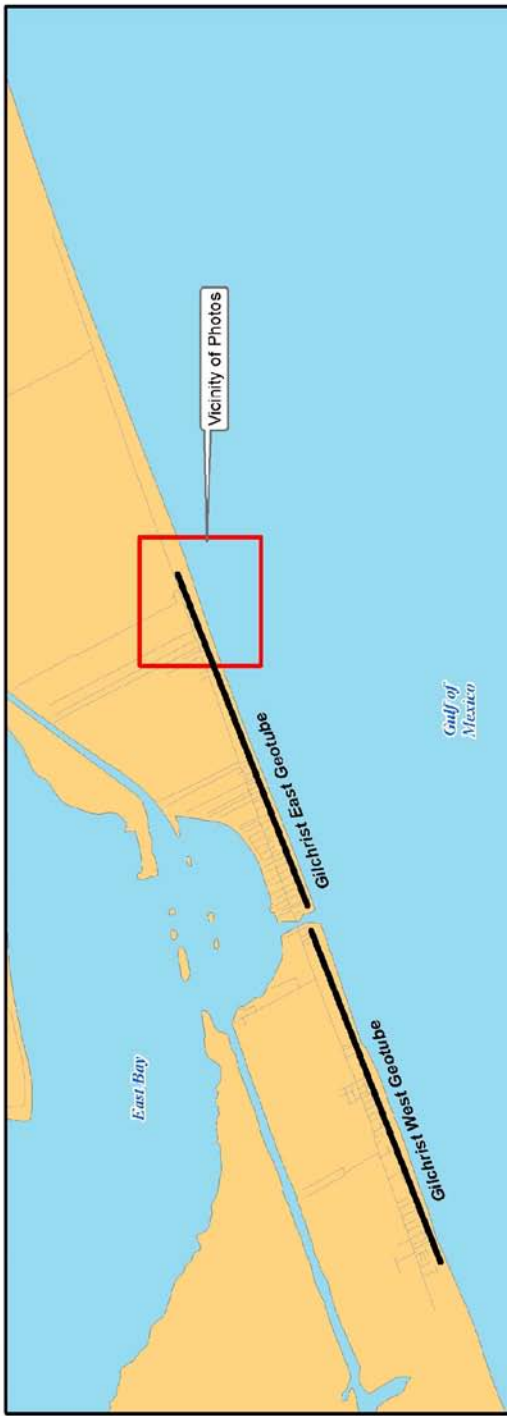
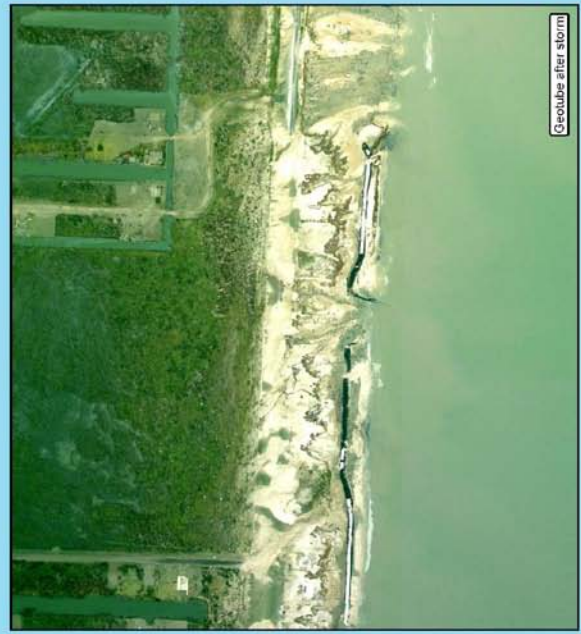
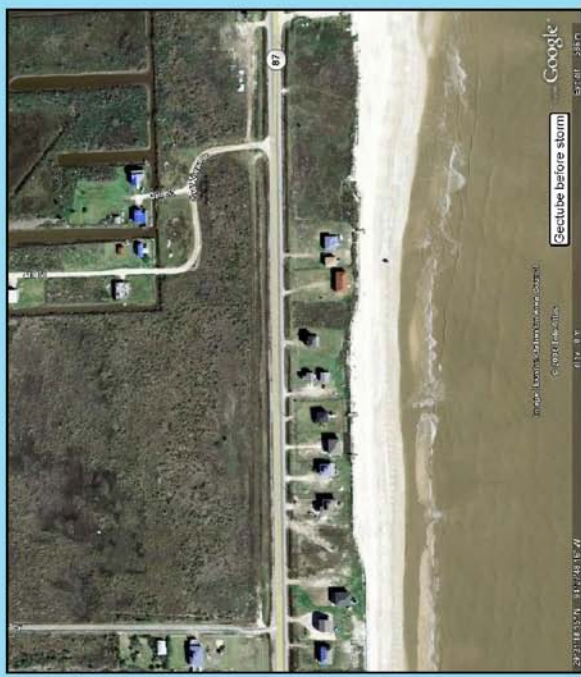
The team also noted that the gulf side scour blanket and tube performed as designed. Much of the gulf side scour tubes were buried in the sand and shells, protecting against gulf side undercutting of the geotube line. The inland scour blanket and tube did not perform so admirably. The scour tube was pushed up against the larger geotube in most locations, and had not buried deep into the sand as designed. The team noted that two different hydraulic conditions on the two sides of the geotube were probably responsible for the different performances. Evidence suggested that wave/scour action from the gulf over the top of the geotube caused uplift forces that literally picked up the scour tube on the inland side and deposited it at the face of the larger geotube. The compromised scour protection could have led to the ultimate undermining of the larger main geotube. When the surge water returned from the bay toward the gulf, the undermined scour holes became drainage points, as evident by the Head-cutting observed just landward of the geotube breaches.

MVS HURRICANE GUSTAV RECOVERY MAP: GEOTUBE EXAMPLES IN GILCHRIST, TEXAS
