Technical Report M29

**SEDIMENTATION STUDY OF THE
MIDDLE MISSISSIPPI RIVER AT
BUFFALO ISLAND
RIVER MILES 28.0 TO 22.0
HYDRAULIC MICRO MODEL INVESTIGATION**

U.S. ARMY CORPS OF ENGINEERS
ST. LOUIS DISTRICT
HYDROLOGIC AND HYDRAULICS BRANCH
APPLIED RIVER ENGINEERING CENTER
FOOT OF ARSENAL STREET
ST. LOUIS, MISSOURI 63118

Final Report – DECEMBER 2003

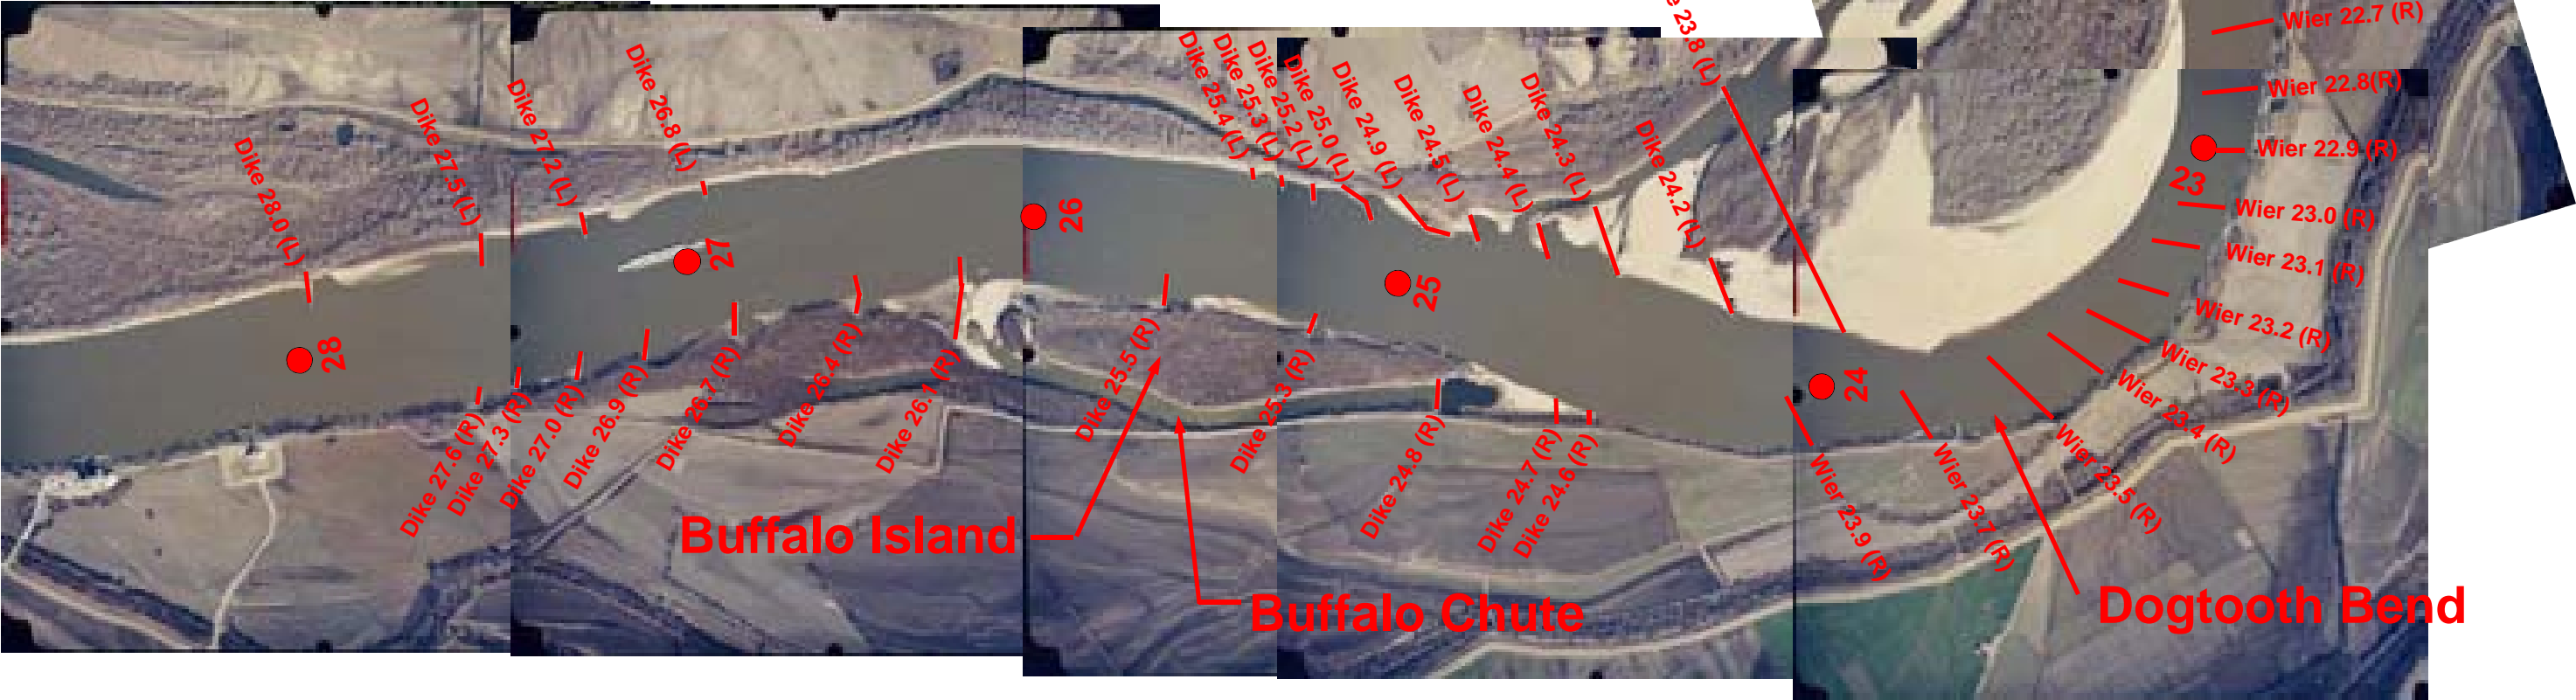
U.S ARMY ENGINEER DISTRICT, ST. LOUIS CORPS OF ENGINEERS ST. LOUIS, MISSOURI	
BUFFALO ISLAND MICRO MODEL STUDY RIVER MILES 28.0 TO 21.0 2002 AERIAL PHOTOS	
<div>3000 2400 1800 1200 600 0 1500 3000</div>	
FILE NAME: 2002.pub	
PLATE NO. 2

At the time of this study, the Buffalo Island study area included three dike fields and one weir field, containing a total of forty-two structures (Plate 2). All dike and weir structures were of stone construction.

Weir Field 1 was located along the RDB and contained 13 weirs as shown on Plate 2. The weirs were located at Miles 24.2R, 23.9R, 23.7R, 23.5R, 23.4R, 23.3R, 23.2R, 23.1R, 23.0R, 22.9R, 22.8R, 22.7R, and 22.45R. Structure lengths varied from 550 feet to 1000 feet.

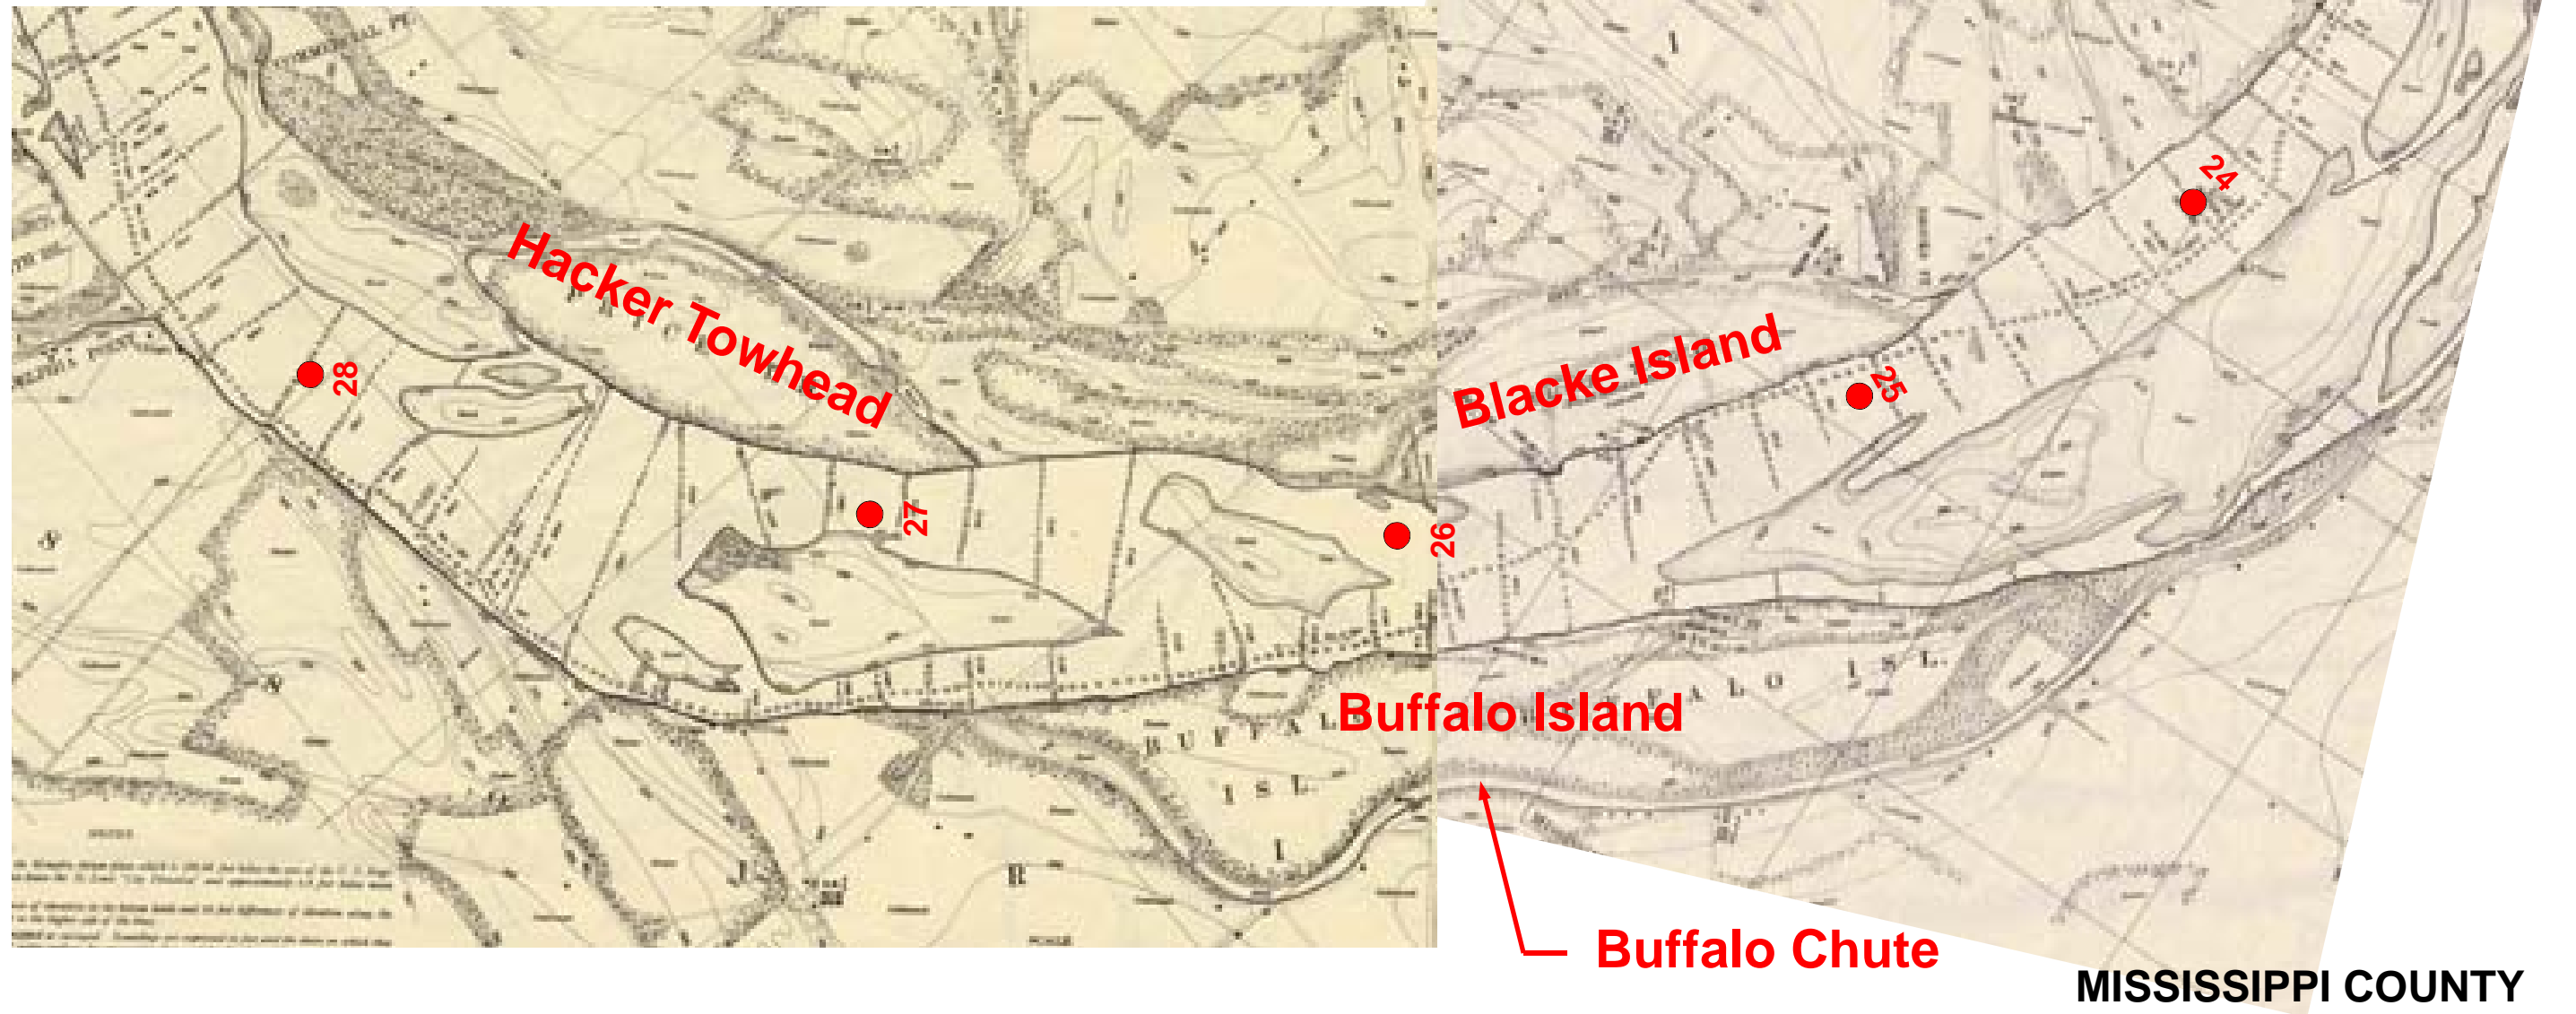
U.S ARMY ENGINEER DISTRICT, ST. LOUIS CORPS OF ENGINEERS ST. LOUIS, MISSOURI	
<small>PREPARED BY: E. RIFF DRAWN BY: E. RIFF CHECKED BY: J. BROWN</small>	BUFFALO ISLAND MICRO MODEL STUDY RIVER MILES 28.0 TO 21.0 1908 SURVEY MAP	
		PLATE NO.
	FILE NAME: 1908.pub	4

Plate 4 is a 1908 historical topography and hydrographic survey map. Buffalo Island's side channel size and location changed slightly since 1880. The survey indicated that the upper entrance to the chute was eroded away as a result of the migration of the main channel. Conversely, the first meander in the chute was eliminated. The notable changes in the main channel were channel migration between Miles 28.0 and 27.0 toward the RDB and additional shoaling and deposition. Large sand bars were observed in the center of the channel at Miles 27.8, 27.2 and 26.3 as well as on the outside of the bend between Mile 25.5 and 23.5. Blacke Island also became part of the floodplain on the LDB. The thalweg was located on the RDB from Mile 28.5 to Mile 26.0 where it then crossed to the LDB. The thalweg remained along the LDB until Mile 24.9, where it then crossed back over toward the RDB at Mile 24.0.

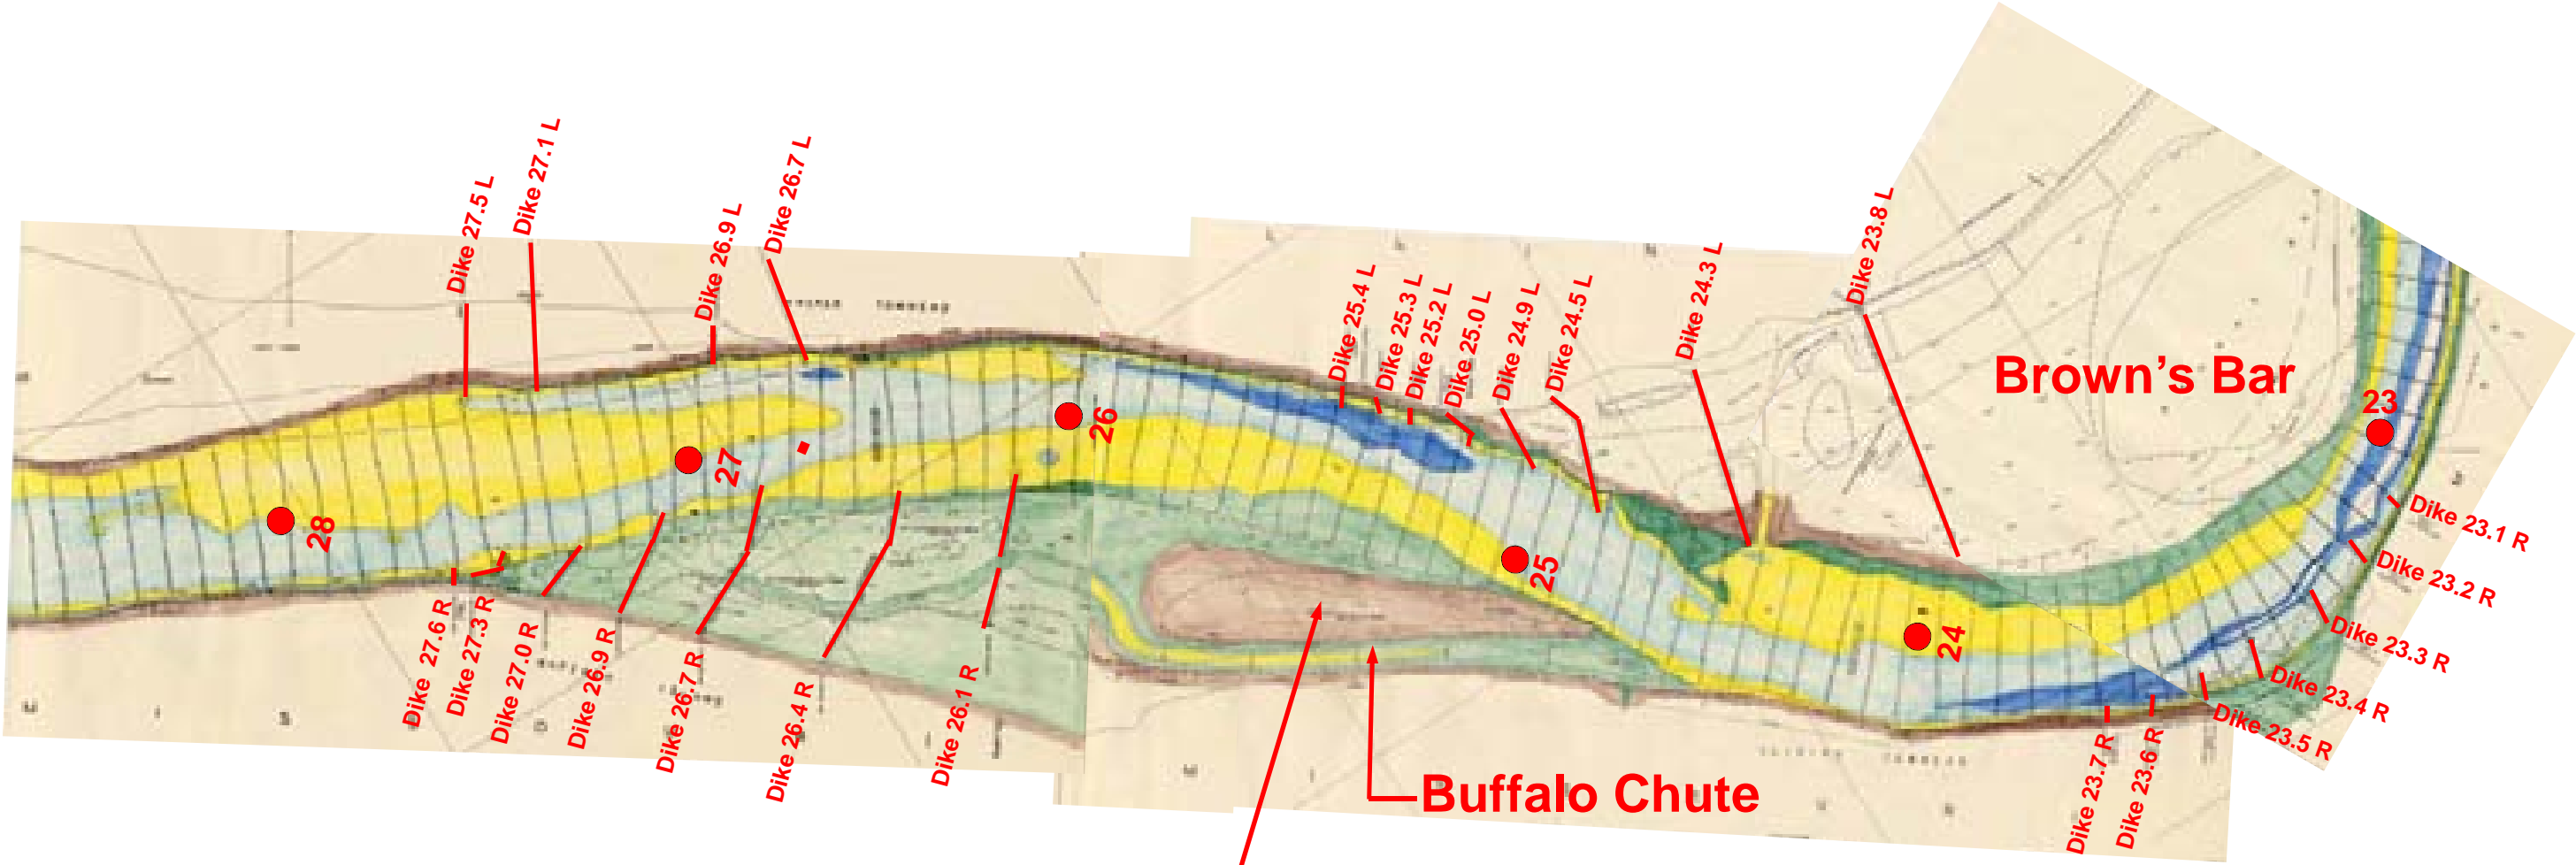
FILE NAME: 1956.pub	PLATE NO. 6

The 1956 hydrographic survey is shown on Plate 6. Several pile dikes were placed across the upstream portion of Buffalo Chute, including Dikes 27.6R, 27.3R, 27R, 26.9R, 26.4R, and 26.1R. The downstream portion of Buffalo Chute was markedly wider than observed in 1929. The main channel between Miles 26.0 and 25.0 was also firmly located along the left descending bank. In addition, the sliding towhead island had become the RDB of the main channel.

To determine the general bathymetric characteristics and sediment response trends that existed in the prototype, several present and historic hydrographic surveys were examined. Plates 6,7,8, and 9 are plan view hydrographic survey maps of the Mississippi River from 1956, 1970, 1977, and 1983 respectively. Plates 11, 12, 13, and 14 are hydrographic surveys taken in 1996, 1998, 2000, and 2001. All of the surveys displayed the same general location of the channel thalweg. Two crossings were consistently observed at Mile 27.0 and Mile 24.0. All of these surveys showed that the thalweg of the main channel crossed from one bank to another twice in this reach. It should be noted, however, that the

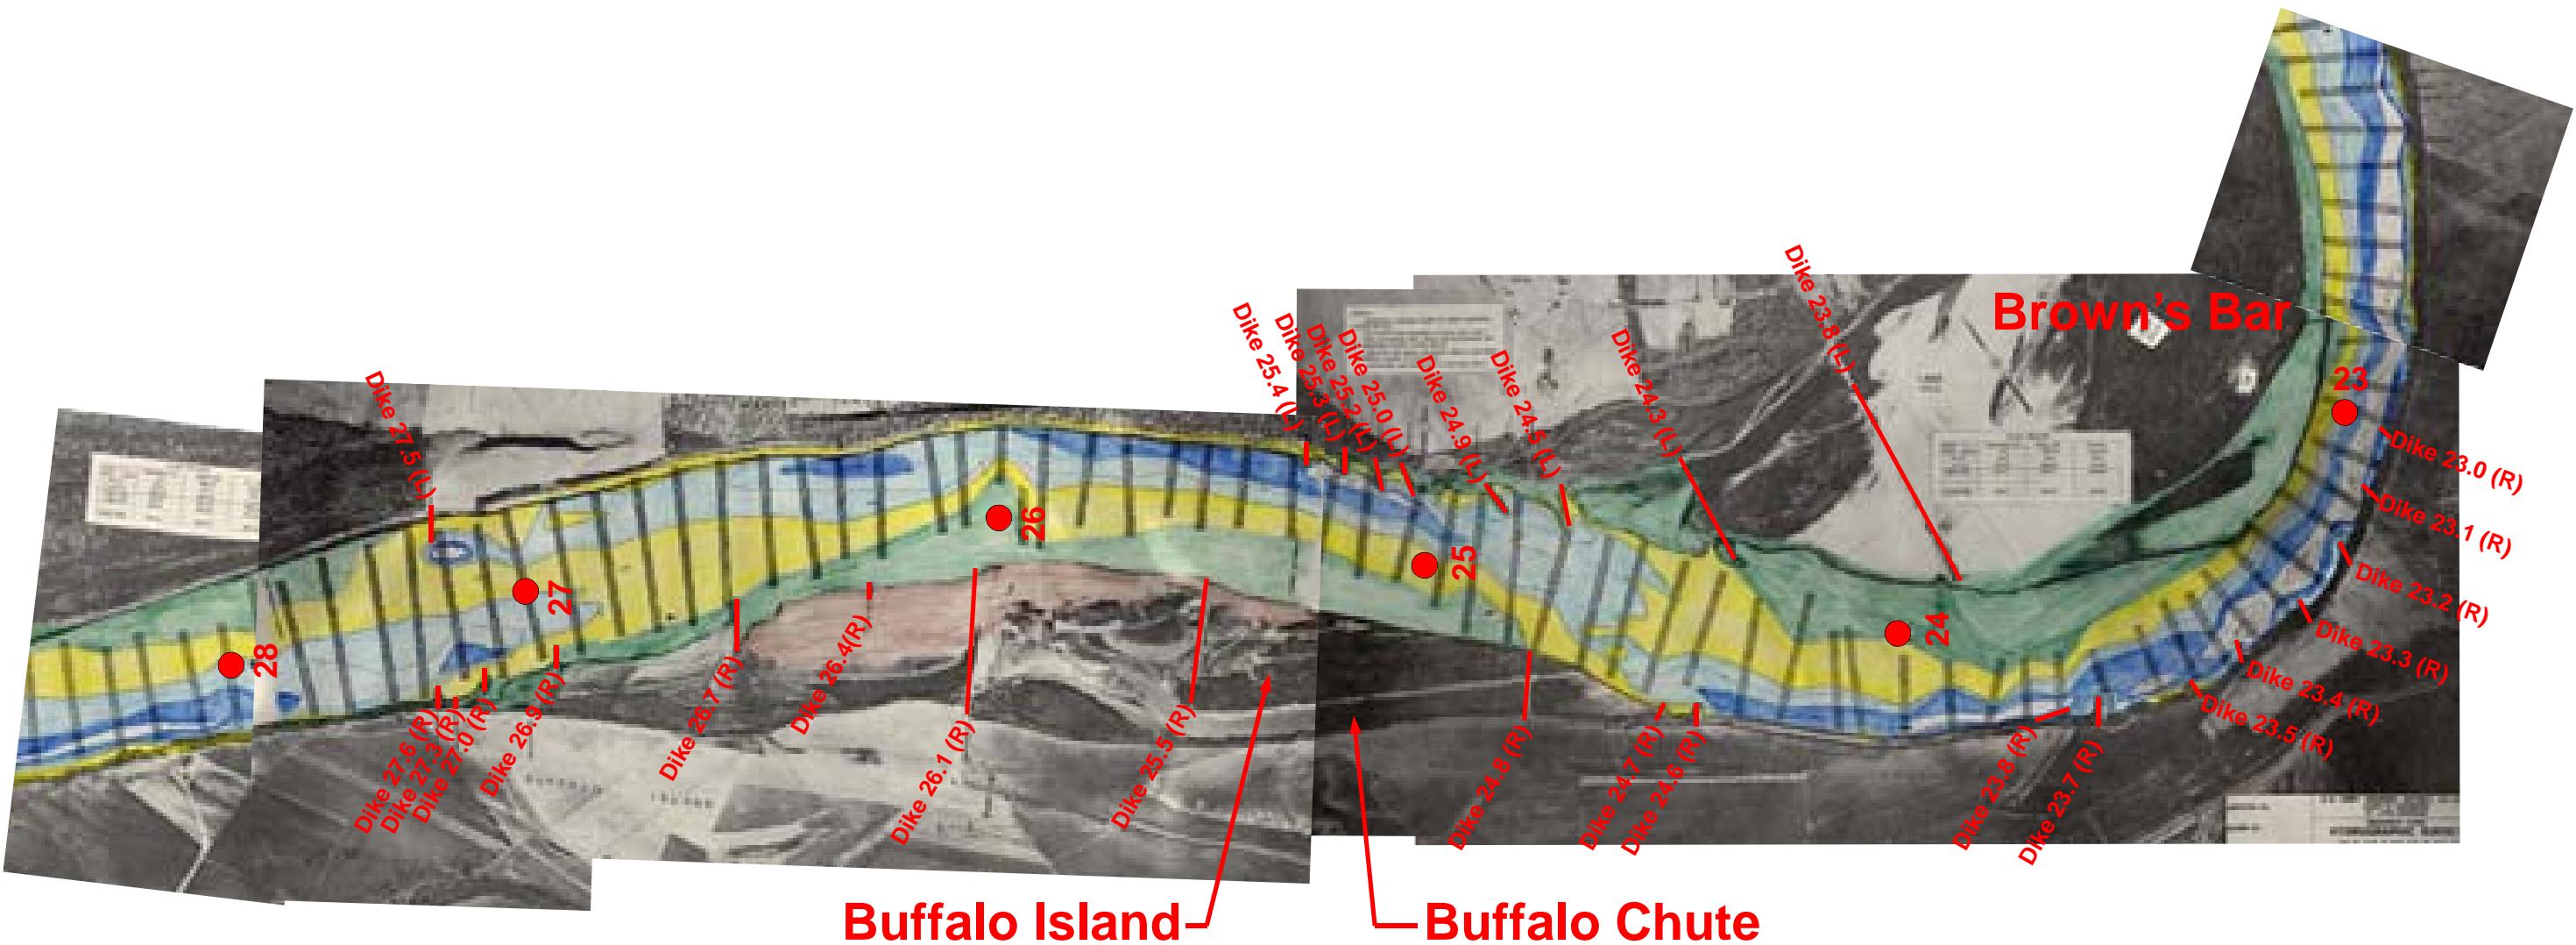
3000 2400 1800 1200 600 0 1500 3000
FILE NAME: 1970.PUB	PLATE NO. 7

The 1970 hydrographic survey is shown on Plate 7. This was the first survey available after several timber pile structures were converted to stone in 1964. Floods, ice and floating drift extensively damaged timber pile structures and in many cases the life span of the structures were short-lived. The location of the thalweg of the main channel in this survey was similar to the 1956 survey. The main difference observed on this map as compared with all previous maps is the marked increase in width and decrease in length of Buffalo Chute. The five most upstream dikes had converted the Buffalo Chute into terrestrial habitat, thereby shortening the upper chute by almost one mile.

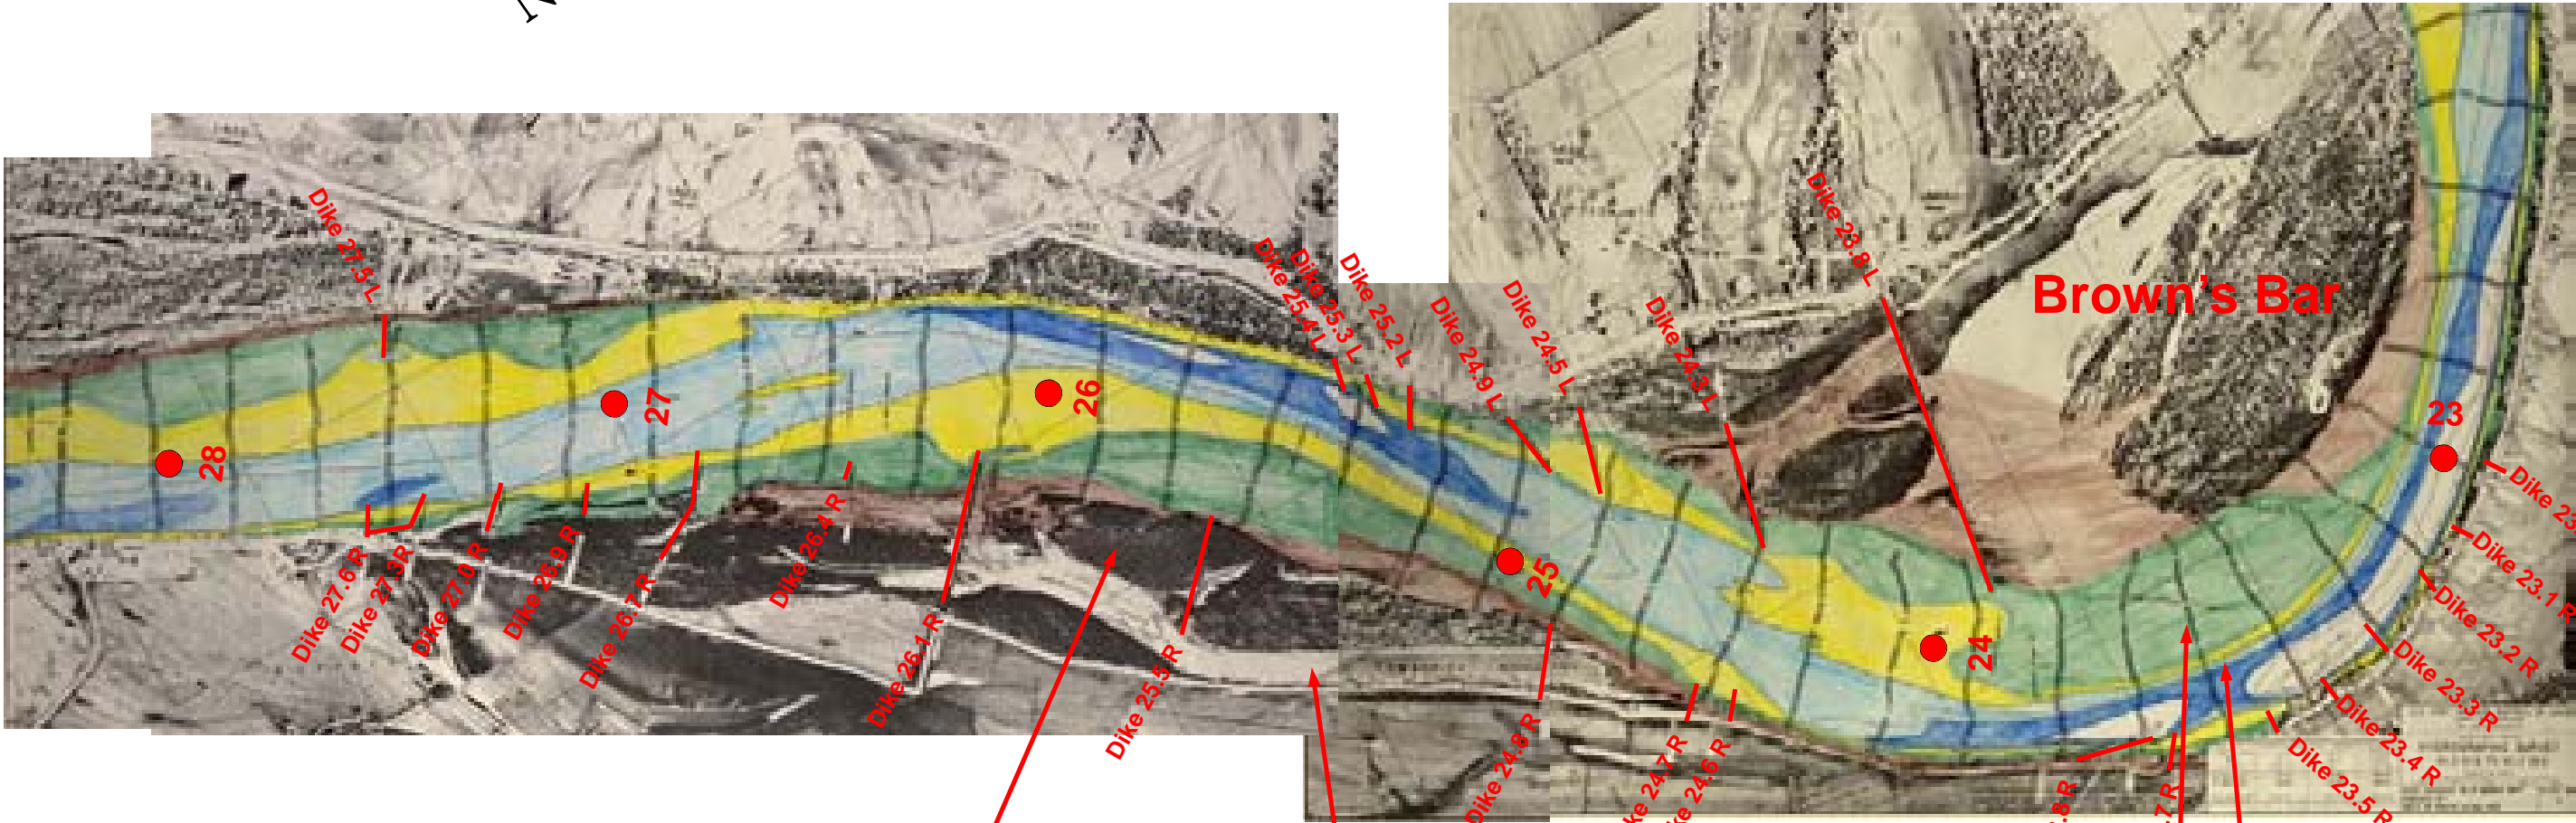
FILE NAME: 1977.PUB	PLATE NO. 8

The 1977 hydrographic survey is shown on Plate 8. The bathymetry of this survey was similar to the 1970 survey. The main change in bathymetry was additional shoaling along the inside of Dogtooth Bend, which caused the channel to become more constricted and deeper through the bend. The trends along Buffalo Chute remained generally the same as in 1970.

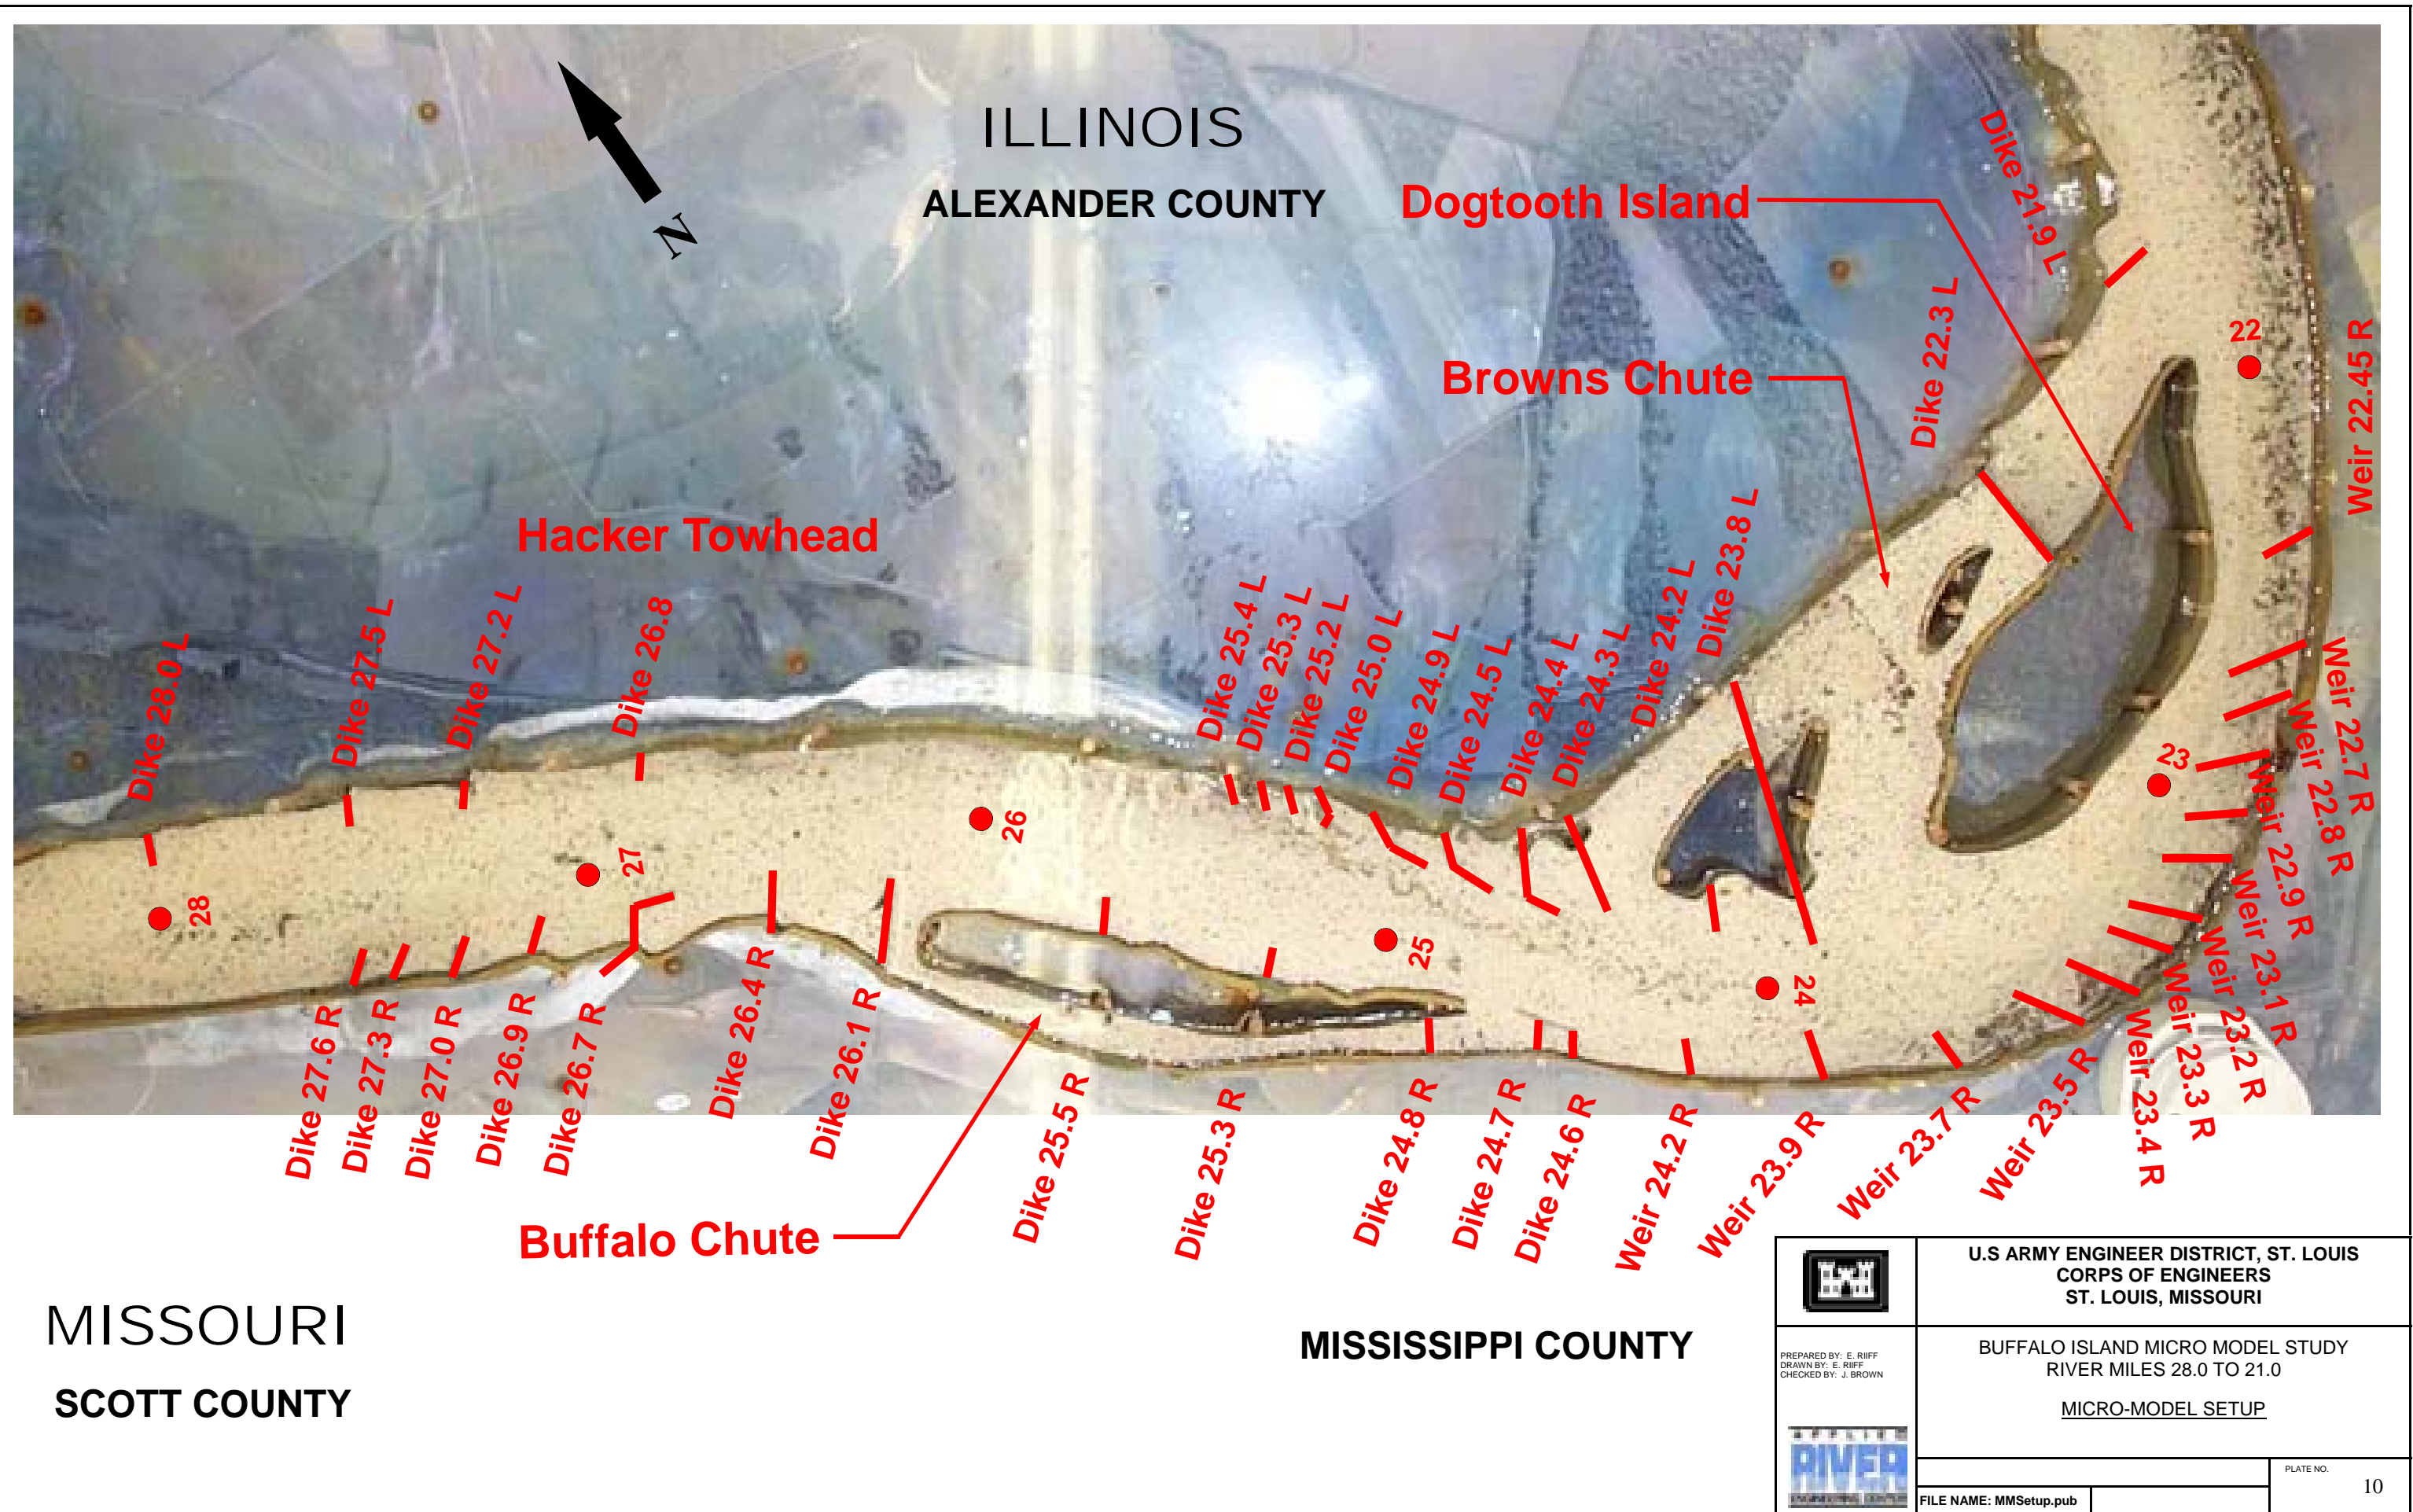
U.S. ARMY ENGINEER DISTRICT, ST. LOUIS CORPS OF ENGINEERS ST. LOUIS, MISSOURI	
	BUFFALO ISLAND MICRO MODEL STUDY RIVER MILES 28.0 TO 21.0 MICRO-MODEL SETUP	
	FILE NAME: MMSSetup.pub	PLATE NO. 10

In order to investigate the sediment transport issues and habitat development described previously, a physical hydraulic micro model was designed and constructed. Plate 10 is a photograph of the hydraulic micro model used in this study. The model employed a horizontal scale of 1 inch = 500 feet, or 1:6000, and a vertical scale of 1 inch = 50 feet, or 1:600, for a 10 to 1 distortion ratio of linear scales. This distortion supplied the necessary forces required for the simulation of sediment transport conditions similar to those of the prototype. The bed material was granular plastic urea, Type II, with a specific gravity of 1.40.

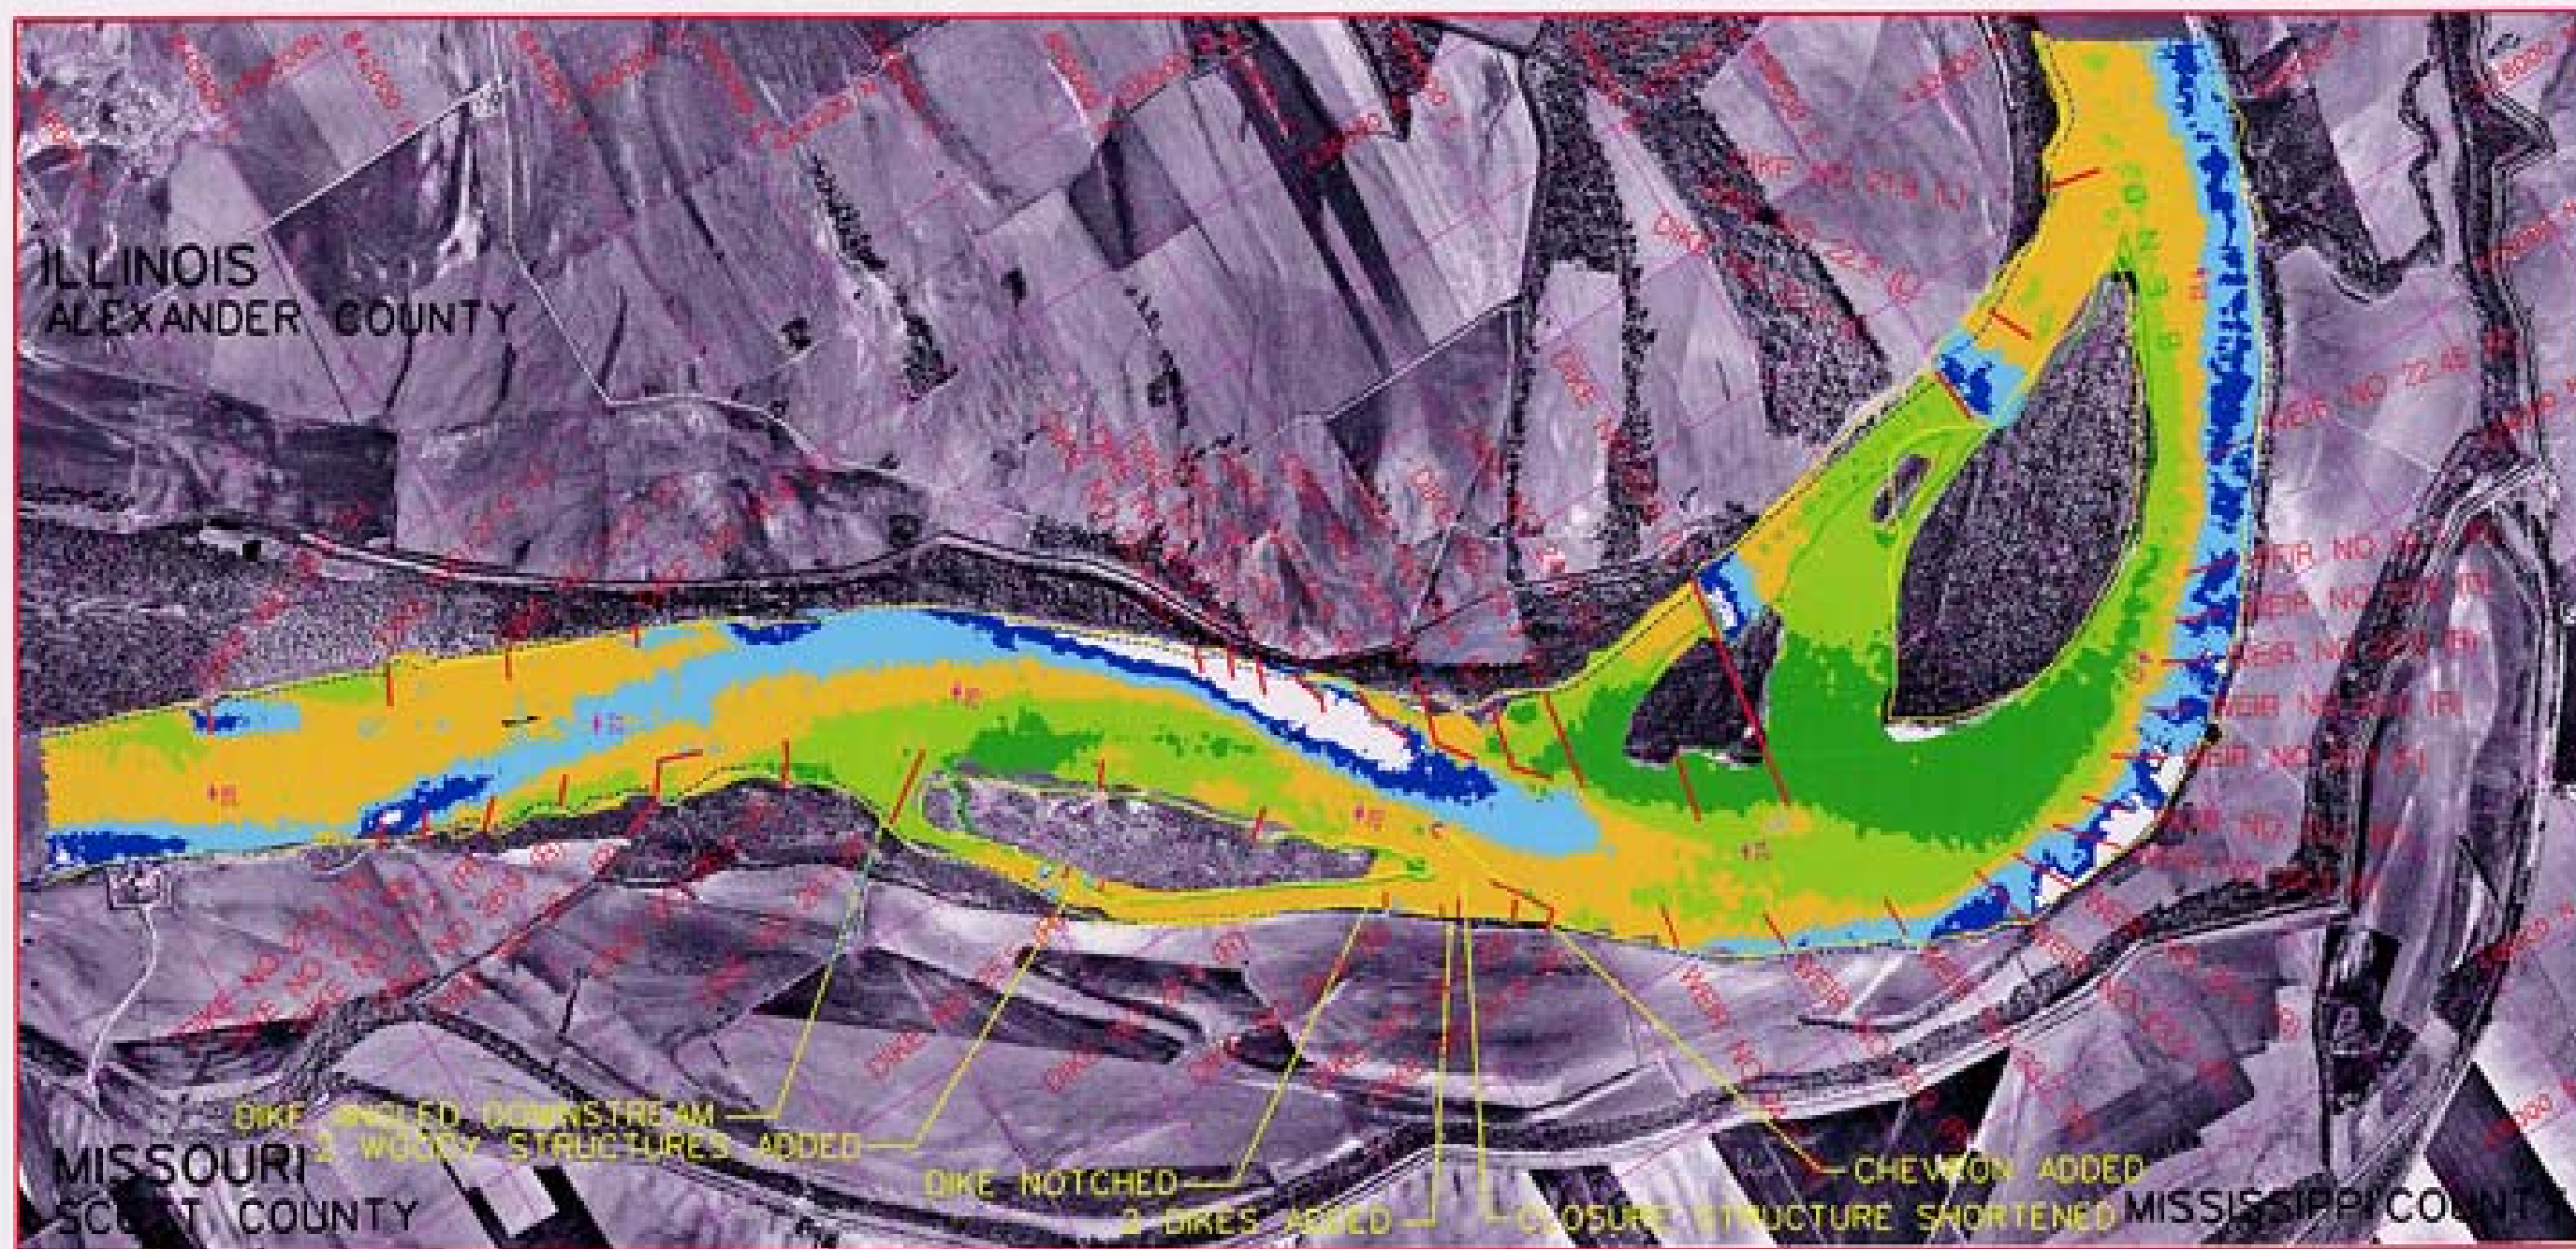
Plate 18 is a plan view map of the resultant bed configuration of Alternative 2. The test results indicated that this design was effective in creating additional depth and diversity in Buffalo Chute. Dike 26.1 R, angled downstream, increase deposition at the entrance of Buffalo Chute when compared to the base test. Further into Buffalo Chute, where there once was a depositional problem at Mile 25.6, increased depth was observed. This area of additional depth continued past the notched Dike 24.8 (R), the two dike structures added at Mile 24.75, and through Buffalo Chute to the lowered 250-foot section of closure structure located at the exit of the channel. The chevron added near the downstream end of the island showed small amounts of scour at the upstream end of the structure, with no other significant departure in bathymetry from the base condition.

- Alternative 2, with Dike 26.1 (R) angled downstream, did not significantly alter the flowrate into Buffalo Chute. Alternative 2 showed that additional depth in Buffalo Chute could be expected at and downstream of Mile 25.5 if implemented. Woody structures added in Buffalo Chute helped to alleviate the issue of shoaling present at Mile 25.5 by effectively reducing channel width in the area. The configuration of structures both modified in and added to the exit condition worked well to focus the majority of the flow in a continuous, nearly unobstructed path out of Buffalo Chute. The chevron added at Mile 24.8 increased flow past the exit of Buffalo Chute. The placement of the chevron effectively reduced the main channel width at Mile 24.8 to 1000 feet in this alternative. This restricted width could pose a risk to navigation in this stretch.
