Technical Report M29

**SEDIMENTATION STUDY OF THE
MIDDLE MISSISSIPPI RIVER AT
BUFFALO ISLAND
RIVER MILES 28.0 TO 22.0
HYDRAULIC MICRO MODEL INVESTIGATION**

U.S. ARMY CORPS OF ENGINEERS
ST. LOUIS DISTRICT
HYDROLOGIC AND HYDRAULICS BRANCH
APPLIED RIVER ENGINEERING CENTER
FOOT OF ARSENAL STREET
ST. LOUIS, MISSOURI 63118

Final Report – DECEMBER 2003

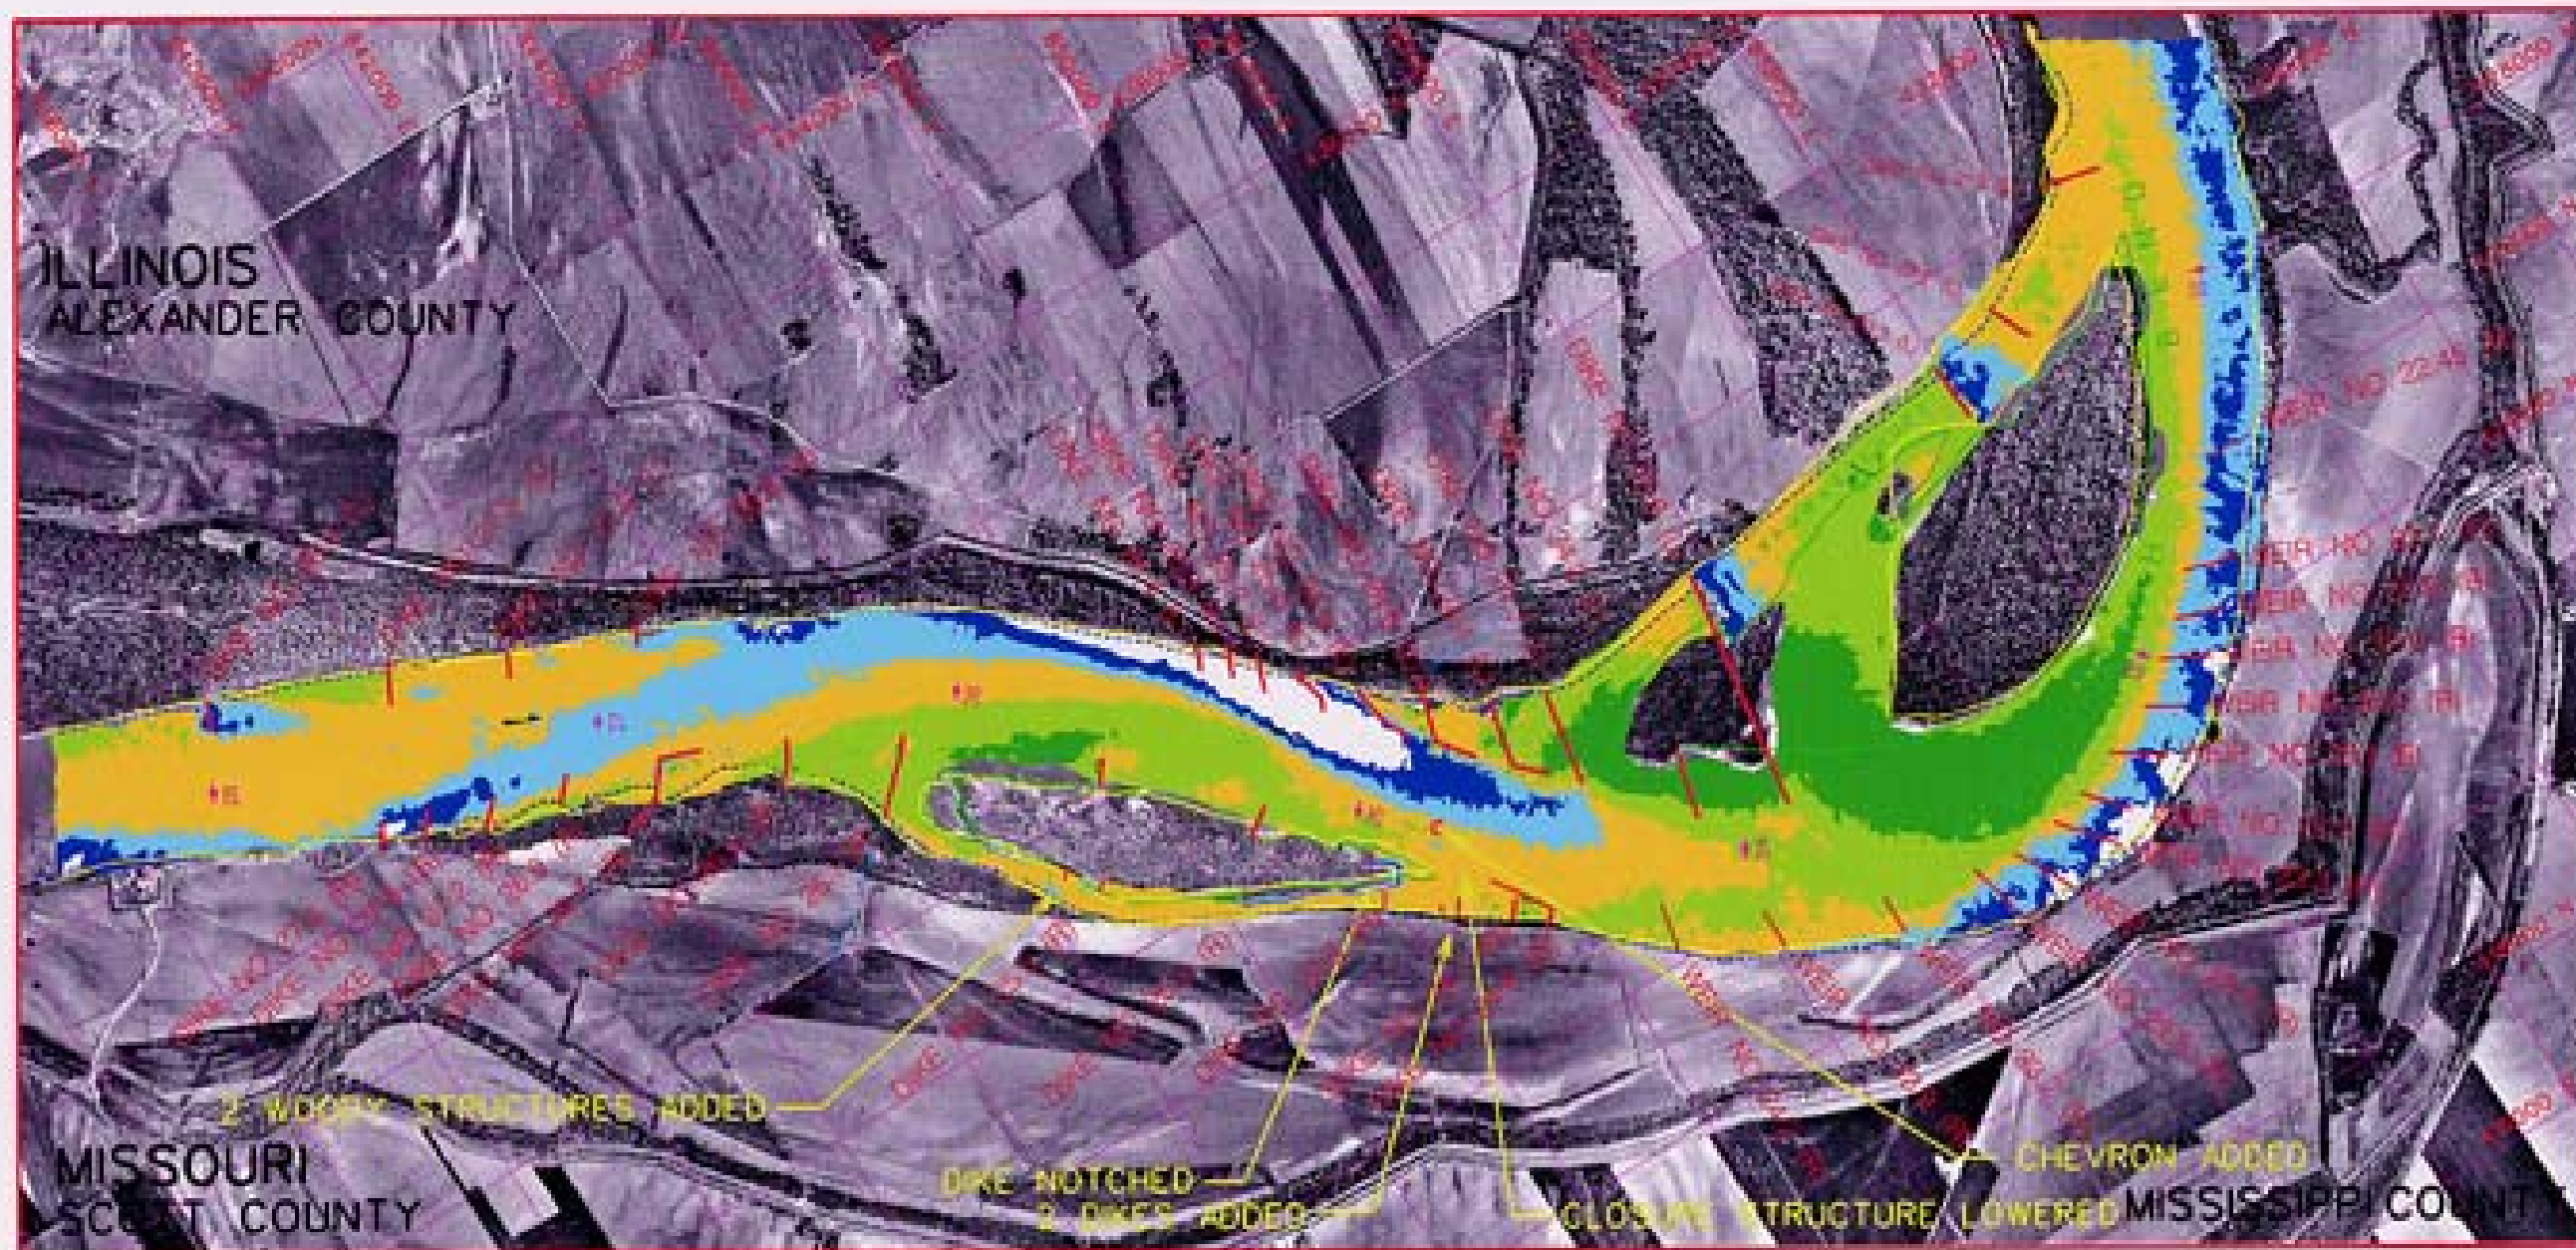
SHEET NO. 19 DRAWN FILE: BUFFALO ISLAND PLOT SCALE: 1"=100' PLOT DATE:

Plate 19 is a plan view map of the resultant bed configuration of Alternative 3. The test results indicated that the bathymetry at the entrance to Buffalo Chute was similar to that of the base test. The bathymetry downstream of the entrance condition, including those around the new chevron, was similar to what was observed in Alternatives 1 and 2.

Flow visualization showed entrance flow velocity and direction similar to the base condition. At Mile 25.5 the flow slows down significantly in front of the woody structures placed on the LDB of Buffalo Chute. The notch in Dike 24.8 (R) combined with the additional dikes added at Mile 25 performed as described in tests 1 and 2. The chevron added near the downstream end of the island at Mile 25.0 performed similar to tests 1 and 2.

- Alternative 3, with no alterations to Dike 26.1 (R), also did not significantly alter the flow rate into Buffalo Chute. Alternative 3 showed that additional depth in Buffalo Chute could be expected at and downstream of Mile 25.5 if implemented. Laser scans indicated that woody structures added in Buffalo Chute helped to alleviate the issue of shoaling present at Mile 25.5 of Buffalo Chute. Flow visualization in front of the woody structures indicated that possible shoaling problems could still be a problem. The configuration of structures both modified in and added to the exit condition worked well to focus the majority of the flow in a continuous, nearly unobstructed path out of Buffalo Chute. The chevron added at Mile 24.8 increased flow past the exit of Buffalo Chute. The placement of the chevron effectively reduced the main channel width at Mile 24.8 to 1000 feet in this alternative. This restricted width could pose a risk to navigation in this stretch.

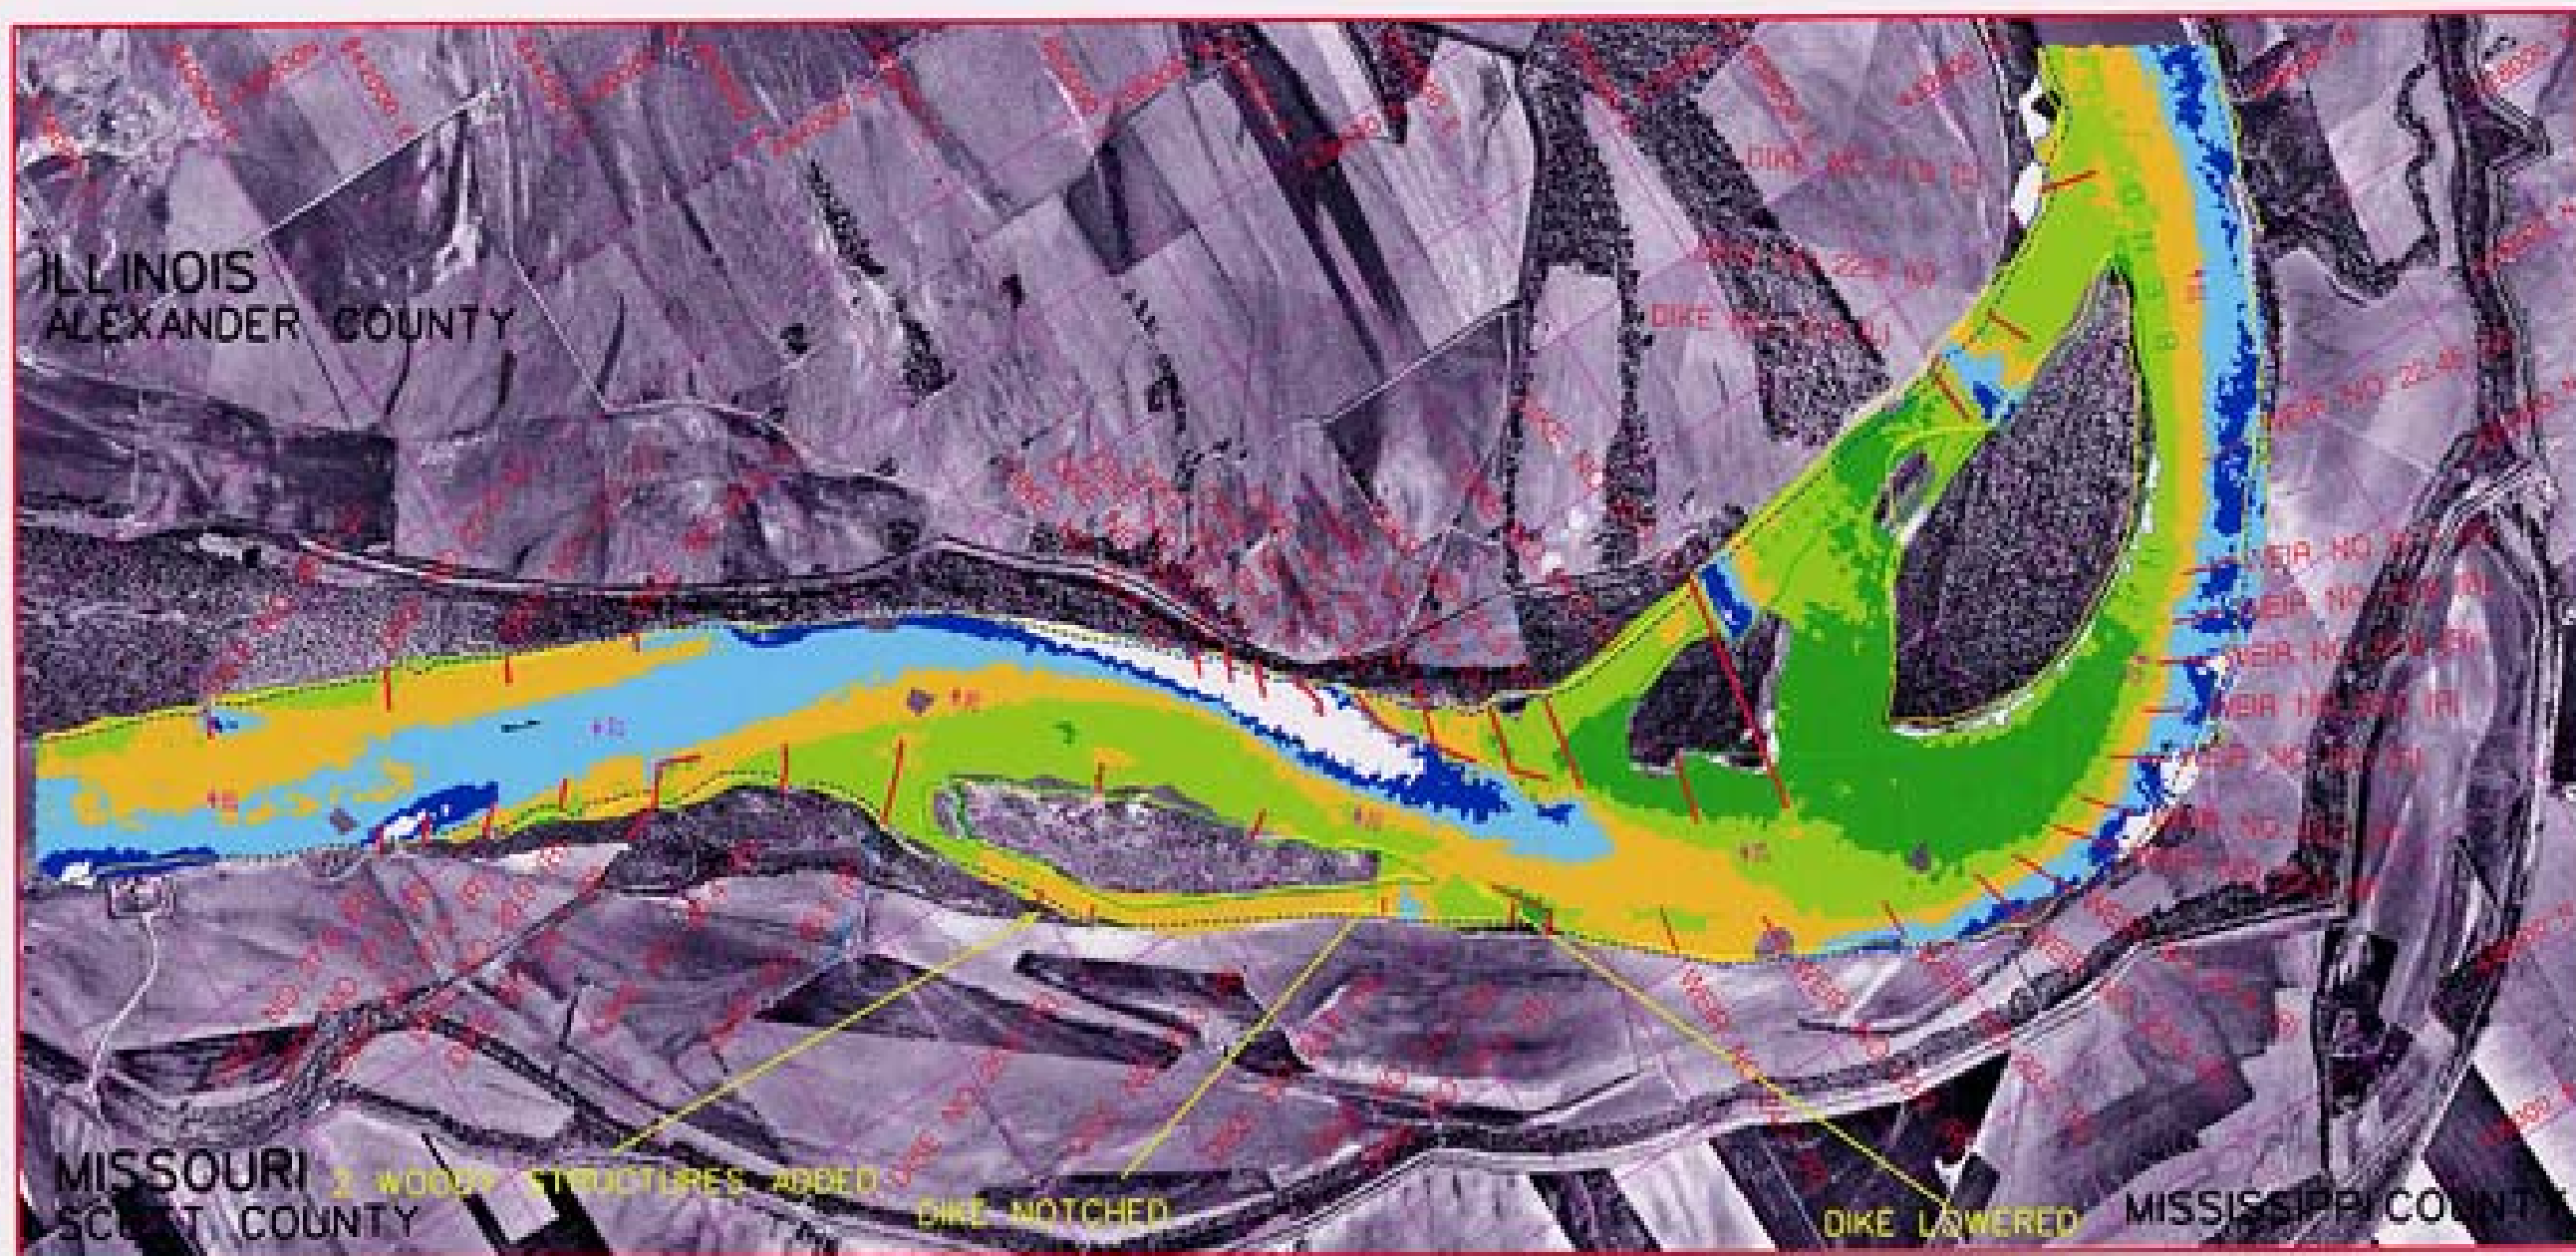
U.S. ARMY ENGINEER DISTRICT, ST. LOUIS CORPS OF ENGINEERS ST. LOUIS, MISSOURI
PREPARED BY: J. BROWN DRAWN BY: J. BROWN CHECKED BY: K. BROWN DATE: 	BUFFALO ISLAND MICRO MODEL, ST. LOUIS RIVER MILES 28.0 TO 31.0 ALTERNATIVE 3 DESIGN FILE: BUFFALO.DGN PLOT SCALE: 1"=100' PLOT DATE: PLATE NO. 22

Plate 22 is a plan view map of the resultant bed configuration of Alternative 6. Additional depth downstream of Mile 25.6 was observed in this alternative when compared to the base test. Other than the increased depth in Buffalo Chute, the model bathymetry was observed to be similar to that of the base test.

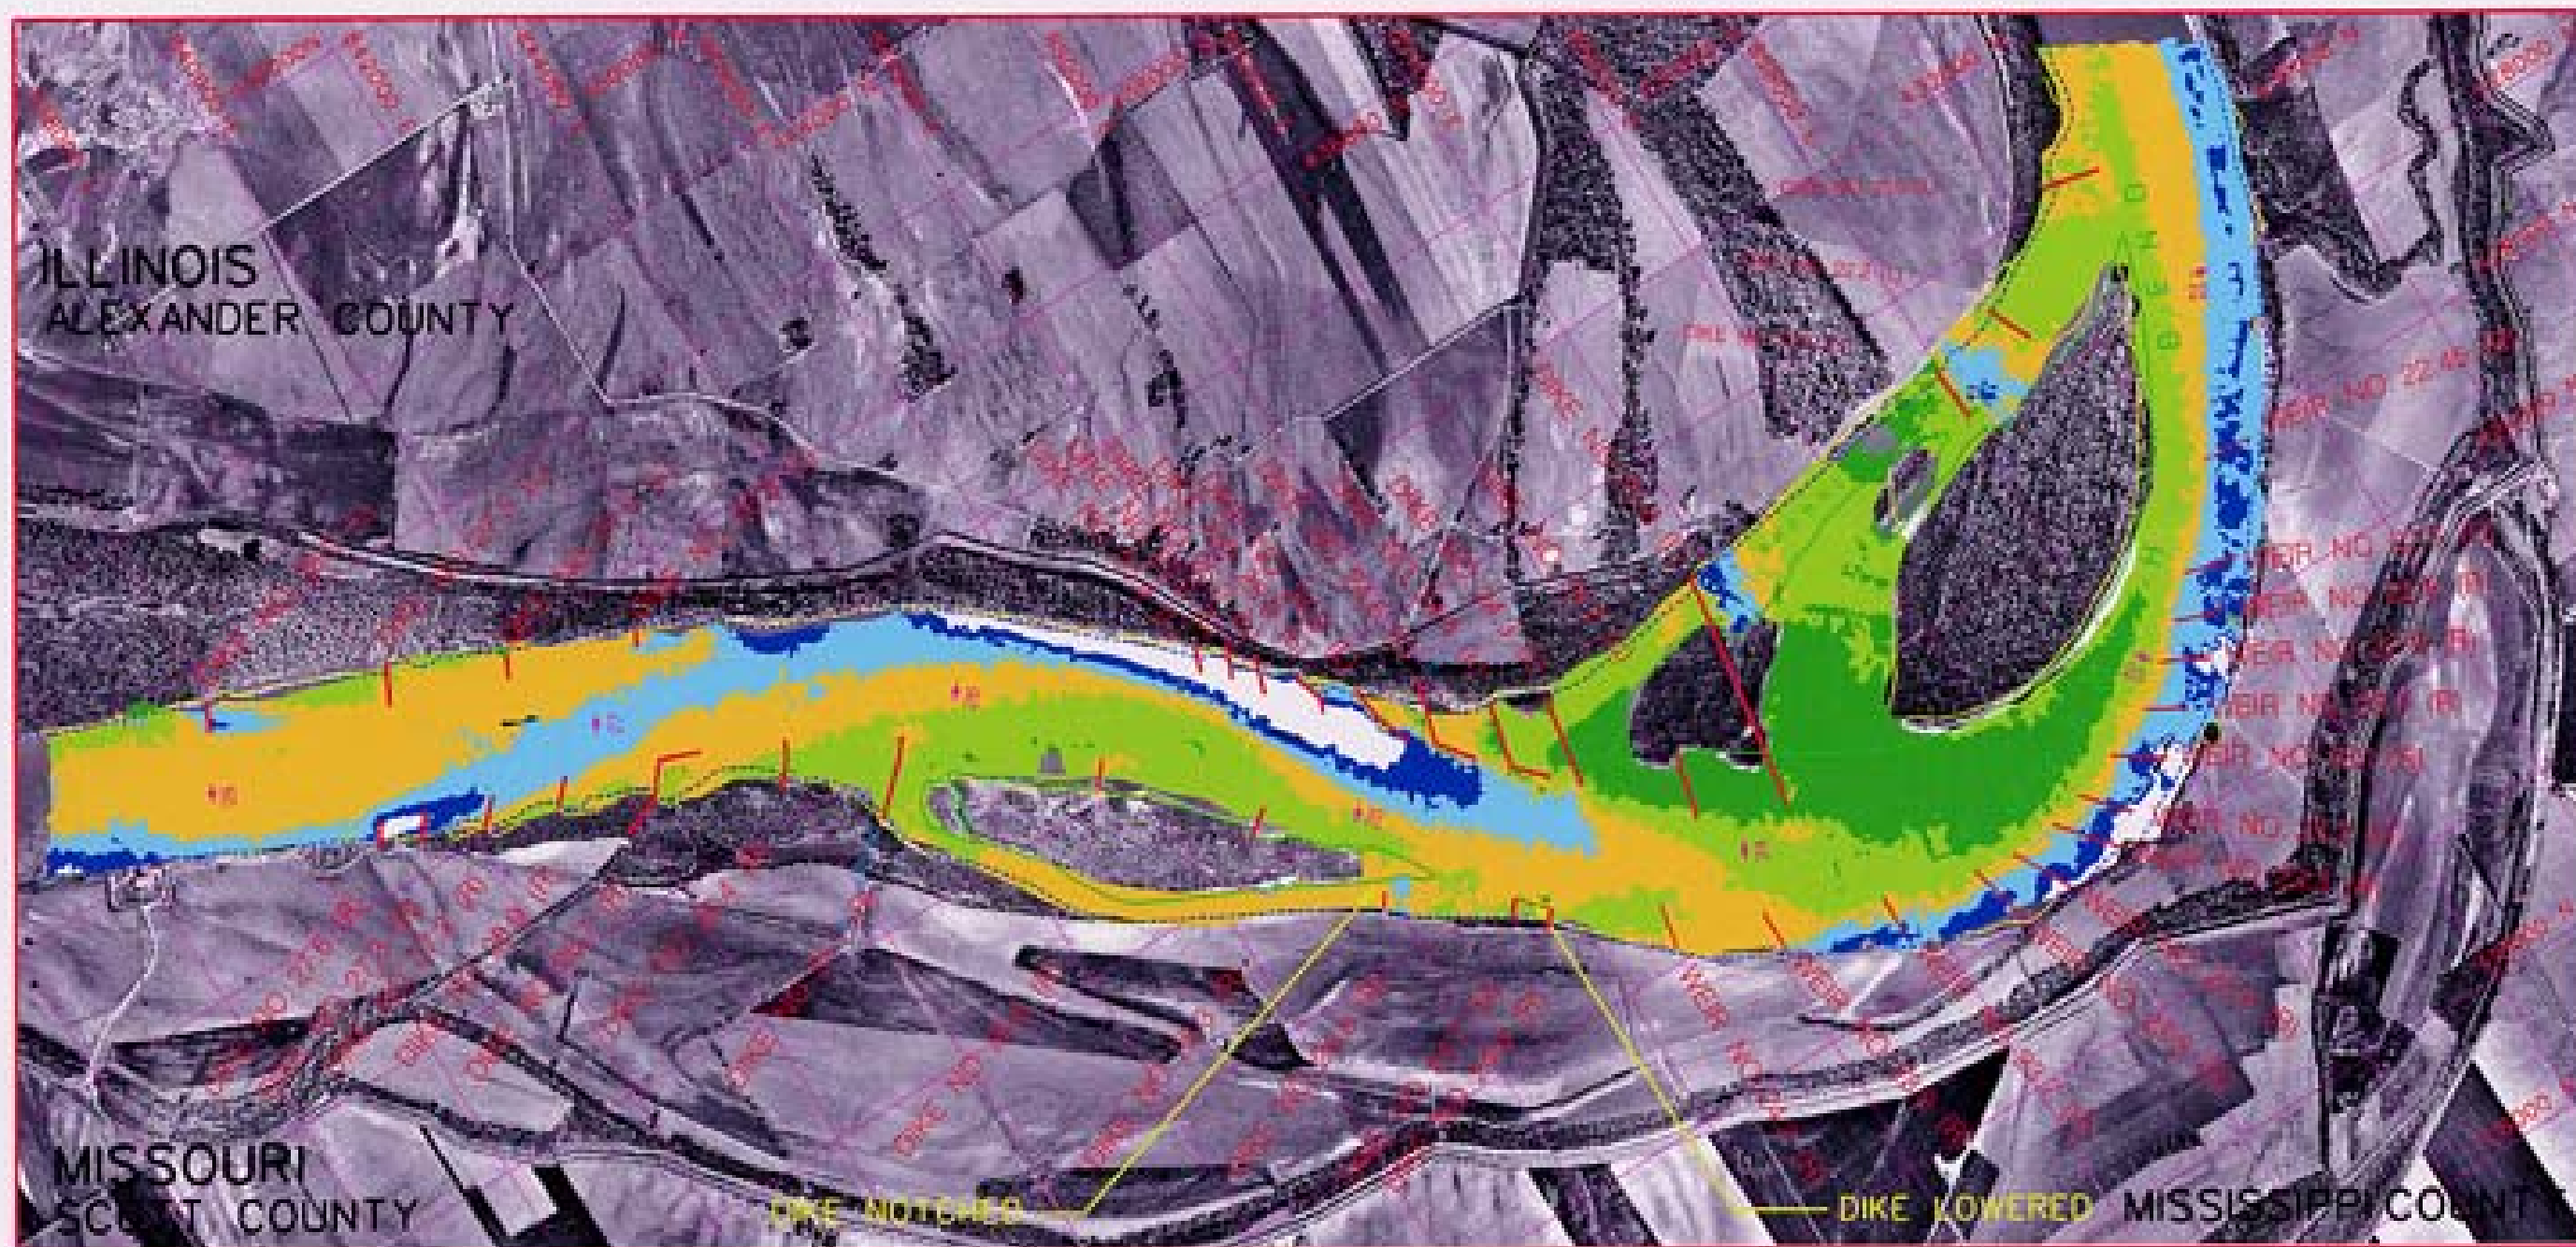
DESIGN FILE: BUFFALO ISLAND PLOT SCALE: 2400' (1"=2400') PLATE NO. 24

Plate 24 is a plan view map of the resultant bed configuration of Alternative 8. The bathymetry upstream and downstream of Buffalo Chute and in the main channel adjacent to Buffalo Island was similar to the base test. The bathymetry of Buffalo Chute was similar to the bathymetry found in Alternatives 1, 2, 3, and 6.

Flow Visualization for this alternative showed similar results to the base condition upstream, downstream, adjacent, into, and through Buffalo Chute. The exit of Buffalo Chute showed flow exiting Buffalo Chute unobstructed before encountering the remaining structures at Mile 24.65 and taking an abrupt turn to exit into the main channel.

- Alternative 8 showed some similarity to Alternative 7, with the only difference being a wider exit condition resulting in decreased exit velocities. Even with the decreased exit velocities, no additional deposition was observed. No other changes were made for alternative 8.
