Summary Report

Lock and Dam 24 Physical Model, Upstream Scour

By: Timothy J. Lauth
Hydraulic Design Section
US Army Corps of Engineers St. Louis District
1222 Spruce St.
St. Louis, MO 63103-2833

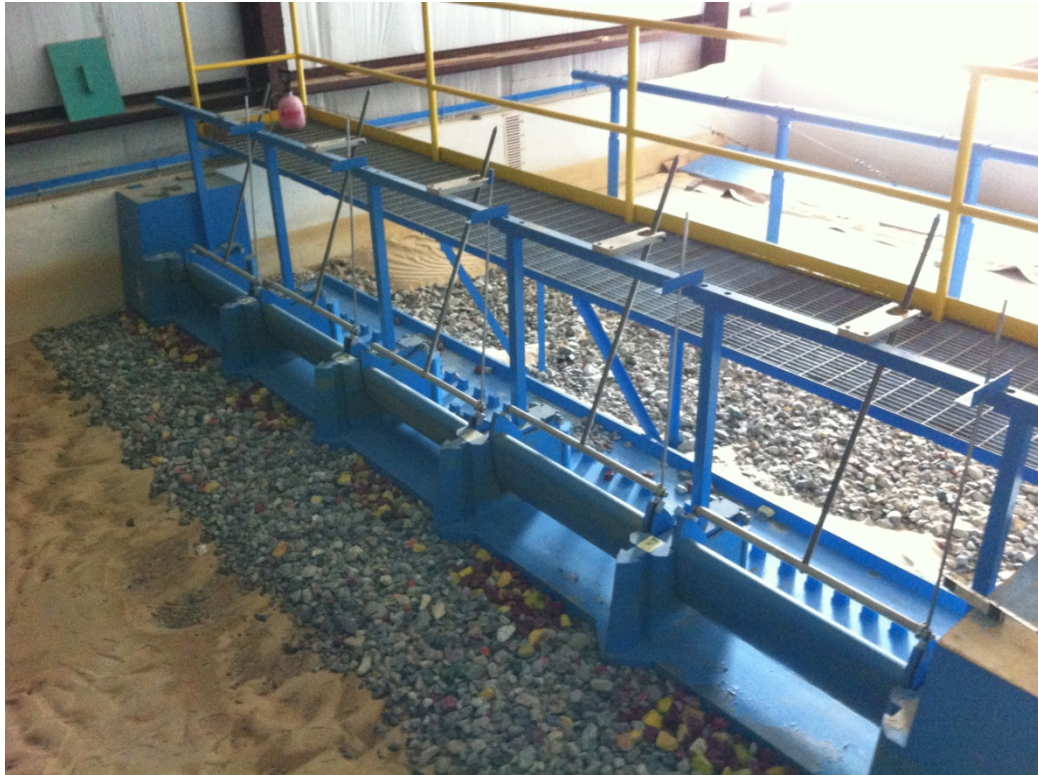
Figure 3 - The model gate structure and walkway viewed from upstream

The Lock and Dam 24 physical model was built at the Engineer Research and Development Center (ERDC) Coastal and Hydraulics Laboratory in Vicksburg, MS. A 1 ft to 25 ft scale model of five tainter gates was constructed inside a 69 ft long, 21.1 ft wide flume. The five tainter gates were used instead of the full upriver dam face (**Figure 3**) due to size and cost limitations and to better isolate the flow occurring in front of individual piers.

The upriver sand bed section of the model sloped up to a bench in front of the gate structure to better replicate the upstream approach geometry. As in the prototype, an armor layer of stone bed protection rests immediately in front of the upstream section of gate structure. This stone has been sized to replicate the in-situ stone at the prototype, for both the original stone placement and the 1977-78 repairs. The prototype stone gradations are presented in **Appendix B**. Filter cloth was used underneath the bed stone armor to provide a better simulation of bedding material and to reducing piping.

A walkway was built over the gates to provide better access to the gates' worm-drive controls and a second, moveable walkway was used to assist with taking measurements and recording video. The gates were outfitted with scaled rods indicating the equivalent feet opening of the gate setting. Markings were placed on the upstream face of the model to aid with the placement of stone bed armor and with setting the gate openings for tests involving the use of underwater video.

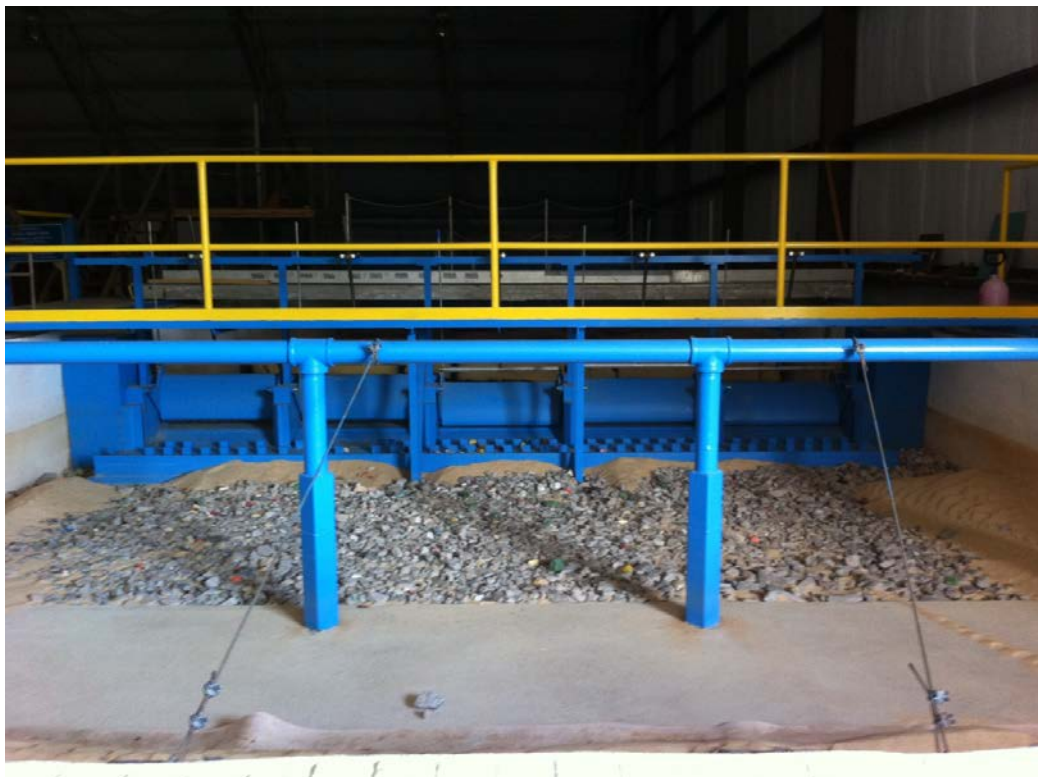
Figure 4 - The model gate structure and walkway viewed from downstream

Stone cobbles were used below the spillway to dissipate the velocity of the flow through the gates (**Figure 4**). The tailwater and upriver pool elevations were measured with rulers set to scale in both portions of the model. The flow into the flume is supplied by 12-inch and 20-inch diameter pipes from a constant head tank fed by multiple pumps. The maximum flow possible into the flume is 40 cfs. A gate was used at the end of the flume to maintain the tailwater pool elevation.

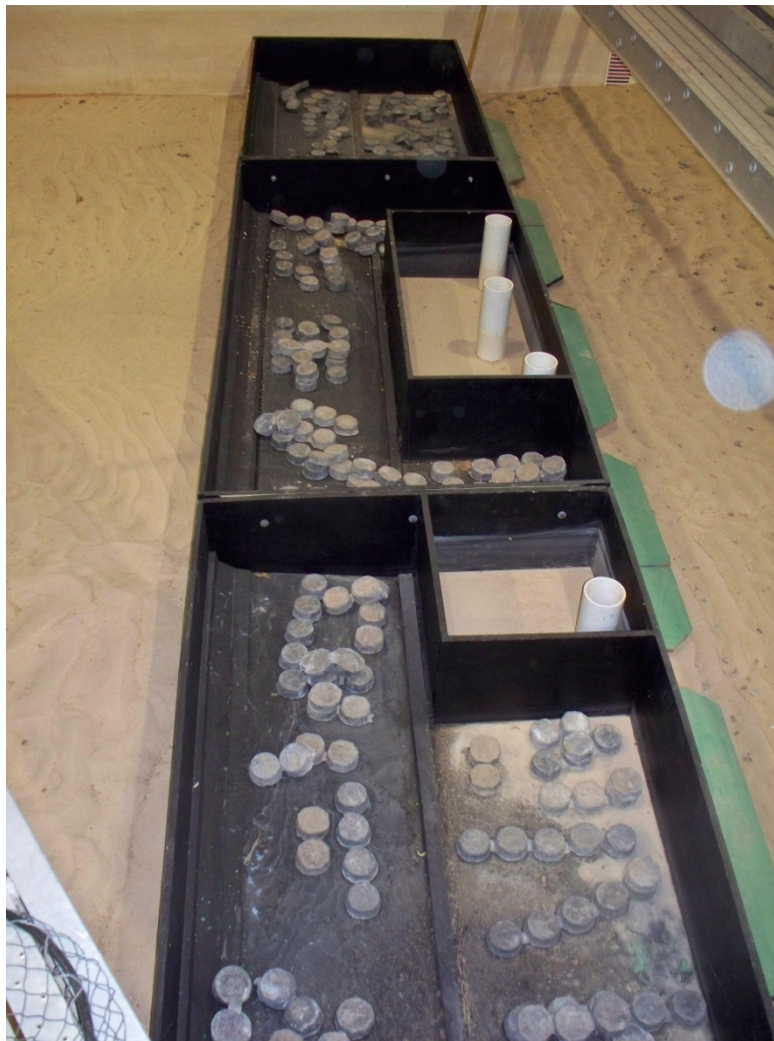
Figure 5 - Wooden raft used to simulate upstream ice

Ice development was simulated using a 21ft x 4ft x 1.2 ft wooden raft built in three sections to facilitate installation and removal (**Figure 5**). The bottom of a raft was sloped and lined with chicken wire to simulate the natural friction of the ice. The draft was controlled by adding or removing lead weights. Initially, walled cutouts were made in three of the sections to allow use of an underwater camera, lighting, and a 2D acoustic Doppler velocimeter (ADV) used to take velocity measurements underneath the ice raft. After later tests suggested that the panels were exaggerating the scour, the cutouts were covered and PVC shafts were installed in the raft to allow for the continued use of the ADV.

One shortcoming of the physical model testing was the simulation of ice. The ice raft, as constructed, could only re-create the ice in complete cohesion. Because the raft could not simulate any ice break-up, it led to the possibility of unnatural situations like the ice potentially controlling the depth in the upper pool.

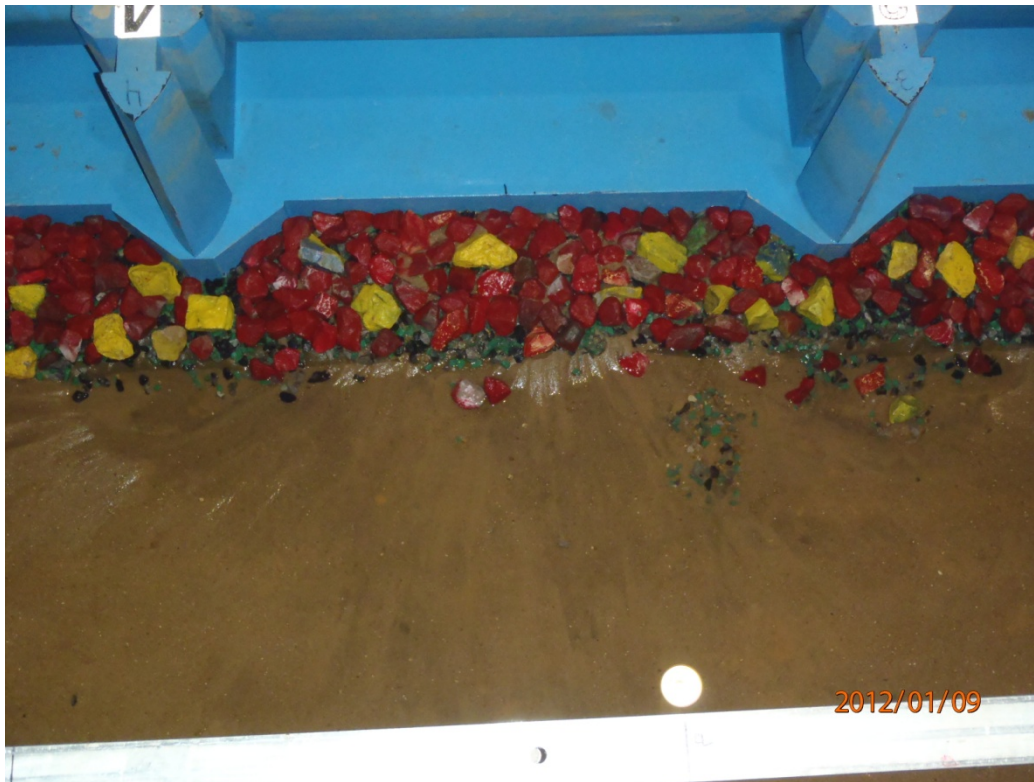
Figure 7 - Variable 3 center gates, 10 ft ice raft draft

The testing proceeded with the modeling of the build-up of ice using the ice raft as done in the Mel Price Scour modeling. Testing was conducted with the ice raft drafting 10 ft and gates 1, 2, and 3 open at multiple heights starting at 5 ft and increasing in 2 ft increments. The filter cloth was buried 6 inches below the sand elevation. This test format, with a slightly increased draft, successfully replicated the scour occurring at Mel Price Lock and Dam during the Mel Price model testing. These tests for the Lock and Dam 24 model led to little scour, and the scour that did occur was not indicative of the scour adjacent to the piers at the prototype (**Figure 7**).

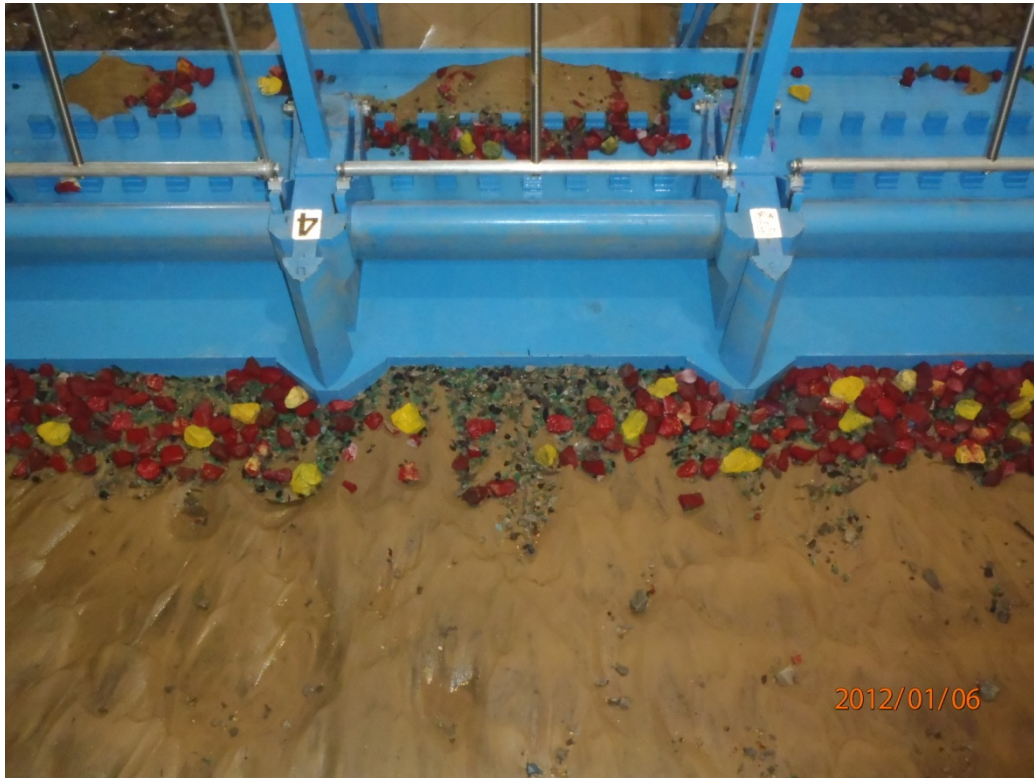
Figure 8 - Variable 3 center gates, 15 ft ice raft draft

The tests were repeated with the draft of the ice raft increased to 15 ft. Additional scour occurred, but the scour was once again not representative of the scour occurring in the prototype, where the scour was focused in front of the gates instead of the piers. This test with three gates open scoured away nearly all of the protection in front of Gate 3 with the little rock remaining in front of the adjacent piers (**Figure 8**).

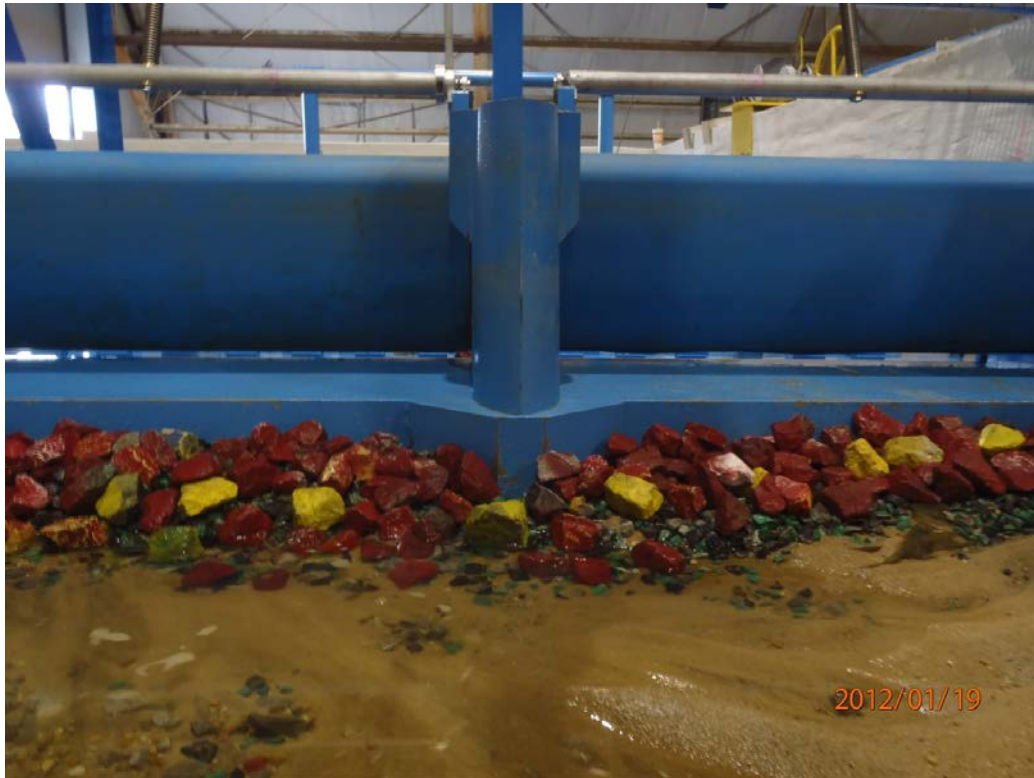
Figure 10 - 7 ft center gates, 20 ft ice raft draft

Given the lack of success to this point in the testing, the modeling team decided to switch from varying the gate openings during tests to setting a constant gate condition and running at that condition for a longer period of time. A gate opening of 7 ft was selected based on discussions with lock and dam staff about ice passage operations (**Figure 10**). Ice drafts of 5 ft, 10 ft, 15ft, and 20 ft were tested at time intervals of 5 hours and overnight due to lab operational hours.

These tests did lead to representative scour along the leading edge of the scour protection and immediately adjacent to the pier. Comparing the results, a greater ice draft led to increased scour both upstream of the stone bed protection and at the dam piers.

Representative scour began occurring with the transition from variable gate openings to longer tests held at a constant gate opening. This scour increased or decreased based on the draft, prompting the 9 ft center gate opening and 15 ft ice raft draft to be set for following tests attempting to discover a solution.

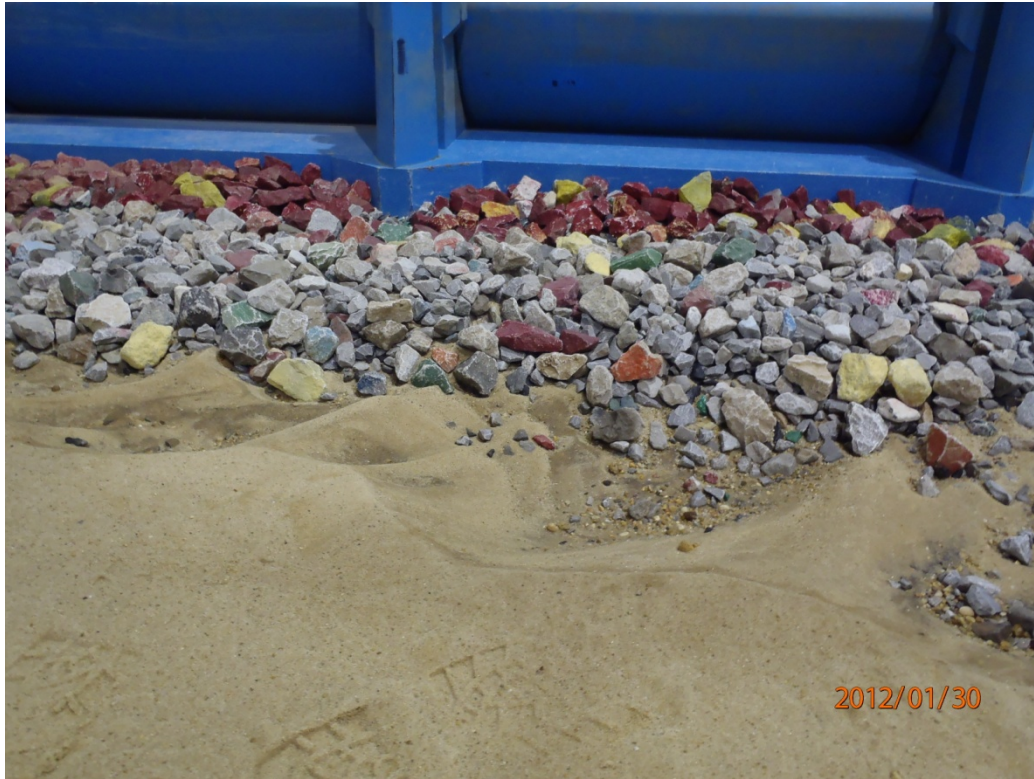
Figure 11 - 7 ft center gates, 20 ft ice raft draft, 30 ft stone protection extension

Once the prototype conditions were successfully re-created, extending the upstream stone bed protection was tested with the 5, 10, 15 and 20 foot ice drafts. The gate openings were increased from 7ft to 9ft to reflect a worse case of ice passage. While the tests resulted in bed scour upstream of the stone protection, the leading edge of the stone remained intact at each ice draft. The pier scour, however, was present at all draft conditions (**Figure 11**).

The first testing avenue explored to alleviate or eliminate upstream scour was the extension upstream of the stone bed protection. The extension of the stone bed protection did lessen the scour at the upstream edge of the protection, but did not reduce the occurrence of upstream scour.

The second recommendation of this study is to extend the stone bed protection an additional 30 ft upstream of the Lock and Dam. The original design length for the stone bed protection was 21 ft; at this length, the upstream edge of protection nearly scoured enough to connect to the pier scour. Model testing supports that a longer length of stone bed protection both lessens the unraveling the leading edge of the upstream protection and supports lowered scour at the piers. This extension was found to be critical to the successful implementation of the side gate openings as a solution to scour reduction.

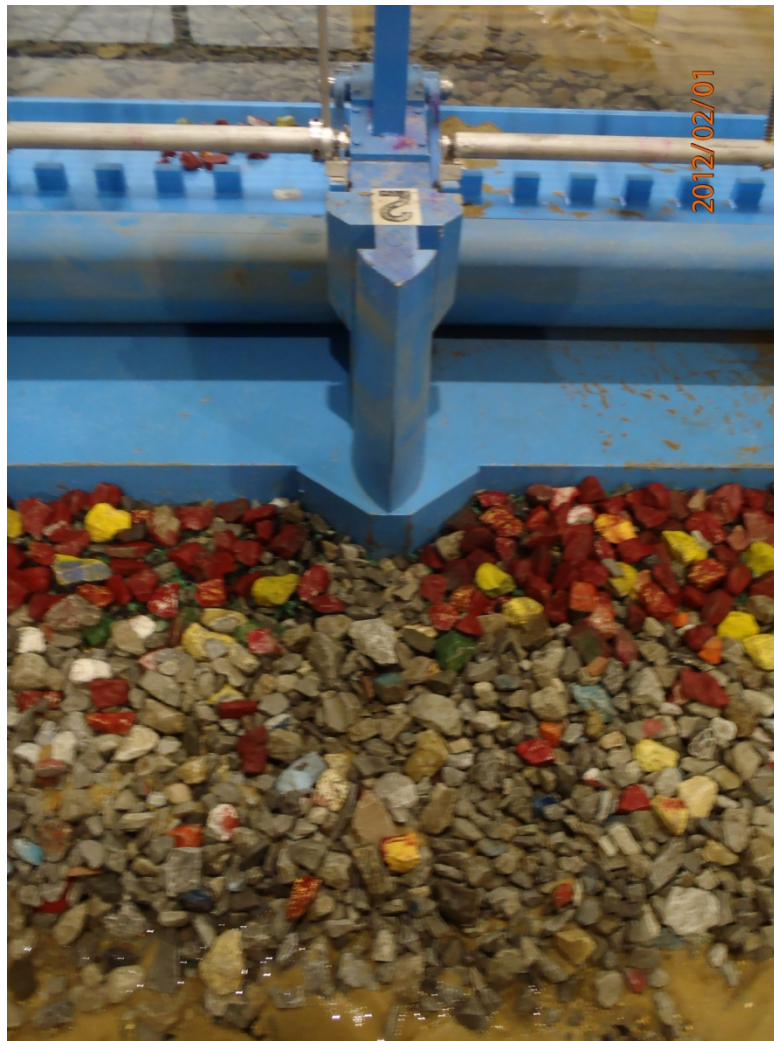
Figure 12 - 9 ft center gates, modified “A” stone over modified “C” stone

The pier scour was tested using different stone placements in the immediate vicinity of the piers. The first placement was based on the Lock and Dam 25 repair. This placement tested two conditions; 1) a pier location where 8 ft of scour had occurred, allowing for placement of both the “A” and “C” stone, and 2) a pier location where 4 ft of scour had occurred, allowing for placement of only “A” stone. For all tests with two placement conditions, a successful possible solution was determined to be a solution where a maximum of 4 ft of scour occurred at the pier on either placement condition. With the ice draft set to 15 ft, the maximum scour depth observed in the first condition was approximately 6 ft (**Figure 12**); the maximum observed in the second condition was approximately 8 ft. Both conditions were more than enough to potentially reach the pier base.

The second attempt to reach a solution was to try different stone placements along with an extension of the stone bed protection. Two different stone placements were attempted: the first based on the Lock and Dam 25 repair, the second using a top layer of derrick stone. Both placements experienced at least a maximum of 6 ft a scour, which would reach the pier base elevation in the prototype.

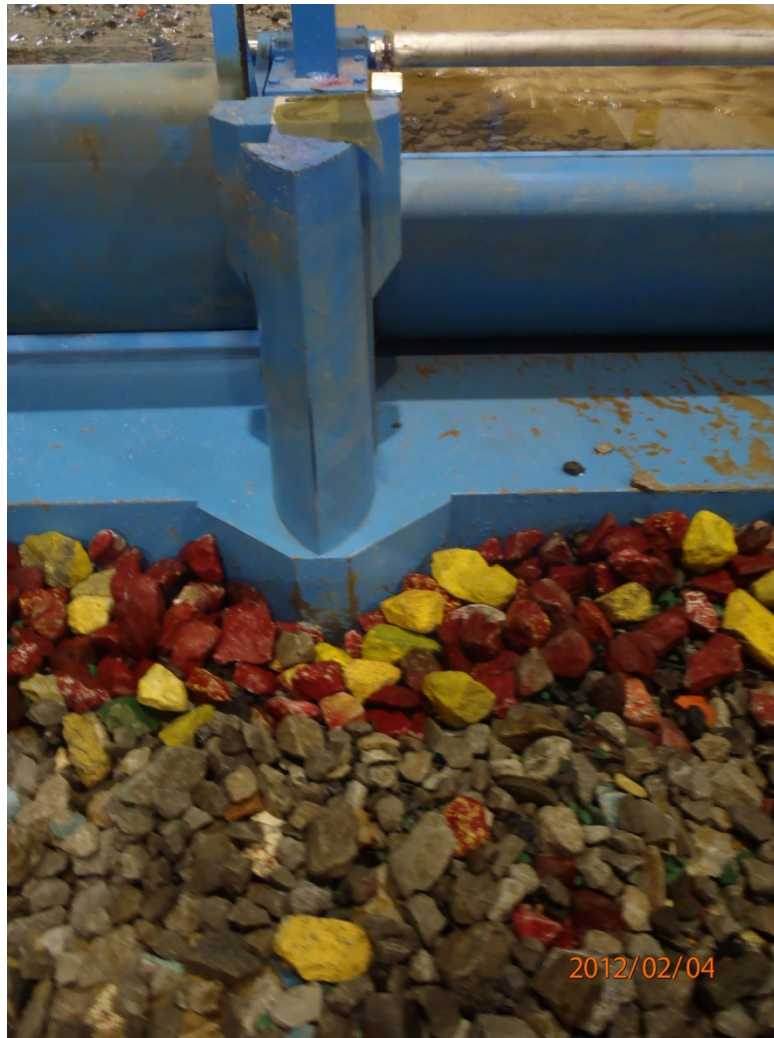
Figure 13 – 9 ft center gates, derrick stone over modified “C” stone

The second placement tested was based on using derrick stone as the top layer of stone protection. Two conditions were again tested: 1) a pier location where 8 ft of scour had occurred, allowing for placement of both the derrick stone and modified “C” stone, and 2) a pier location where 4 ft of scour had occurred, allowing for placement of only derrick stone. The tests for these two conditions both yielded a maximum scour depth of 5-6 ft at the piers (**Figure 13**).

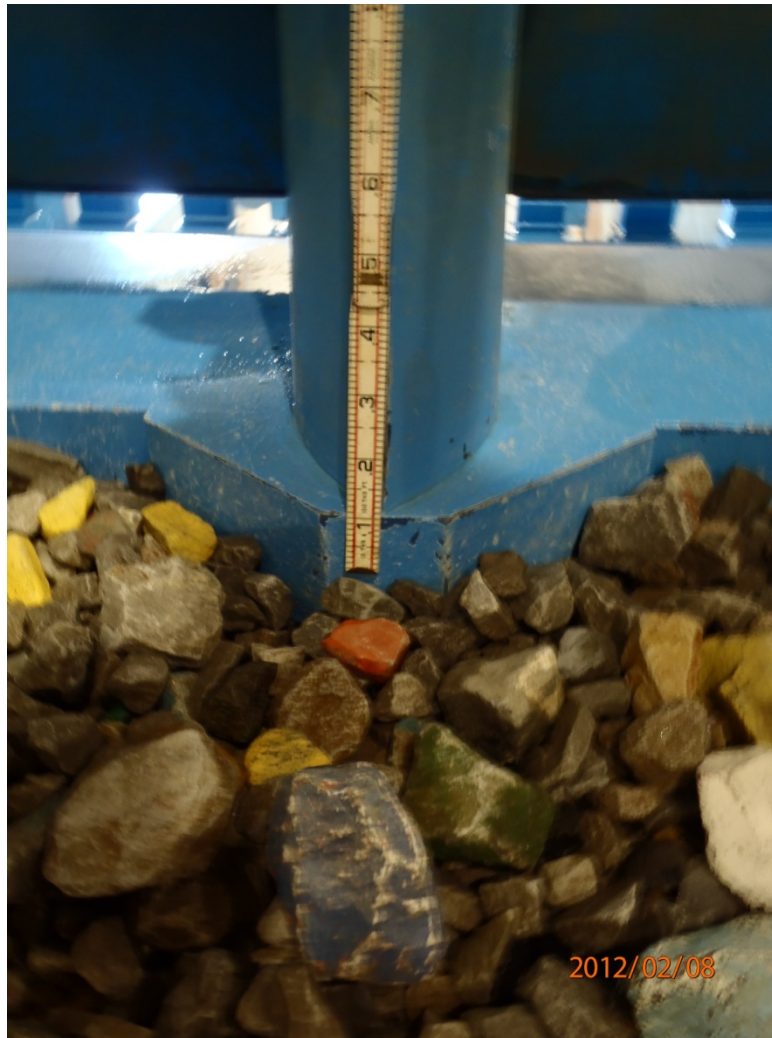
Figure 14 - 9 ft center gates, 5 ft side gates, modified "A" stone over modified "C" stone

After the stone placements were tested, the model was run with the gates adjacent to the main ice passage gates open. For these tests, the three center gates of the model were held open 9 ft with the two outer gates opened 1, 3 and 5 feet. These openings were tested for two stone placements: 1) an 8 ft scour hole filled with the L&D 25 repair and 2) a 4 ft scour hole filled with modified "A" stone. The side gates open 1ft produced a maximum of 9 ft scour in the immediate vicinity of the pier and the 3 ft open tests produced a maximum of 8 ft scour. The 5 ft side gate open tests, however, produced a maximum scour depth of 3-4 ft at one gate with the other gates experiencing less than 3 ft of scour (**Figure 14**).

The third path to a solution investigated was opening the gates adjacent to the main ice passage gates. The side gates were opened 1 ft, 3 ft, and then 5 ft. The 5 ft side gate opening was found to be successful at reducing scour to a level where the pier bases would not be exposed. Once the success of opening the side gates to alleviate scour was validated, testing examined the need for the length extension of the stone bed protection. The use of a shorter extension (15 ft) and the complete removal of the extension were both tested; the 30 ft extension was found to perform better than both. The use of only modified “A” stone without modified “C” stone underneath was also tested; the test without the smaller stone underneath experienced far more scour.

The first recommendation of this study is to open the gates adjacent to the main ice passage gates at least 5 ft during ice passage situations. Opening the adjacent gates limits the formation of vortices around the piers as the river flows through the open gates and lowers the near-bed velocity which will reduce the transport of sands and protection stone. This was found to reduce scour to a maximum of 3-4 ft in the model, a depth above the pier base elevation not threatening the sheet pile cutoff wall.

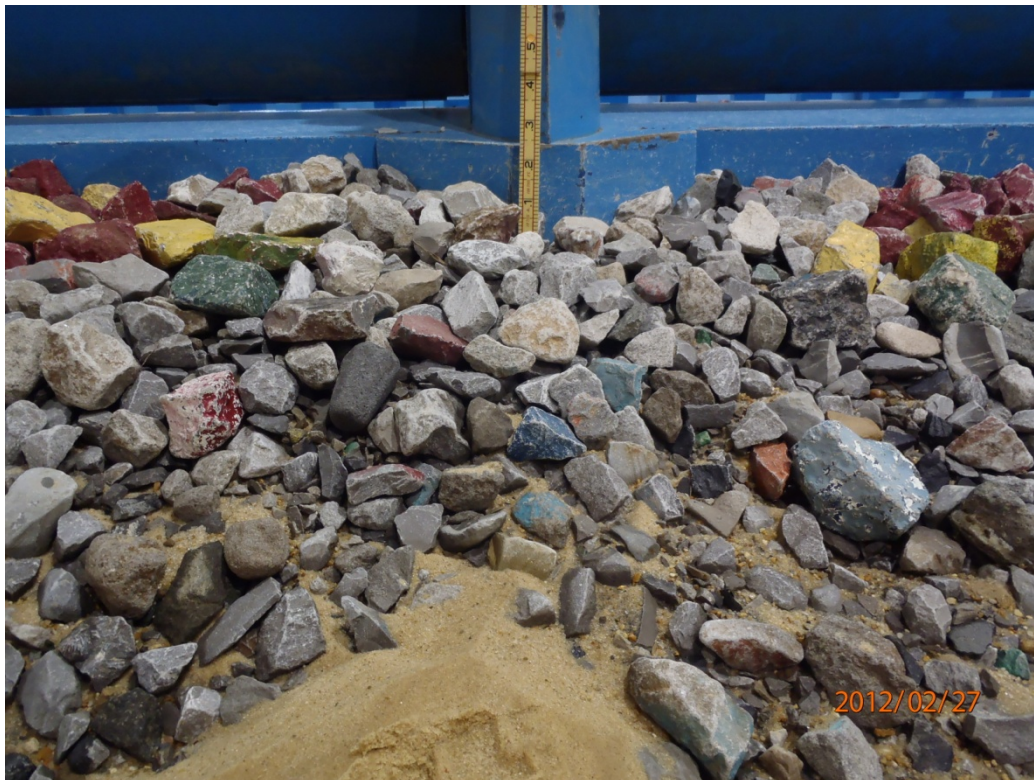
Figure 15 - 9 ft center gates, 5 ft side gates, 15 ft protection extension

With the side gate openings identified as a possible means of alleviating pier scour, tests were performed with the side gates open to determine if additional upstream stone bed protection was needed. The design length of the stone bed protection tested with the side gates open 5 ft produced pier scour with depths between 6 and 9 feet deep. This pier scour was also accompanied by scour that unraveled large portions of the upstream edge of the stone bed protection in front of Gate 3.

A test with a 15 ft extension of the stone bed protection produced 5 ft of pier scour and, although the upstream protection edge again unraveled, the stone protection in front of the gates was more stable than in previous tests (**Figure 15**). A re-testing of the 30 ft extension produced a scour depth of approximately 3-4 ft with little unraveling of the upstream edge of protection.
