BANK EROSION AND HISTORICAL MORPHOLOGY STUDY OF THE MIDDLE KASKASKIA RIVER

**Study Conducted
Jun 2001-Dec 2002**

<p align="center">U.S. ARMY ENGINEER DISTRICT, ST. LOUIS CORPS OF ENGINEERS ST. LOUIS, MISSOURI</p>
<p>PREPARED BY: E. Brauer DRAWN BY: E. Brauer CHECKED BY: R. Daverrey</p>	<p align="center">KASKASKIA RIVER BANK EROSION STUDY STUDY REACH MAP</p>
	<p align="center">17600 14880 10560 7040 3520 0 8960 17600</p> <p align="right">PLATE NO.</p>

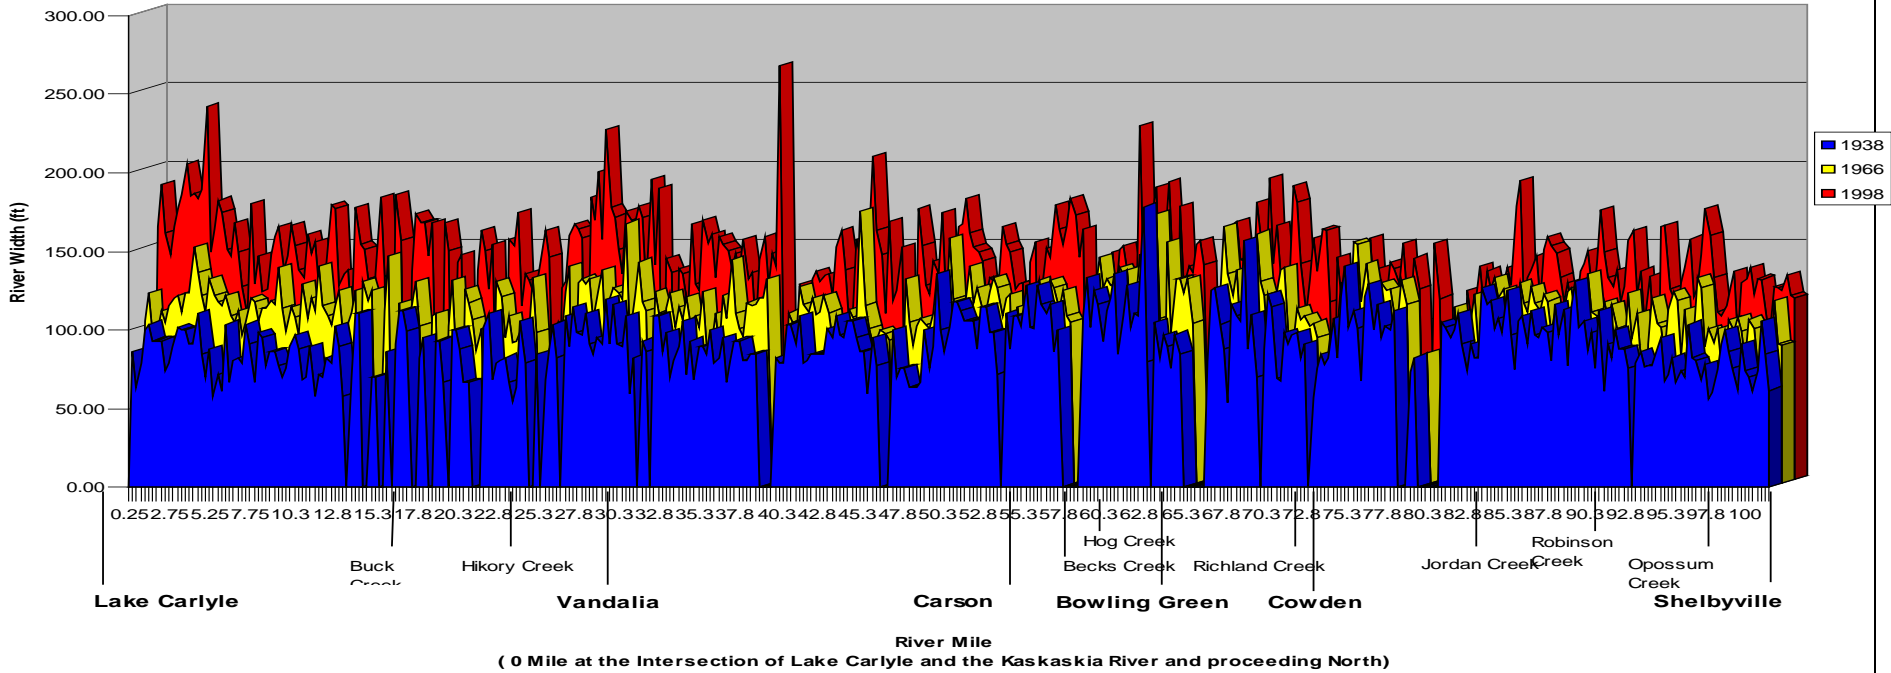
**Kaskaskia Erosion Study:
River Mile vs. River Width**

The Widening Rate has been same from 1938 to 1998, about 1 foot per year

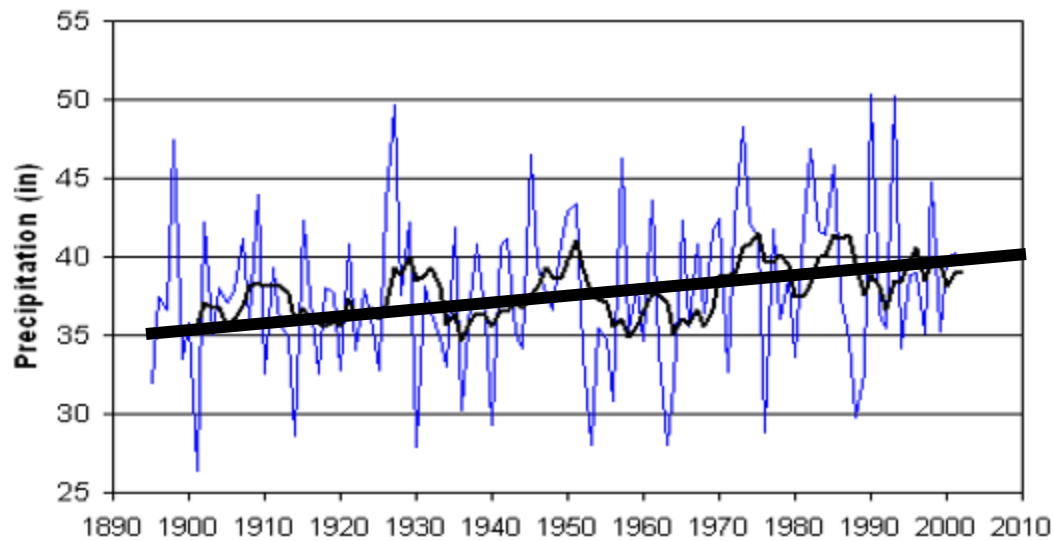
Rainfall Trends For the State of Illinois

Illinois - Precipitation

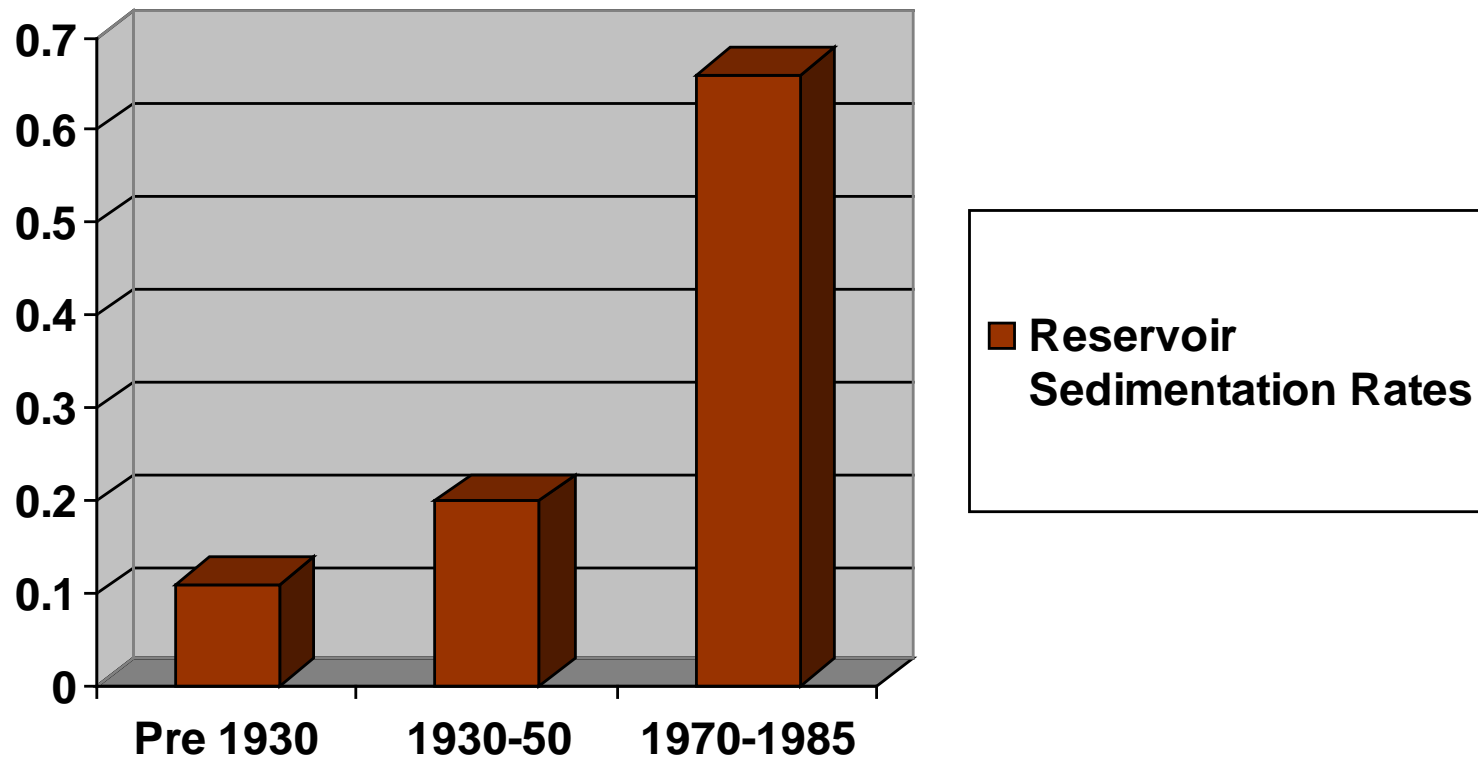
United States Reservoir Sedimentation Rates, in acre feet per square mile per year (NRCS 1995).

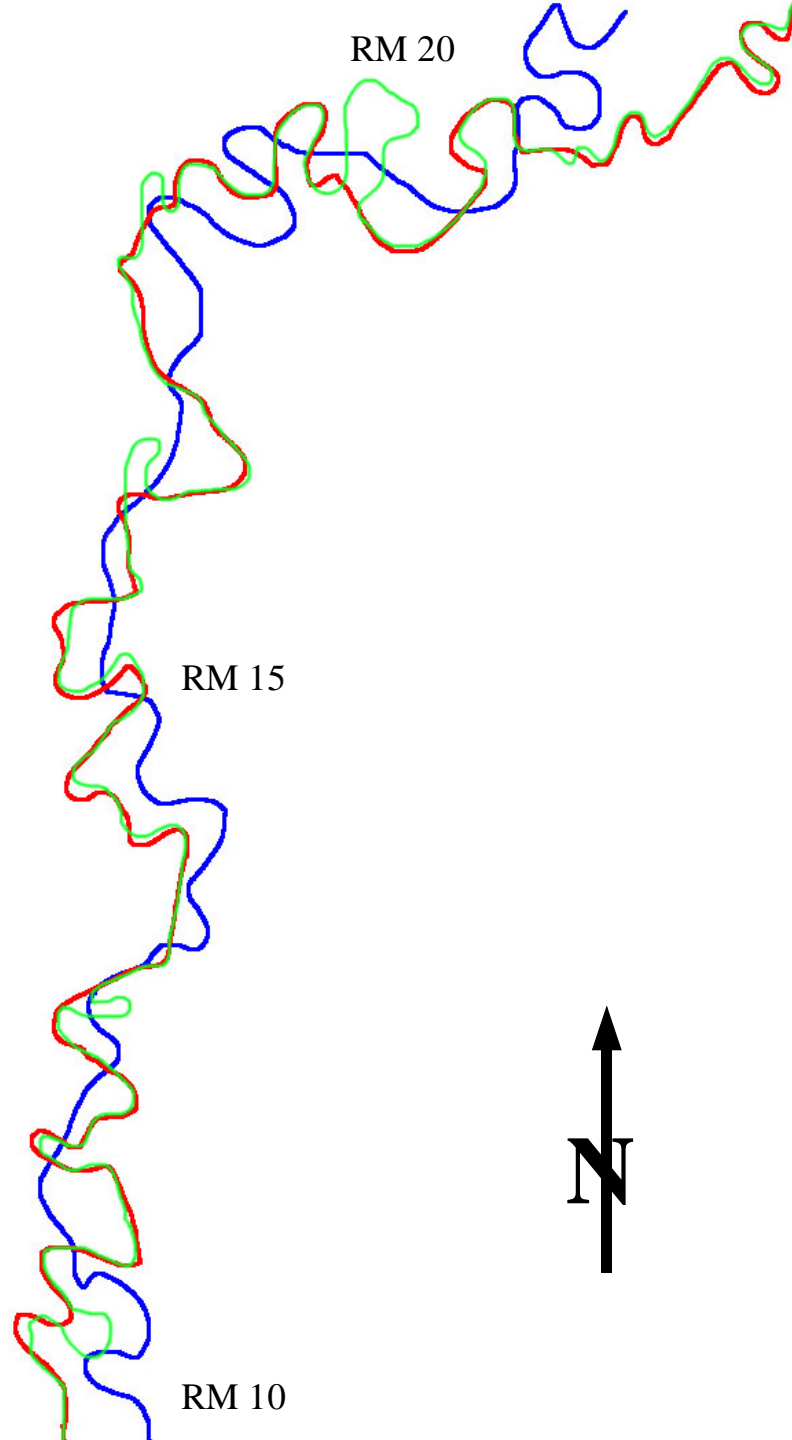
RED 1998
GREEN 1938
BLUE 1820

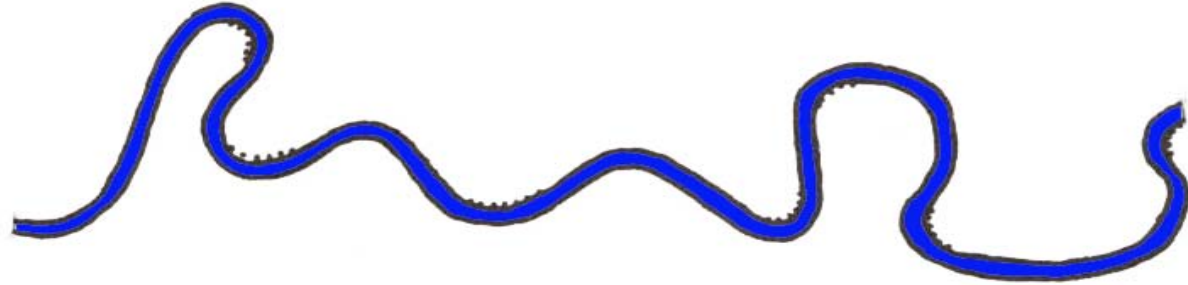
1938

Sinuious Canaliform

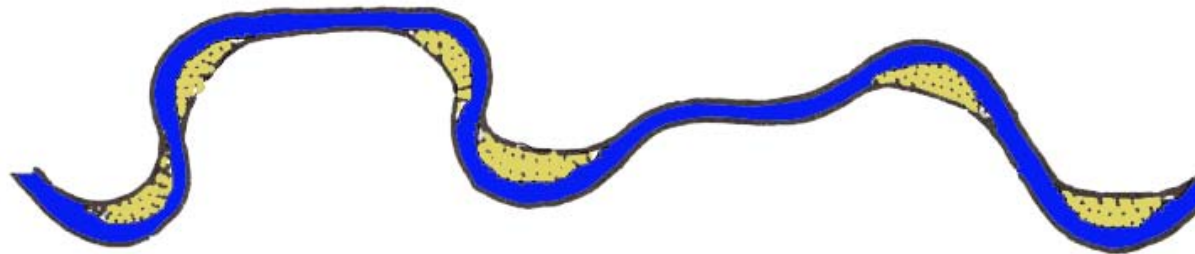
1998

Sinuious Braided Canaliform

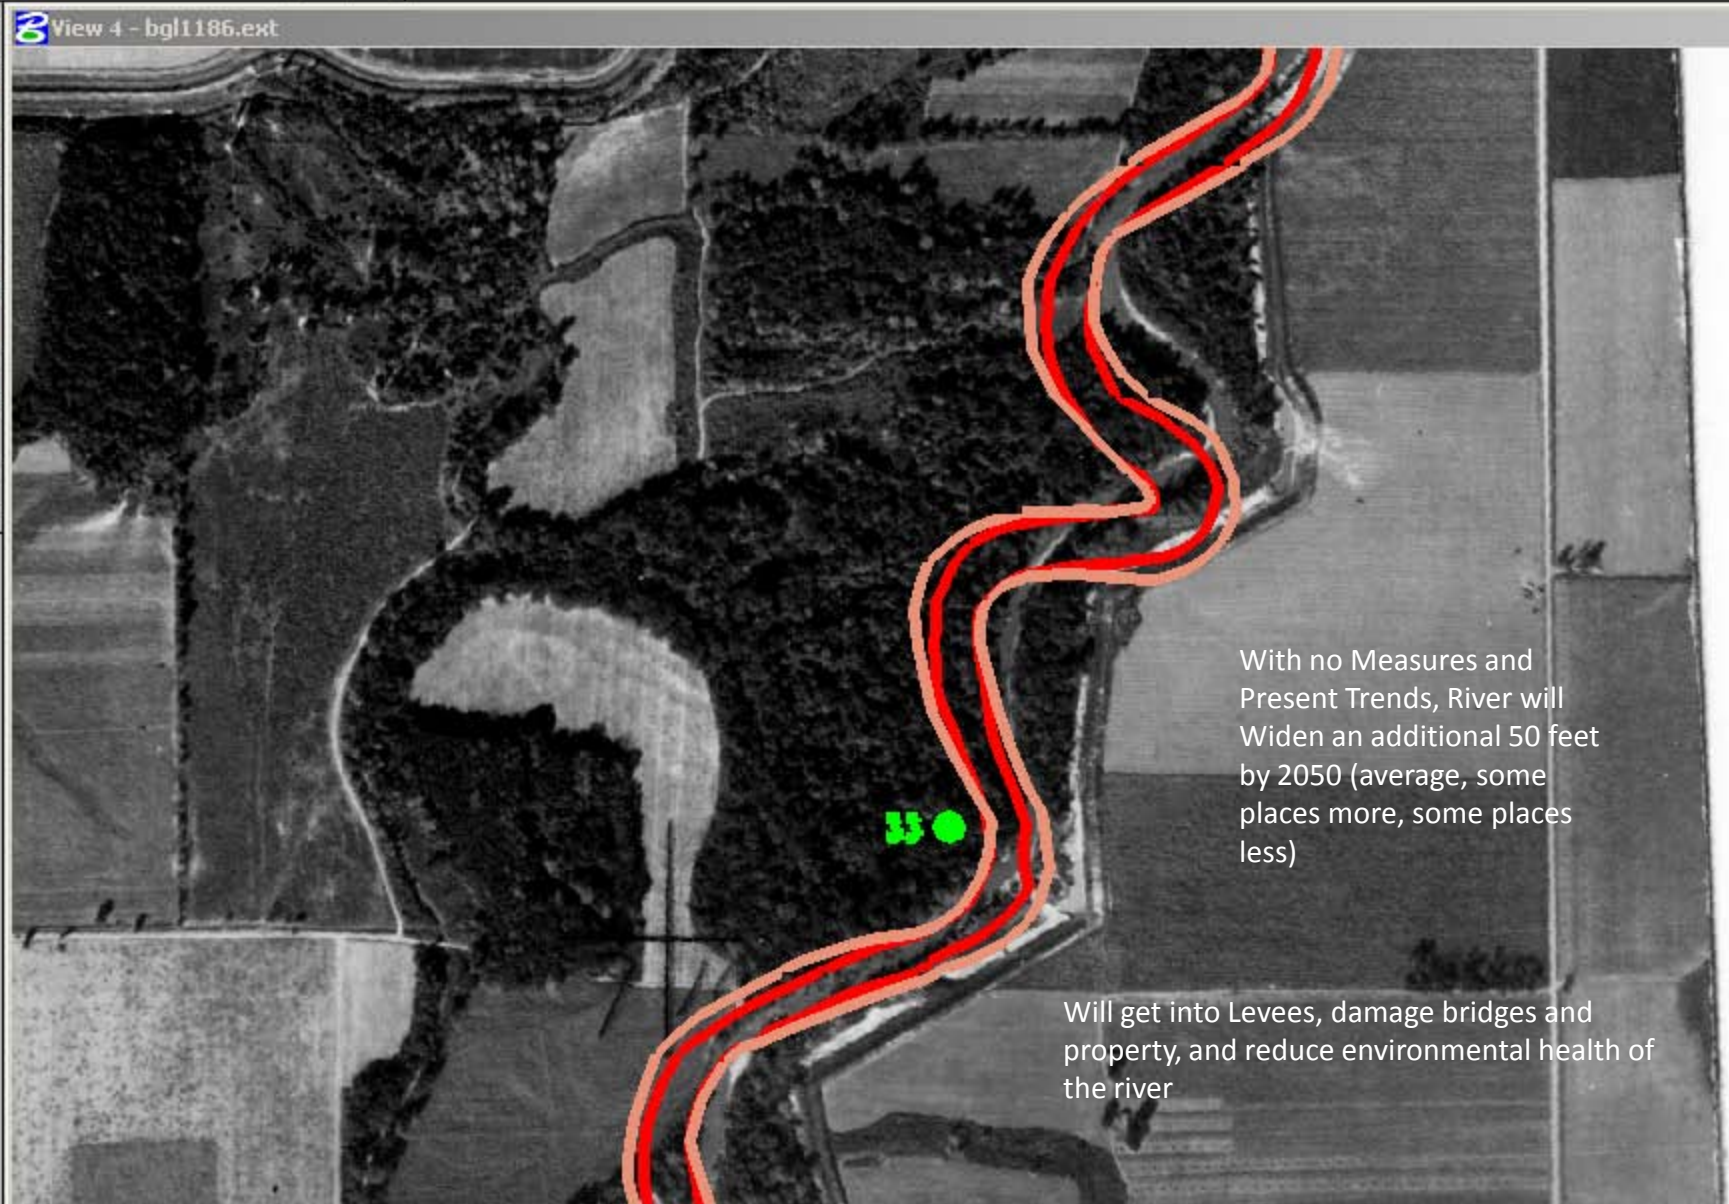
Plan A. Do Nothing

With no Measures and Present Trends, River will Widen an additional 50 feet by 2050 (average, some places more, some places less)

Will get into Levees, damage bridges and property, and reduce environmental health of the river

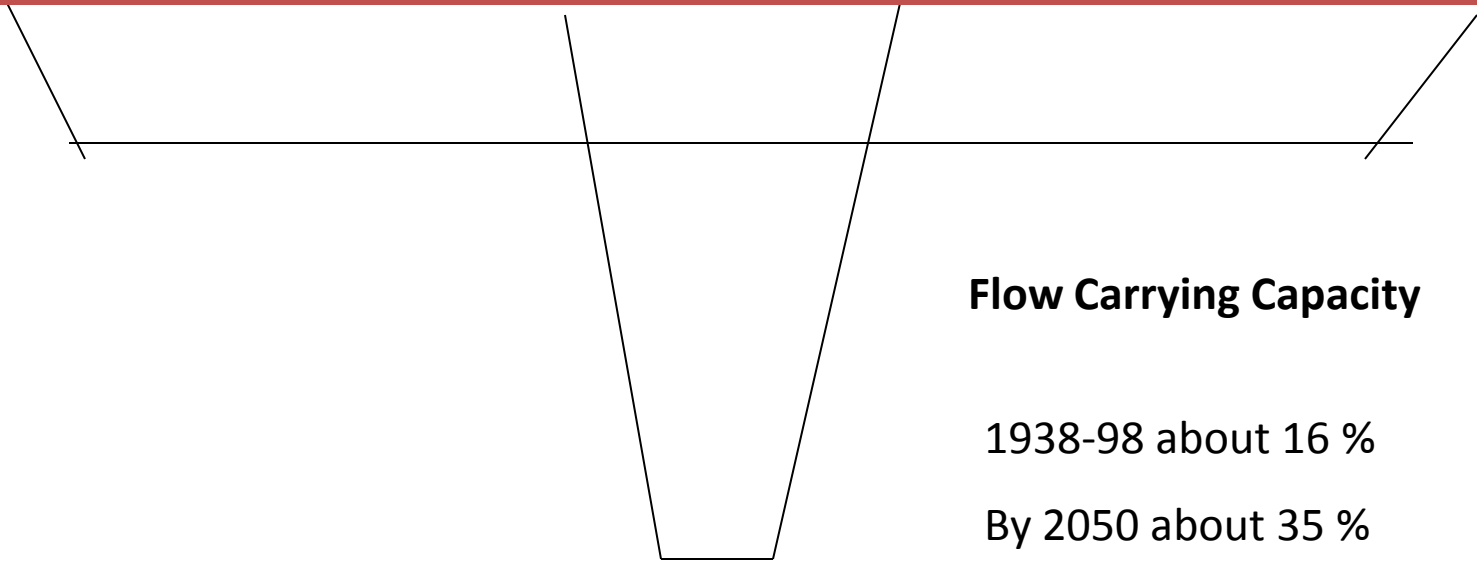
POSSIBLE LOCATION FOR FUTURE
AGRICULTURAL LEVEE FAILURES

Loss of Flood Protection

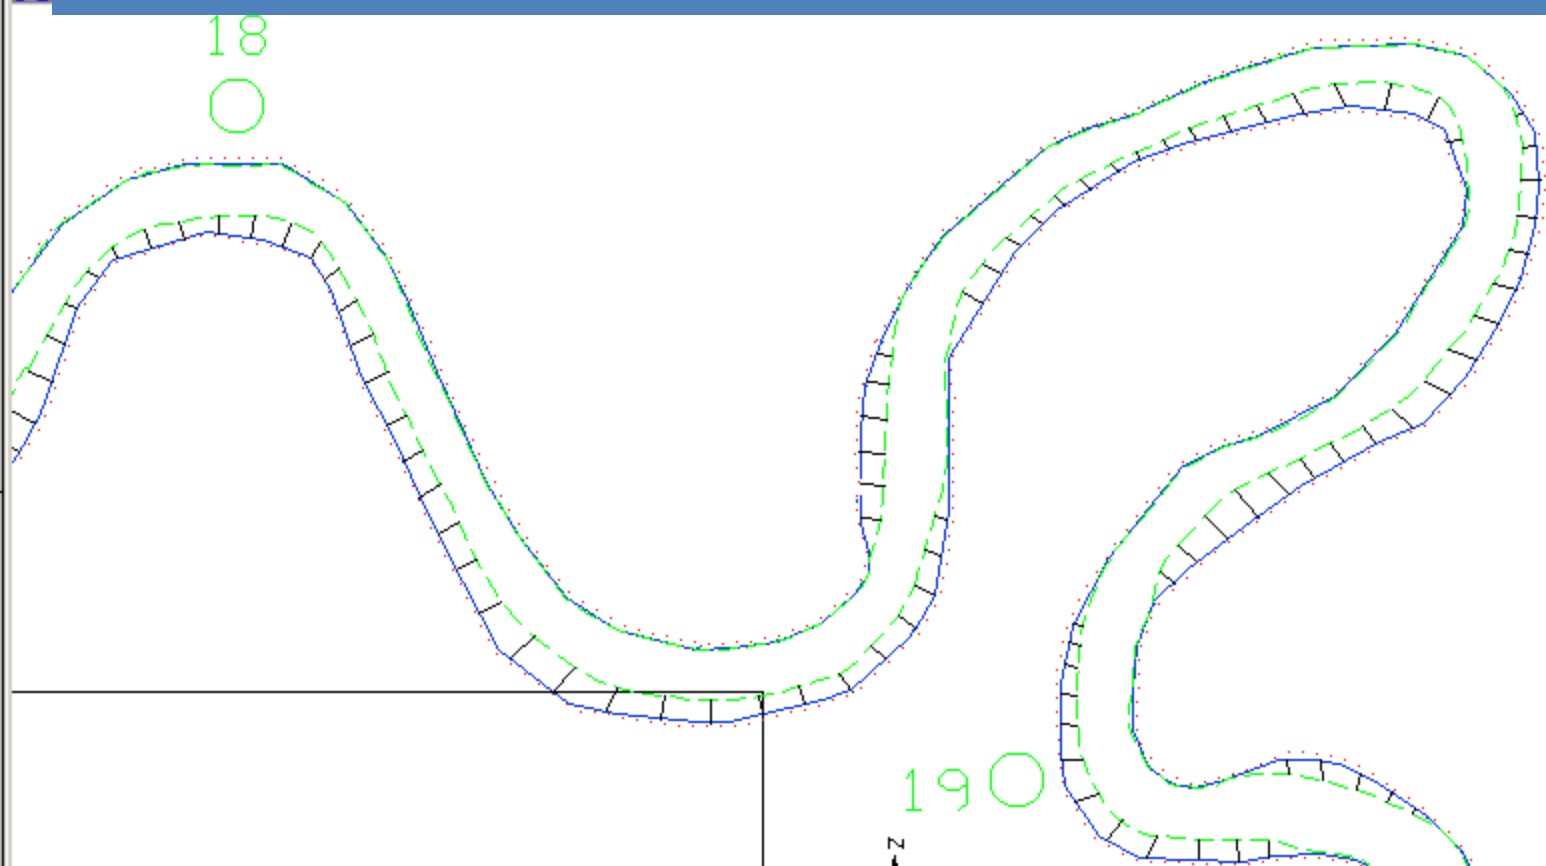
Plan C: Restore the River to Approximate 1938 Planform with Dike and Revetments

1938 RIVER
-

PROPOSED RIVER
-   DIKE STRUCTURES
-   REVETMENT
